Family Forest Fish Passage Program: Barrier Evaluation Form - Single Culvert at Crossing

Project Name: Becerra/Skagit Land Trust		RCO/SRFB Project #:	County: Skagit
Road: Private		Latitude: 48.50618	Longitude: -122.04058
Township: 35	Range: 6 <input checked="" type="checkbox"/> East <input type="checkbox"/> West	Section: 21	¼ Section: SE
Stream Name: Day Cr SI		Tributary To: Day Cr; Skagit R	WRIA #: 3

Level A Culvert Assessment Report

Site ID: DY4	Stream: unnamed	WRIA: 03.0298X	
Latitude: 48.50614	Tributary To: Day Cr Sl	Fish Use Potential: Yes	
Longitude: -122.04127

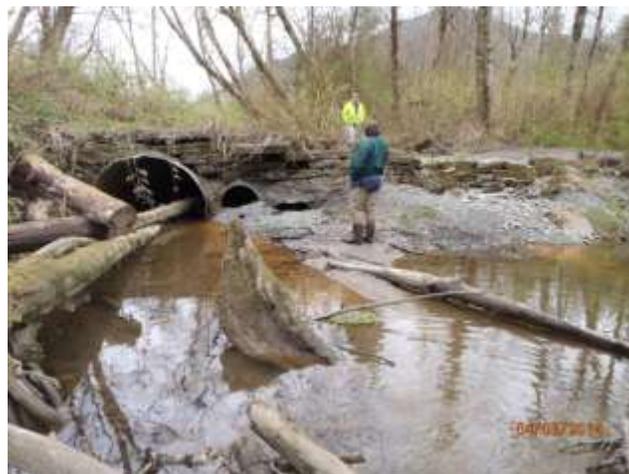
Assessment Results			
Barrier:	Yes	Passability (%):	33
Reason:	Failed	Fishway Present:	No
		Method:	Professional Judgment
		Recheck:

Comments
Inlets of smaller pipes are buried outlets are over half full of sediment, inlet of sqsh pipe is covered with debris. Water flows over road frequently. Stream flows east to west.
