WDFW Fish Passage and Diversion Screening Inventory Database

Site ID 900008

Stream:	Cowling Cr
Tributary To:	Miller Bay
WRIA:	15
River Mile:	-999.99
Fish Use Potential:	Yes
FUP Criteria:	Biological

Level A Culvert Assessment Report

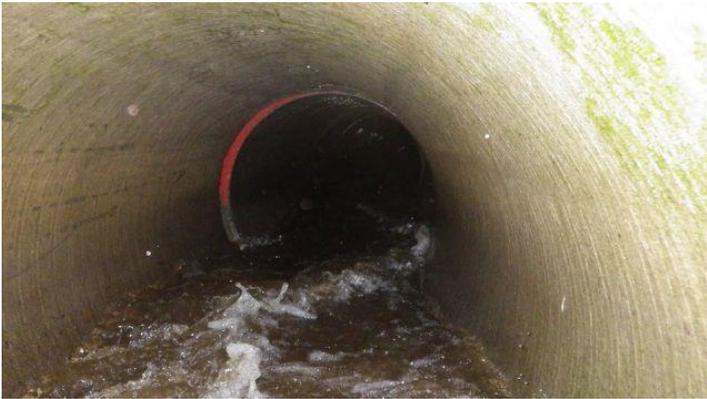
Image Name: 900008_3.JPG, Date/Time: 08/06/2012 03:50

Comments
Culvert 1.2 is on LB, 2.2 is on RB. Picture 3 is inside culvert 1.2, Picture 4 is inside culvert 2.2. Culvert 1.2 turns to the right going downstream under Miller Bay Road.
