# Salmon Creek Culvert Replacement Hydraulic Analysis W. Uncas Road

**Prepared for:**  
**Jefferson County Public Works**  
623 Sheridan Street,  
Port Townsend, WA 98368

**Prepared by:**  
**Watershed Science & Engineering**  
110 Prefontaine Pl S., Suite 508  
Seattle, WA 98104

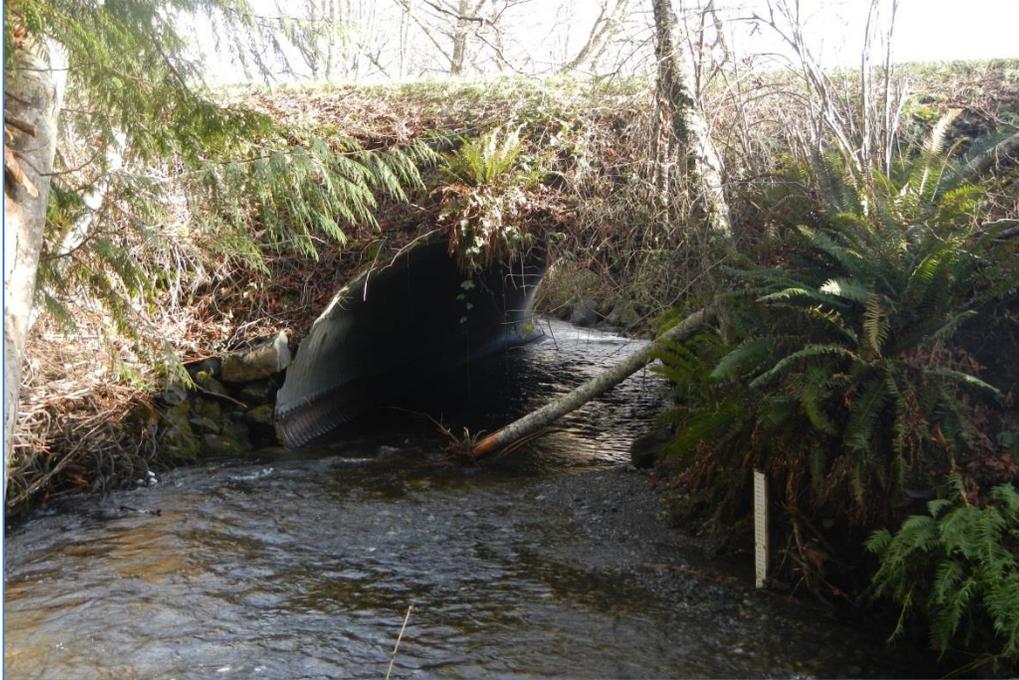
- 2 The road surface is approximately 20 feet above the stream bed and the culvert is buried under approximately 10 feet of fill, as measured from the road crest to the top of the culvert (See Photo 1).

Photo 1. Viewing downstream through the existing culvert opening (Dec 19, 2014). Culvert alignment focuses flow toward the left (north) edge of the culvert opening.

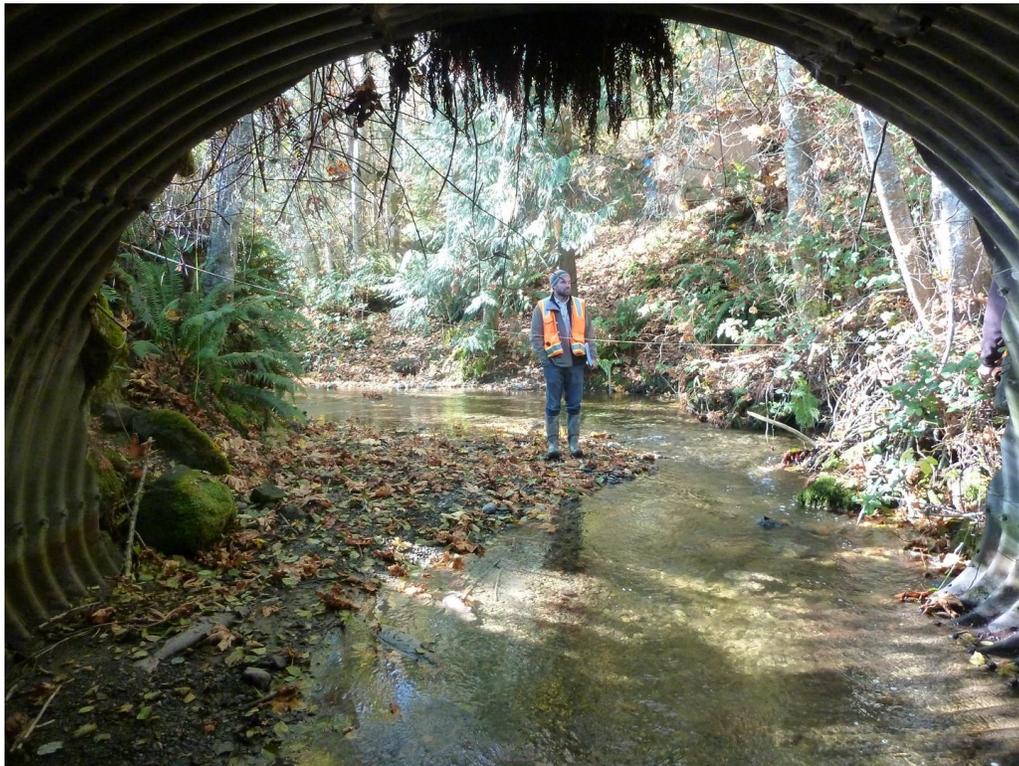
- 3 The culvert is located on a slight skew, and the upstream creek channel bends approximately 130 degrees to enter the culvert (Photo 2 and Photo 3). This has encouraged sediment deposition along the inside of the bend, creating a channel bar, and helps maintain the existing channel thalweg location along the north side of the culvert.

Photo 2. Viewing upstream from culvert entrance. (Photo courtesy of WDFW)

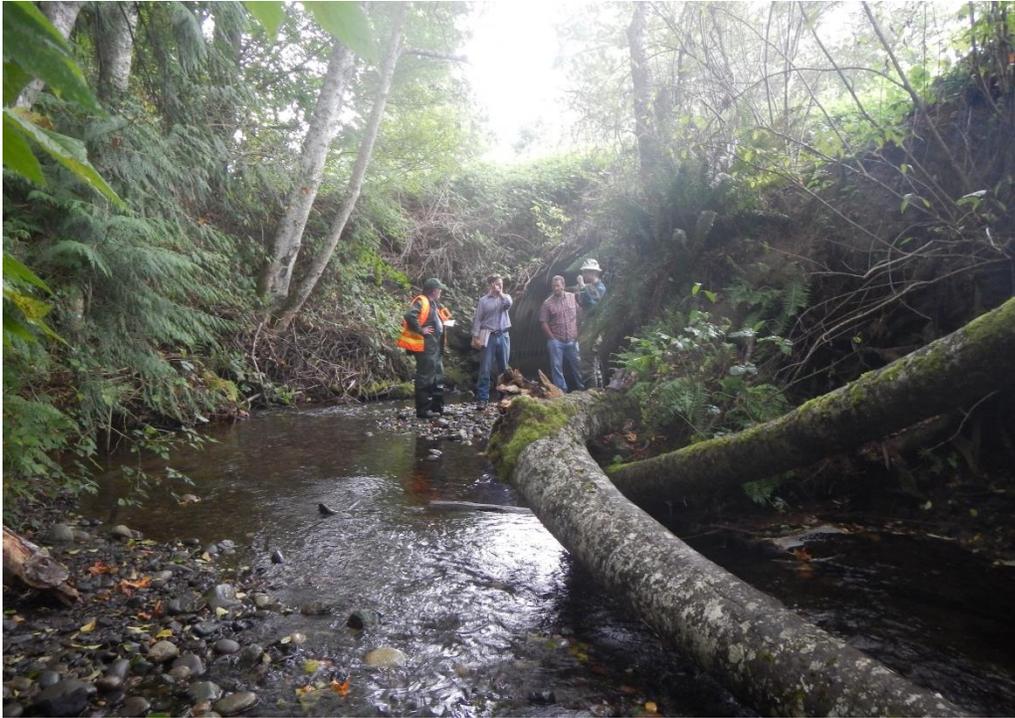
Photo 3. Viewing downstream toward existing culvert from approximately 100 feet upstream (Sept 19, 2014). The individuals pictured are standing on the gravel bar deposited at the entrance to the culvert. The channel bends approximately 130 degrees around the bar to enter the culvert.

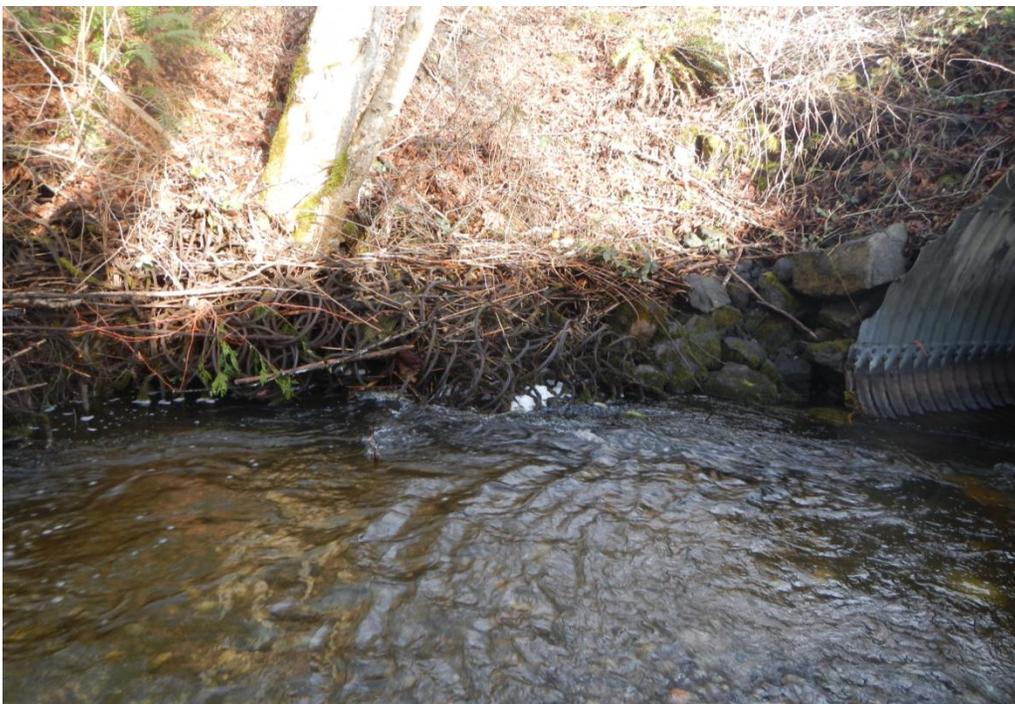
- 4 A scour pool has developed immediately upstream from the crossing along the left (north) bank as a result of the channel bend (Photo 4). Metal wire bank reinforcement is located in this area, presumably to protect the bank from further erosion.

Photo 4. Scour pool at culvert entrance (Dec 19, 2014). Coiled wire along the bank is currently helping to prevent additional erosion.

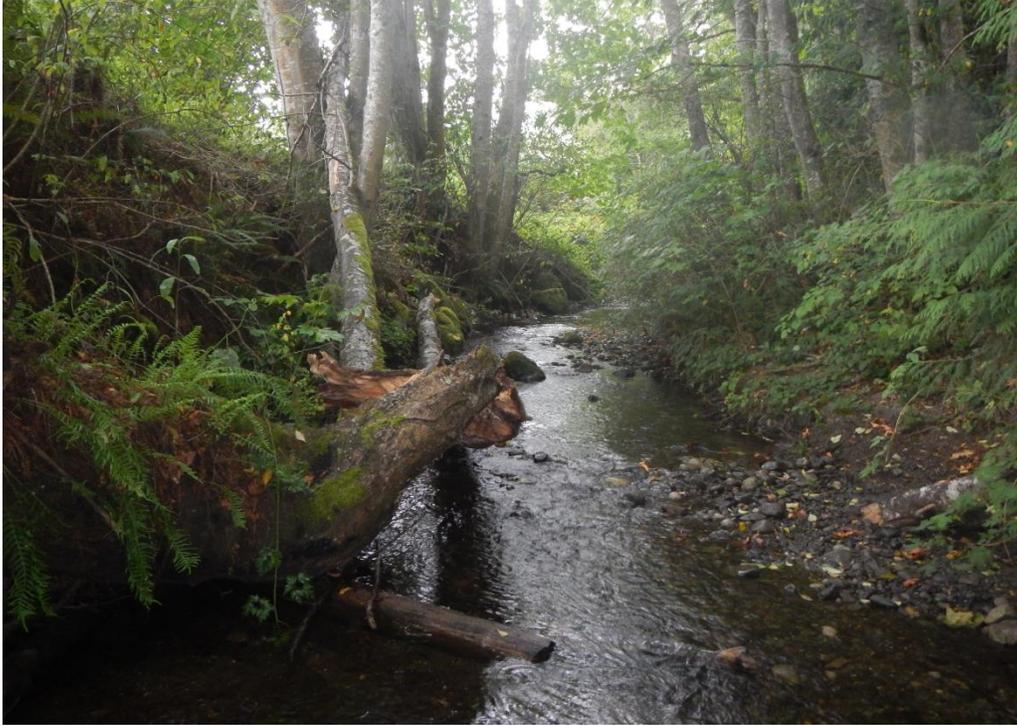
- 6 The creek channel upstream from the crossing is entrenched and shows evidence of past incision. Banks are steep and have been armored in many locations (Photo 5, Photo 8). The channel banks currently appear stable with no evidence of significant lateral erosion.

Photo 5. Viewing upstream from the scour pool at the culvert entrance (Dec 19, 2014). Riprap protection is present on the east channel bank (left of photo).

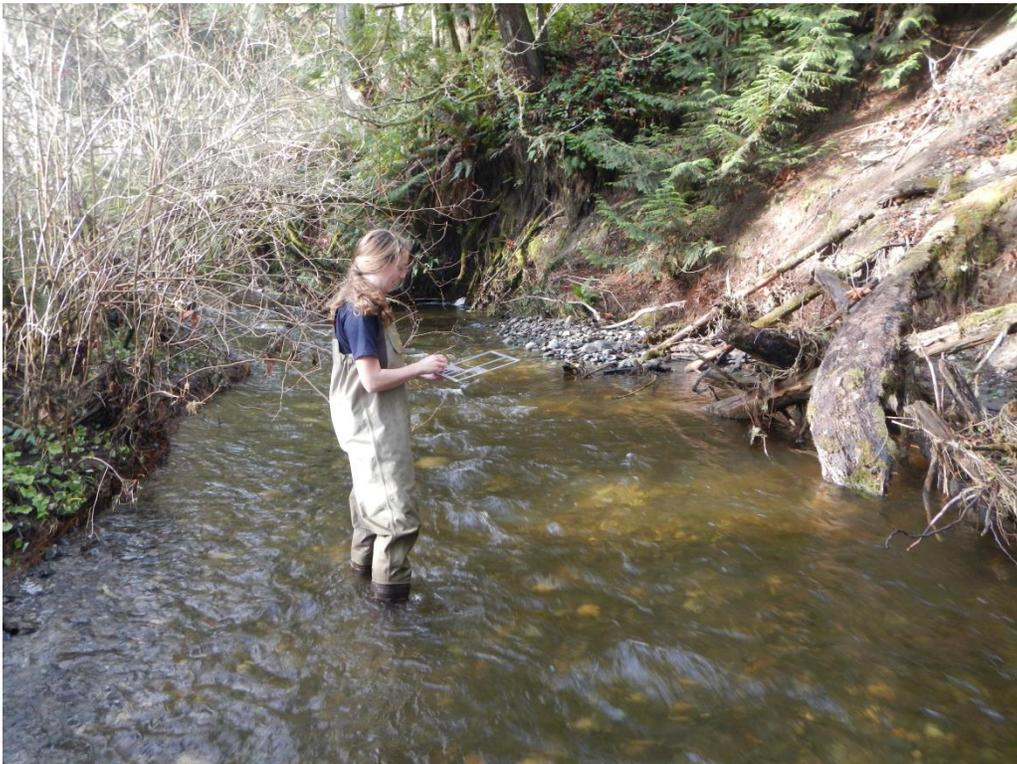
- 8 WSE completed Wolman Pebble counts in order to estimate a surface bed material gradation (Photo 6). Two separate counts were conducted: one at the riffle immediately upstream from the culvert and the other approximately 600-feet upstream. Both counts suggest a mean particle diameter ( $D_{50}$ ) of approximately 35 mm (1.5 inches, see Figure 2). (Note – Figure 2 contains additional sediment size gradation data which will be discussed later in this report.)

Photo 6. WSE conducting a Wolman pebble count at a location approximately 600 feet upstream of culvert crossing (Dec 19, 2014).

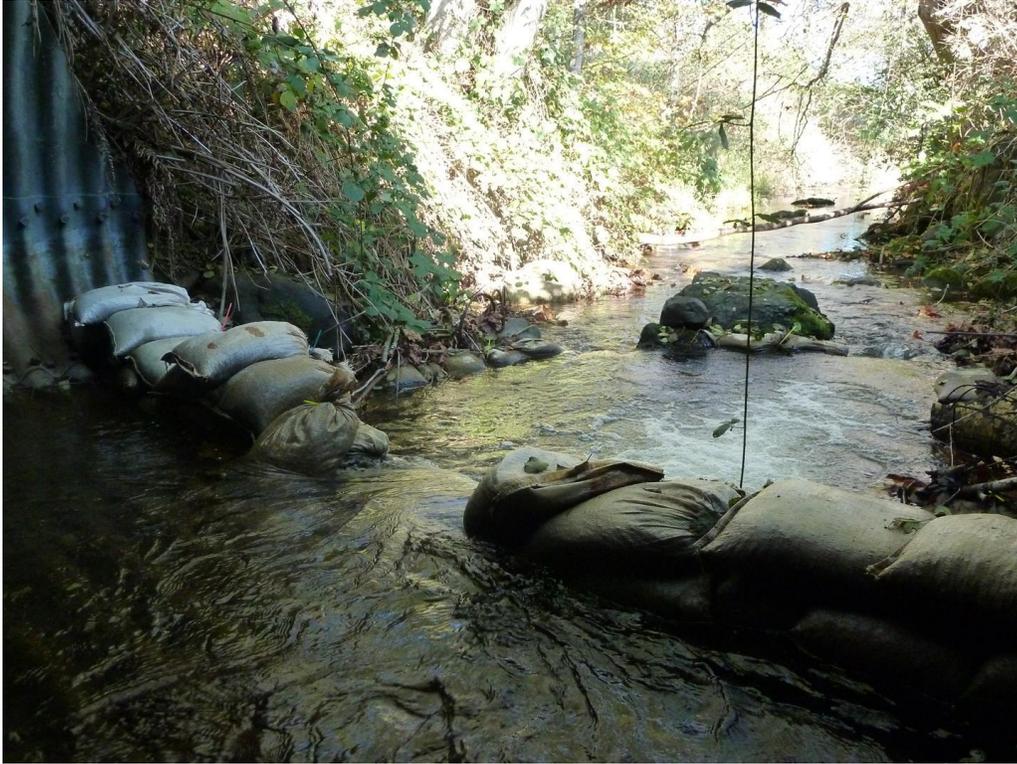
- 9 Photos 7 and 8 show the condition of the downstream channel and the drop at the culvert outlet. Sandbag weirs shown in Photo 7 are placed seasonally to backwater the culvert and improve fish passage conditions. Current downstream channel conditions are shown in Photo 9.

Photo 7. Viewing downstream through culvert outlet to downstream channel (Sept 2013). Sand bag weirs are installed seasonally as a temporary retrofit to improve fish passage. (Photo courtesy of WDFW)

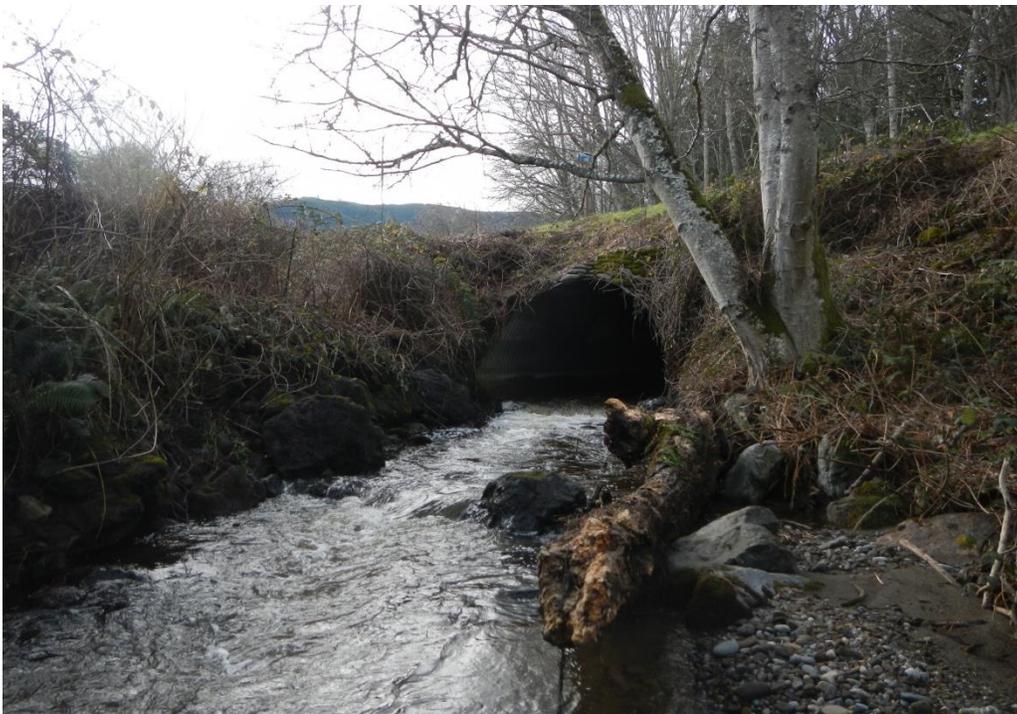
Photo 8. Viewing upstream toward culvert outlet on December 19, 2014 (sand bag weir shown in Photo 7 have since been removed).

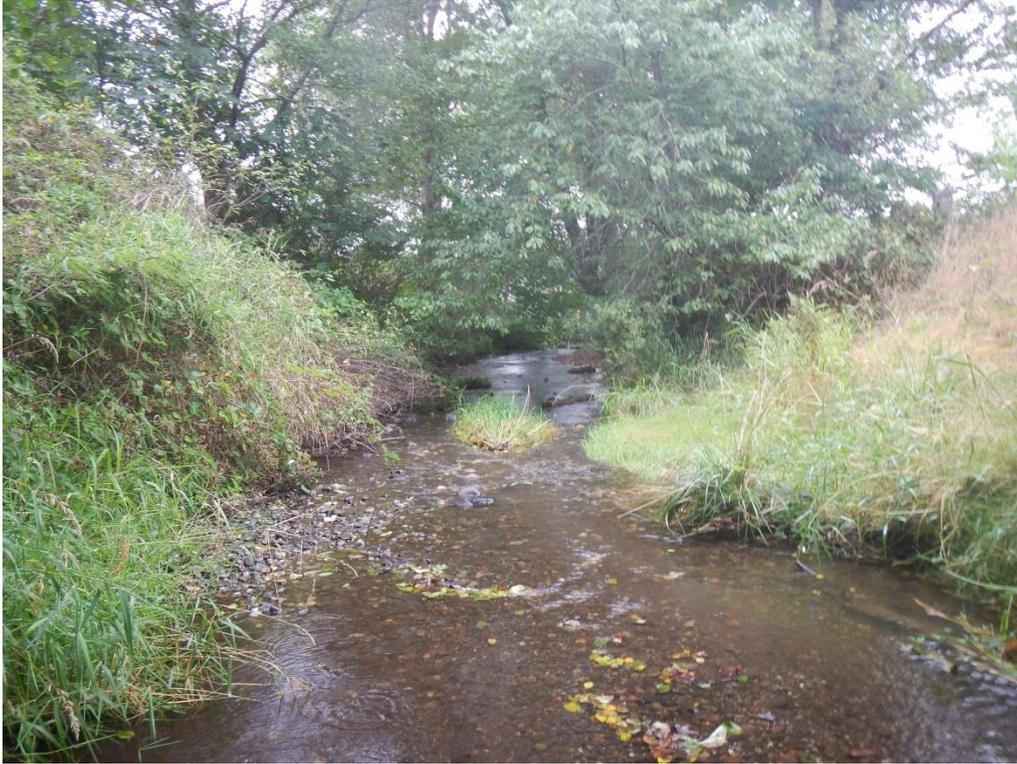
Photo 9. Viewing downstream to downstream channel from near location of Photo 8 (Sept 19, 2014).
