### **Wild Fish Conservancy Watertype Assessment Project Summary WRIA 13 Phase III**

**December 2014**

#### **WRIA 13 Assessment Project –Phase III**

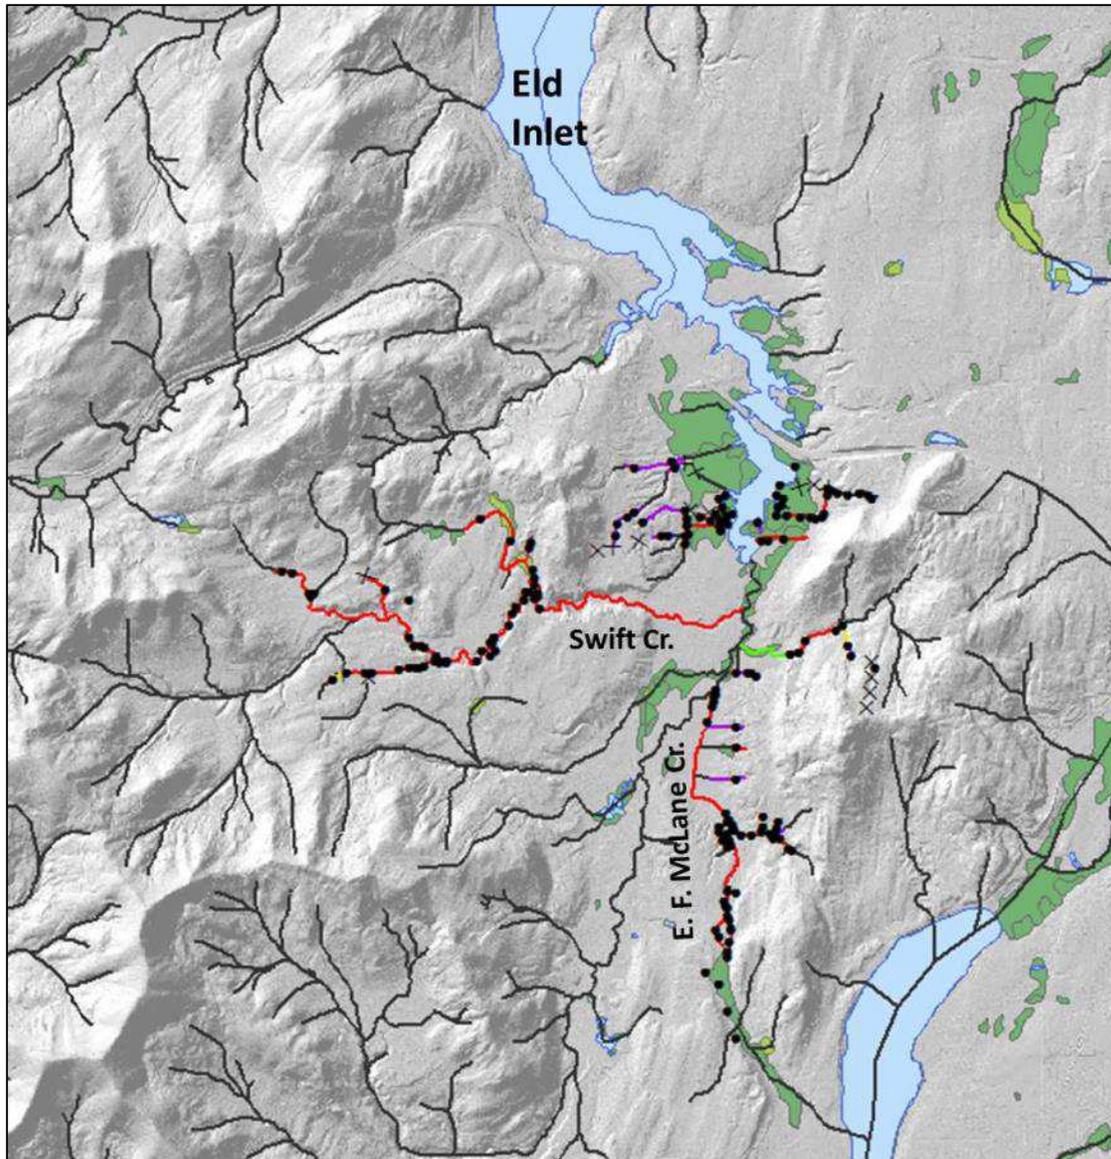
Figure 1. Geographic extent of WFC's WRIA 13 Water Type Assessment - Phase III in Thurston County.

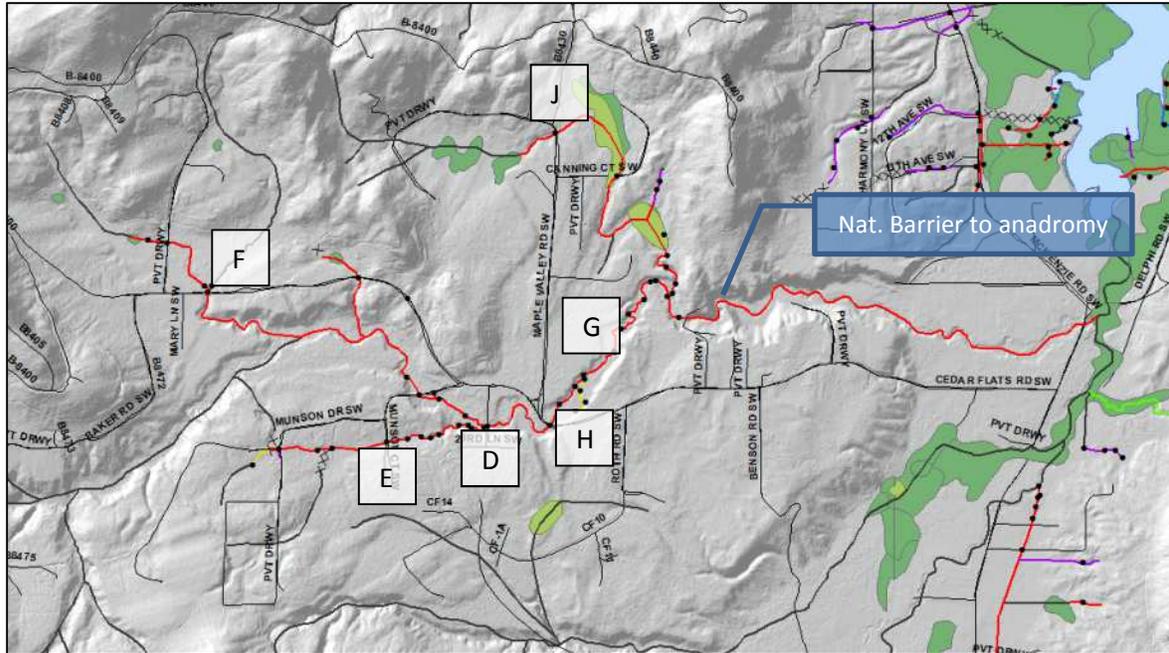
Figure 2. Swift Creek subbasin assessment area. Letters in boxes reference project opportunities identified in Appendix A.

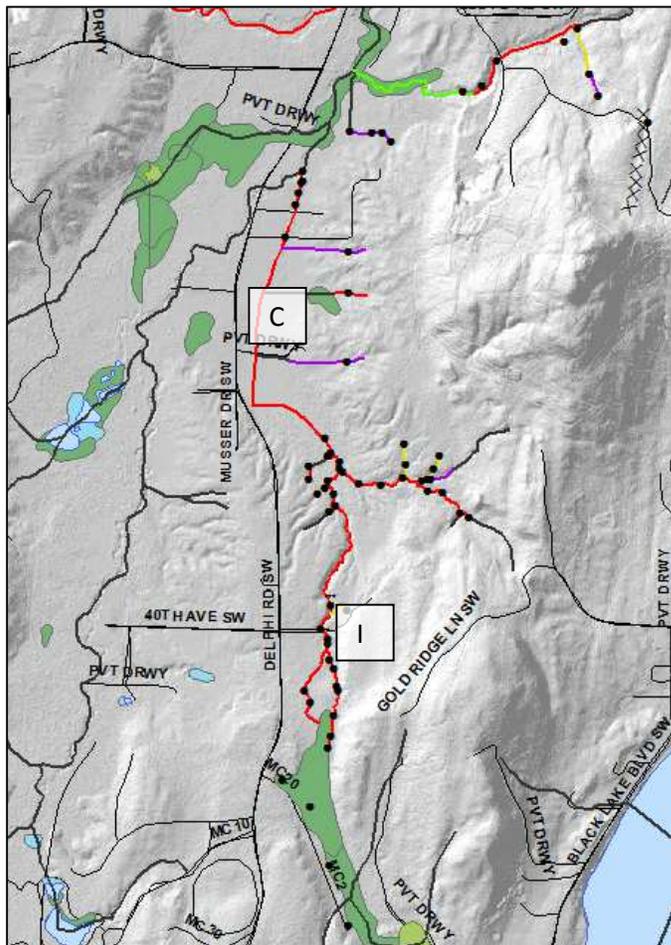
Figure 3. East Fork McLane subbasin assessment area. Letters in boxes reference project opportunities identified in Appendix A.

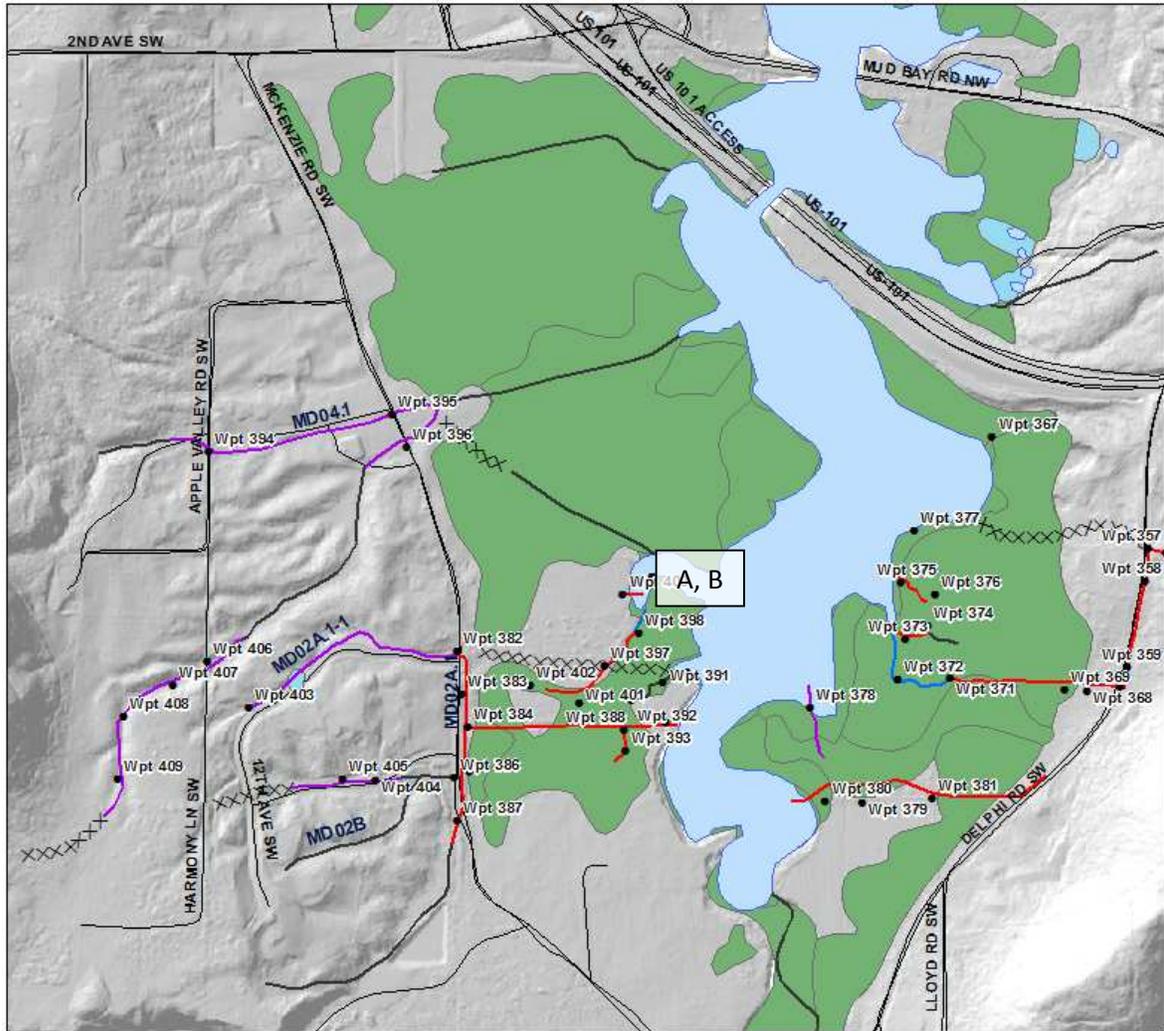
Figure 4. Survey extent – Mud Bay tributaries. Letters in boxes reference project opportunities identified in Appendix A.

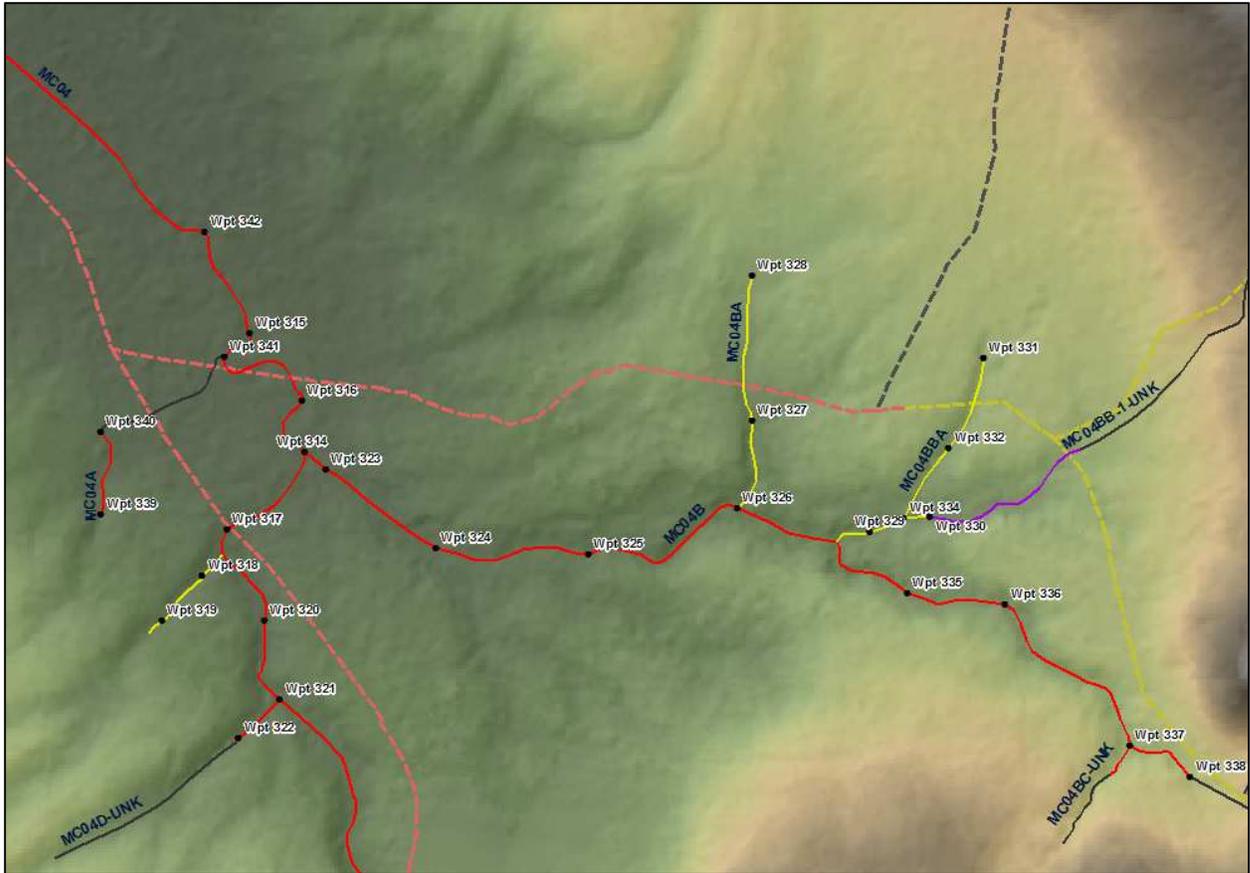
As expected based on previous Wild Fish Conservancy water type assessments, significant discrepancies existed between the Washington Department of Natural Resources (WDNR) regulatory maps and what we found on the ground (Figure 5). For example, over the study area WDNR had identified 24.8 miles of streams. WFC found that 1.1 miles of those WDNR mapped channels did not exist, but that an additional 3.4 miles of stream channels did exist that were not on the official WDNR water type maps.

Figure 5. Example of discrepancy between DNR modeled stream channel location (dashed) and classification, and WFC field observations (solid). This is an unnamed right-bank tributary to East Fork McLane.
