Figure 6. Lower Big Quilcene River area photos

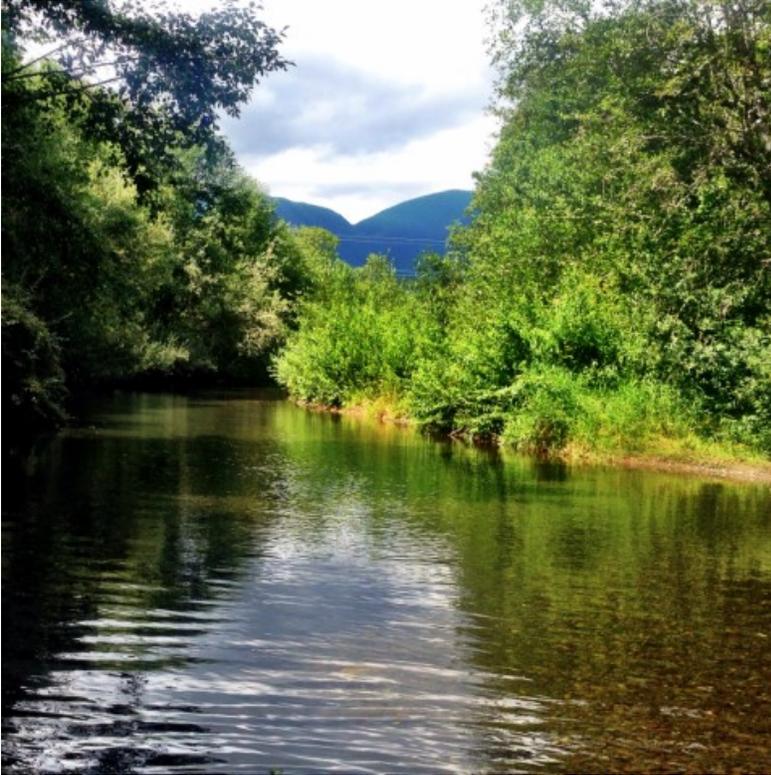
Photo 1. Lower Big Quilcene River Looking west toward Olympic Mountains. The shallow riffle demonstrates the aggradation in this part of the river. Much of the flow is below the substrate surface.

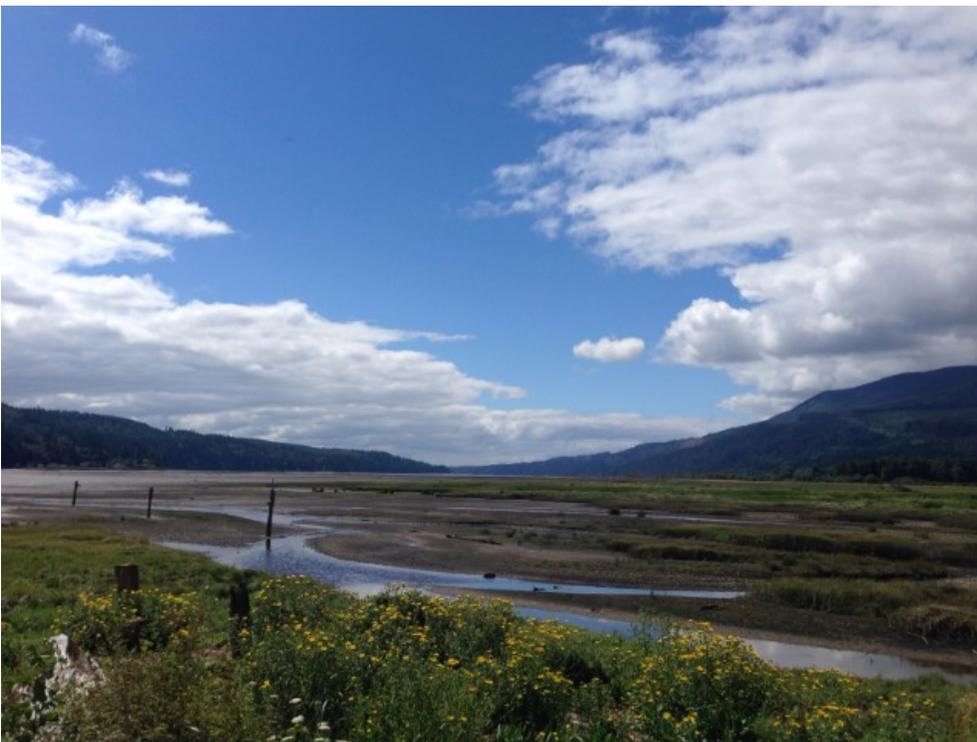
Photo 2. Big Quilcene River estuary. Looking south toward shellfish beds and the mouth of Quilcene Bay

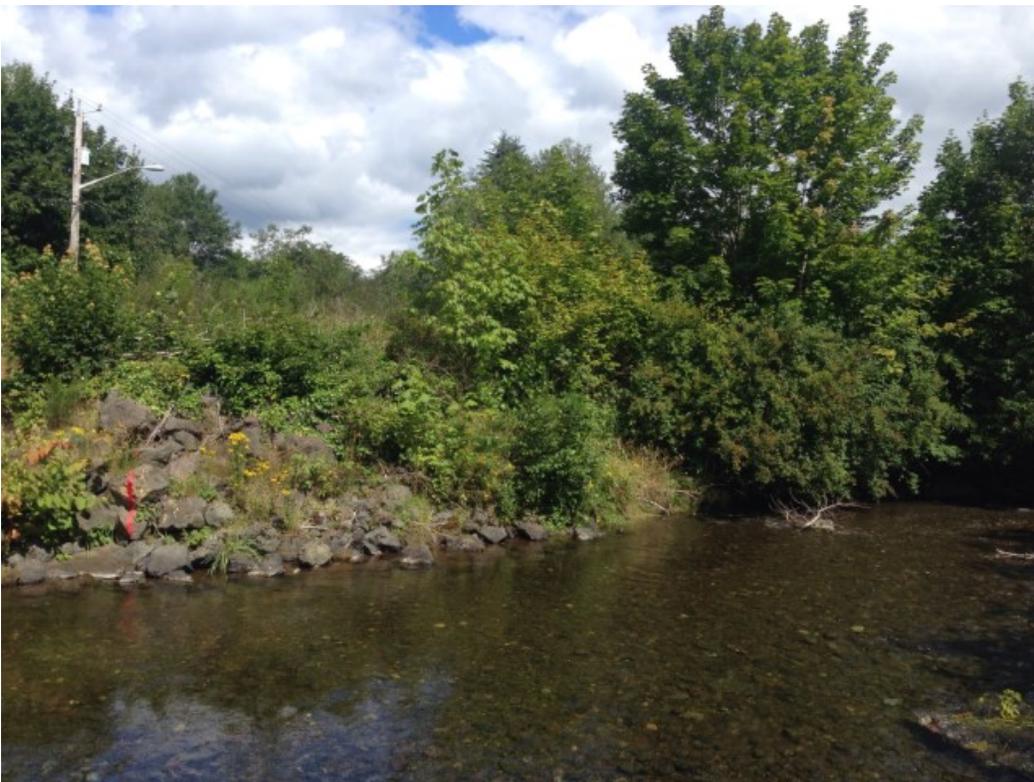
Photo 4. Big Quilcene River at Rogers Road. There is armoring along the levees on both sides here, restricting access to habitat and natural river flow.
