Figure 2. Beach Lake Acquisition and Restoration Project and Elwha Dam Removal Sediments. The dominant direction of sediment transport at the project shoreline will deliver material from the expanding delta to the project site. Acquisition and removal of shoreline armor will encourage natural deposition of beach building sediments as delta evolves. Derelict armor being planned for removal is directly adjacent to delta.

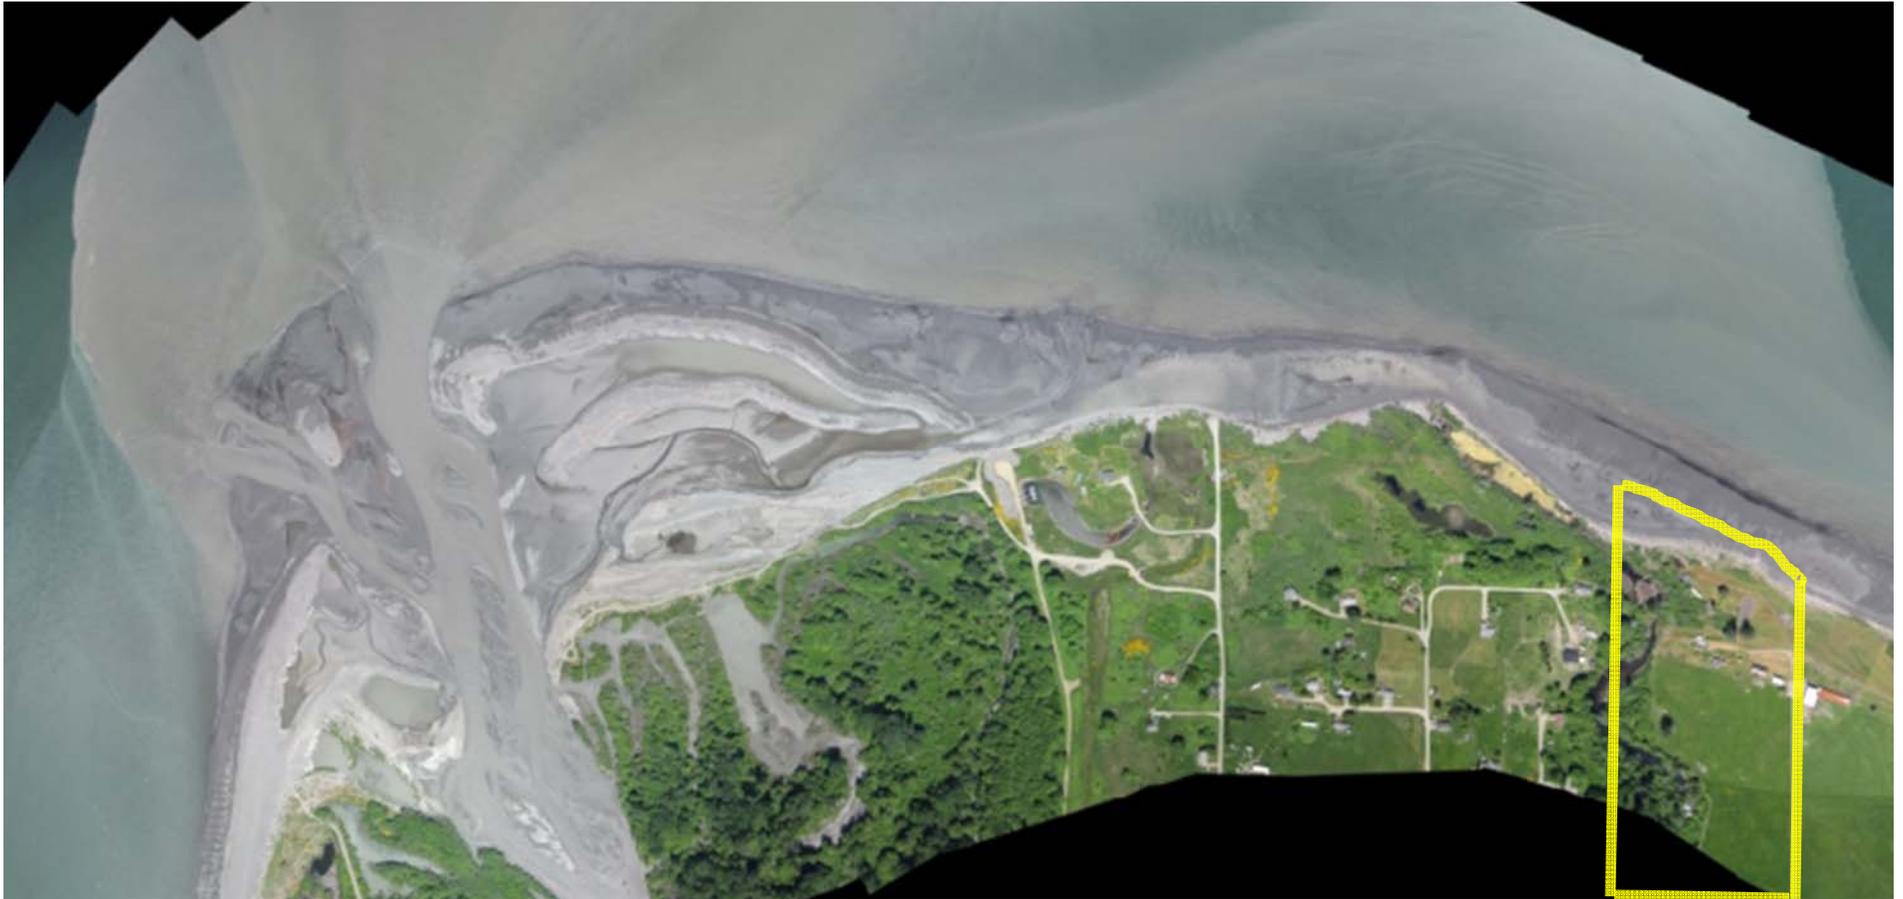
Figure 1. Beach Lake parcel in relation to the Elwha River. Parcel is less than 1 mile from main river channel and less than 1,200 feet from the easternmost channel of the delta. Rapid expansion of the delta is occurring as a result of sediments made available by the removal of 2 dams from the river - it is anticipated that the project site will be within the delta complex shortly. (AerialPhoto: Andy Ritchie, USGS April 2015)

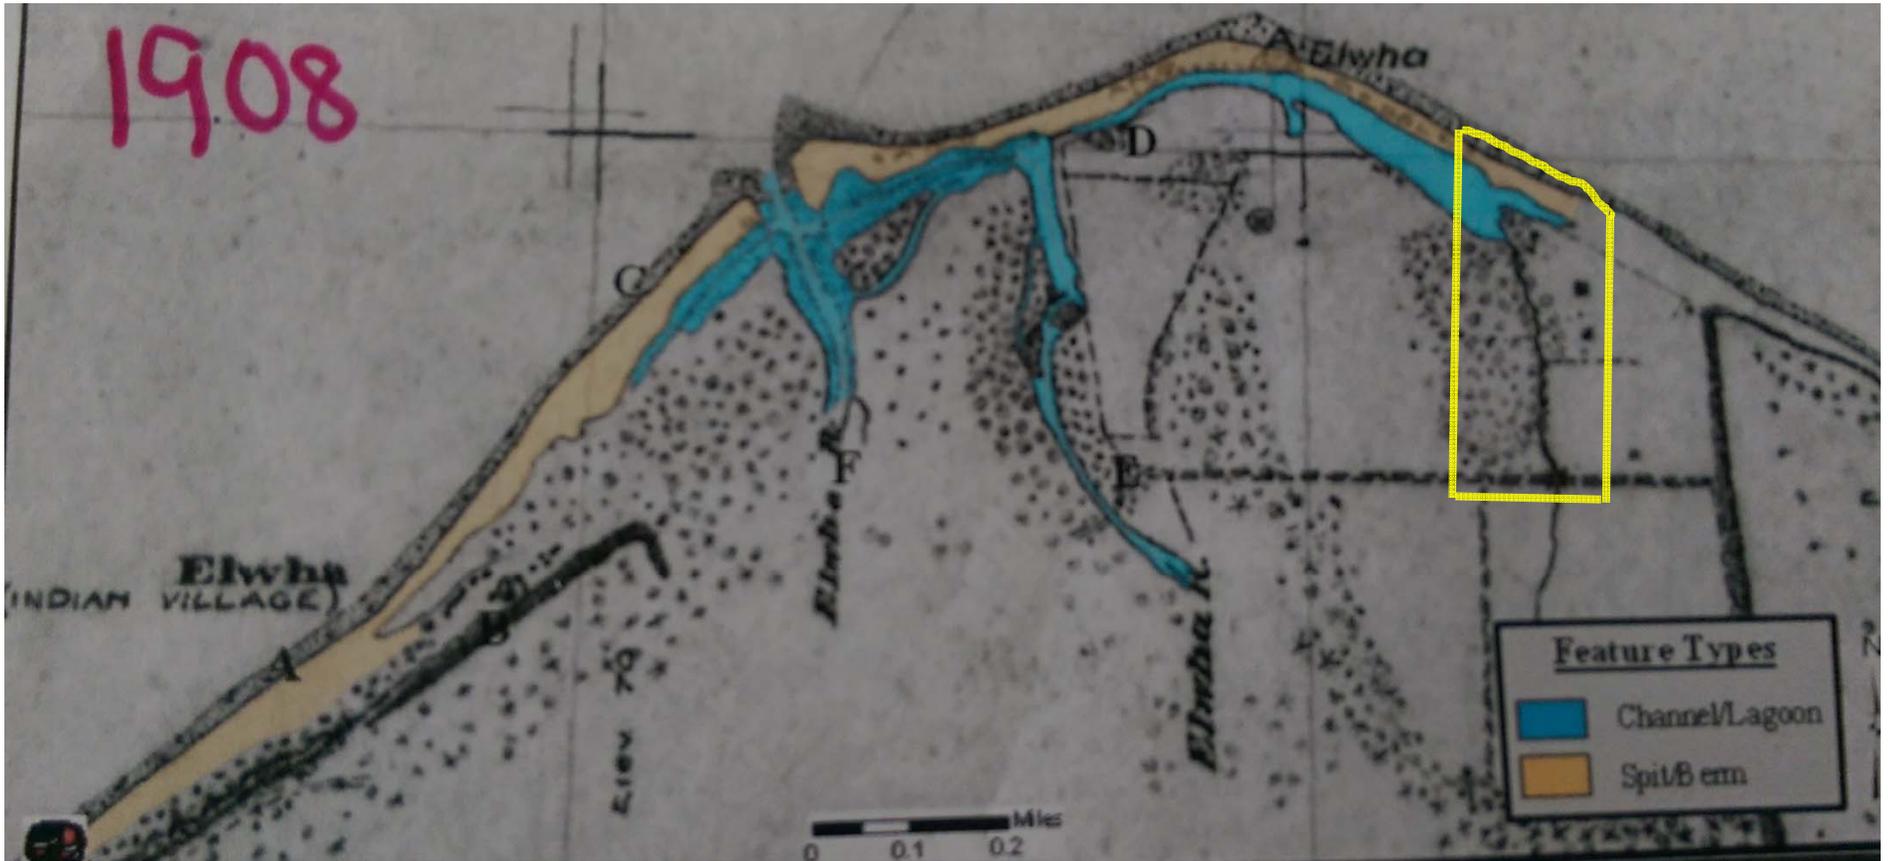
Figure 3. Beach Lake was historically a lagoon hydrologically connected to both the mainstem Elwha River and floodplain high flow channels.

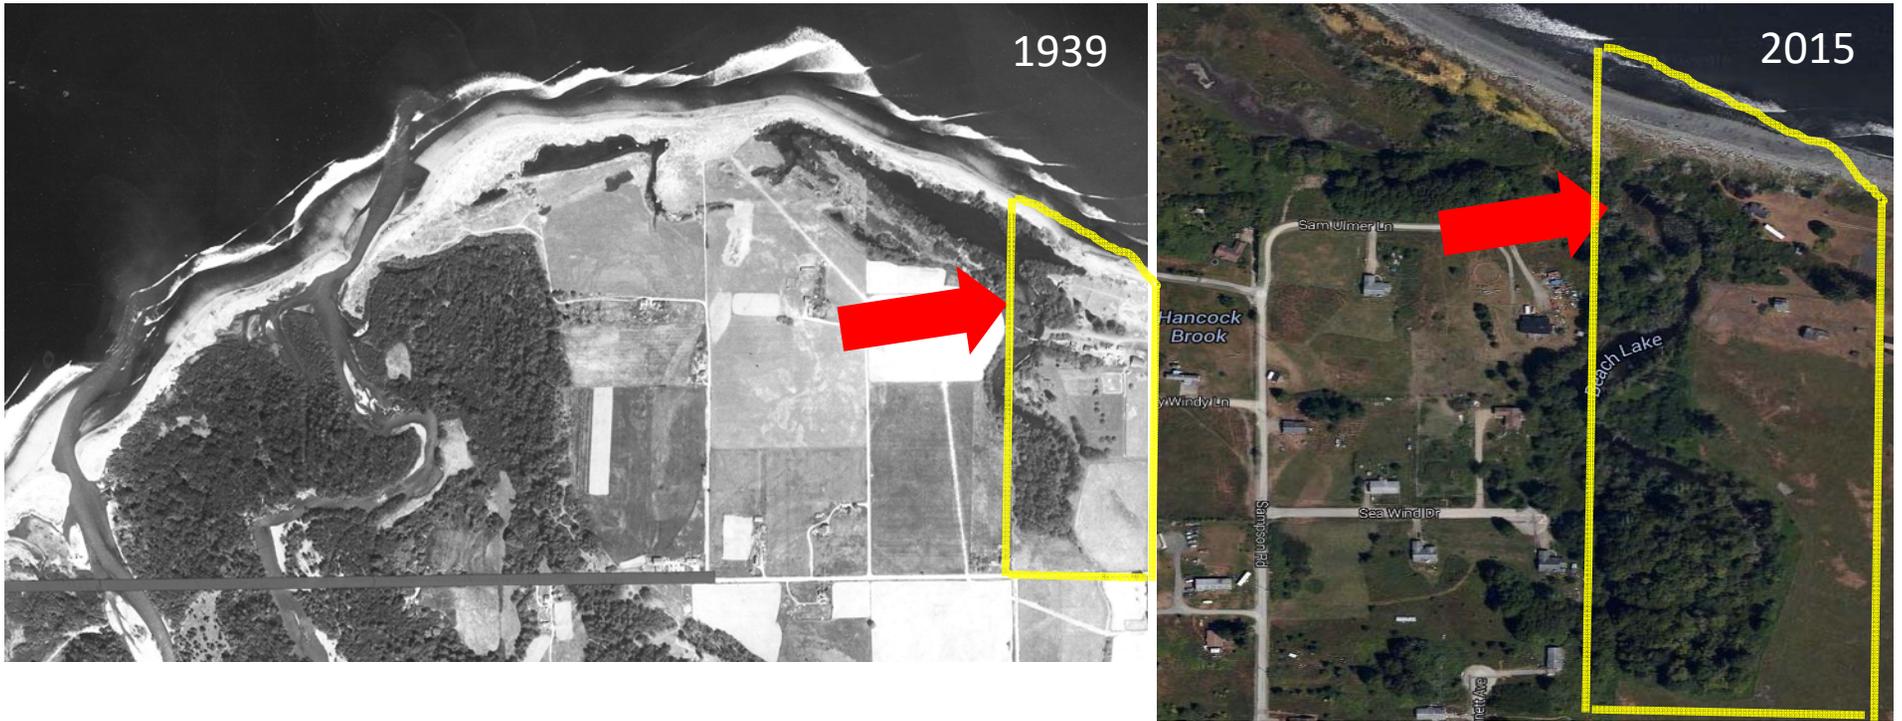
Figure 4. Beach Lake has transitioned to a much smaller isolated lake as a result of coastal erosion exacerbated by sediment starvation associated with the former river dams. Arrow depicts same location in both graphics. Now that the dams have been removed, it is anticipated that the shoreline at the project site will become incorporated into the Elwha River delta estuary. Removal of failed shoreline armor will improve the capacity of the project area shoreline to receive beach forming sediments and allow unimpeded Beach Lake evolution.

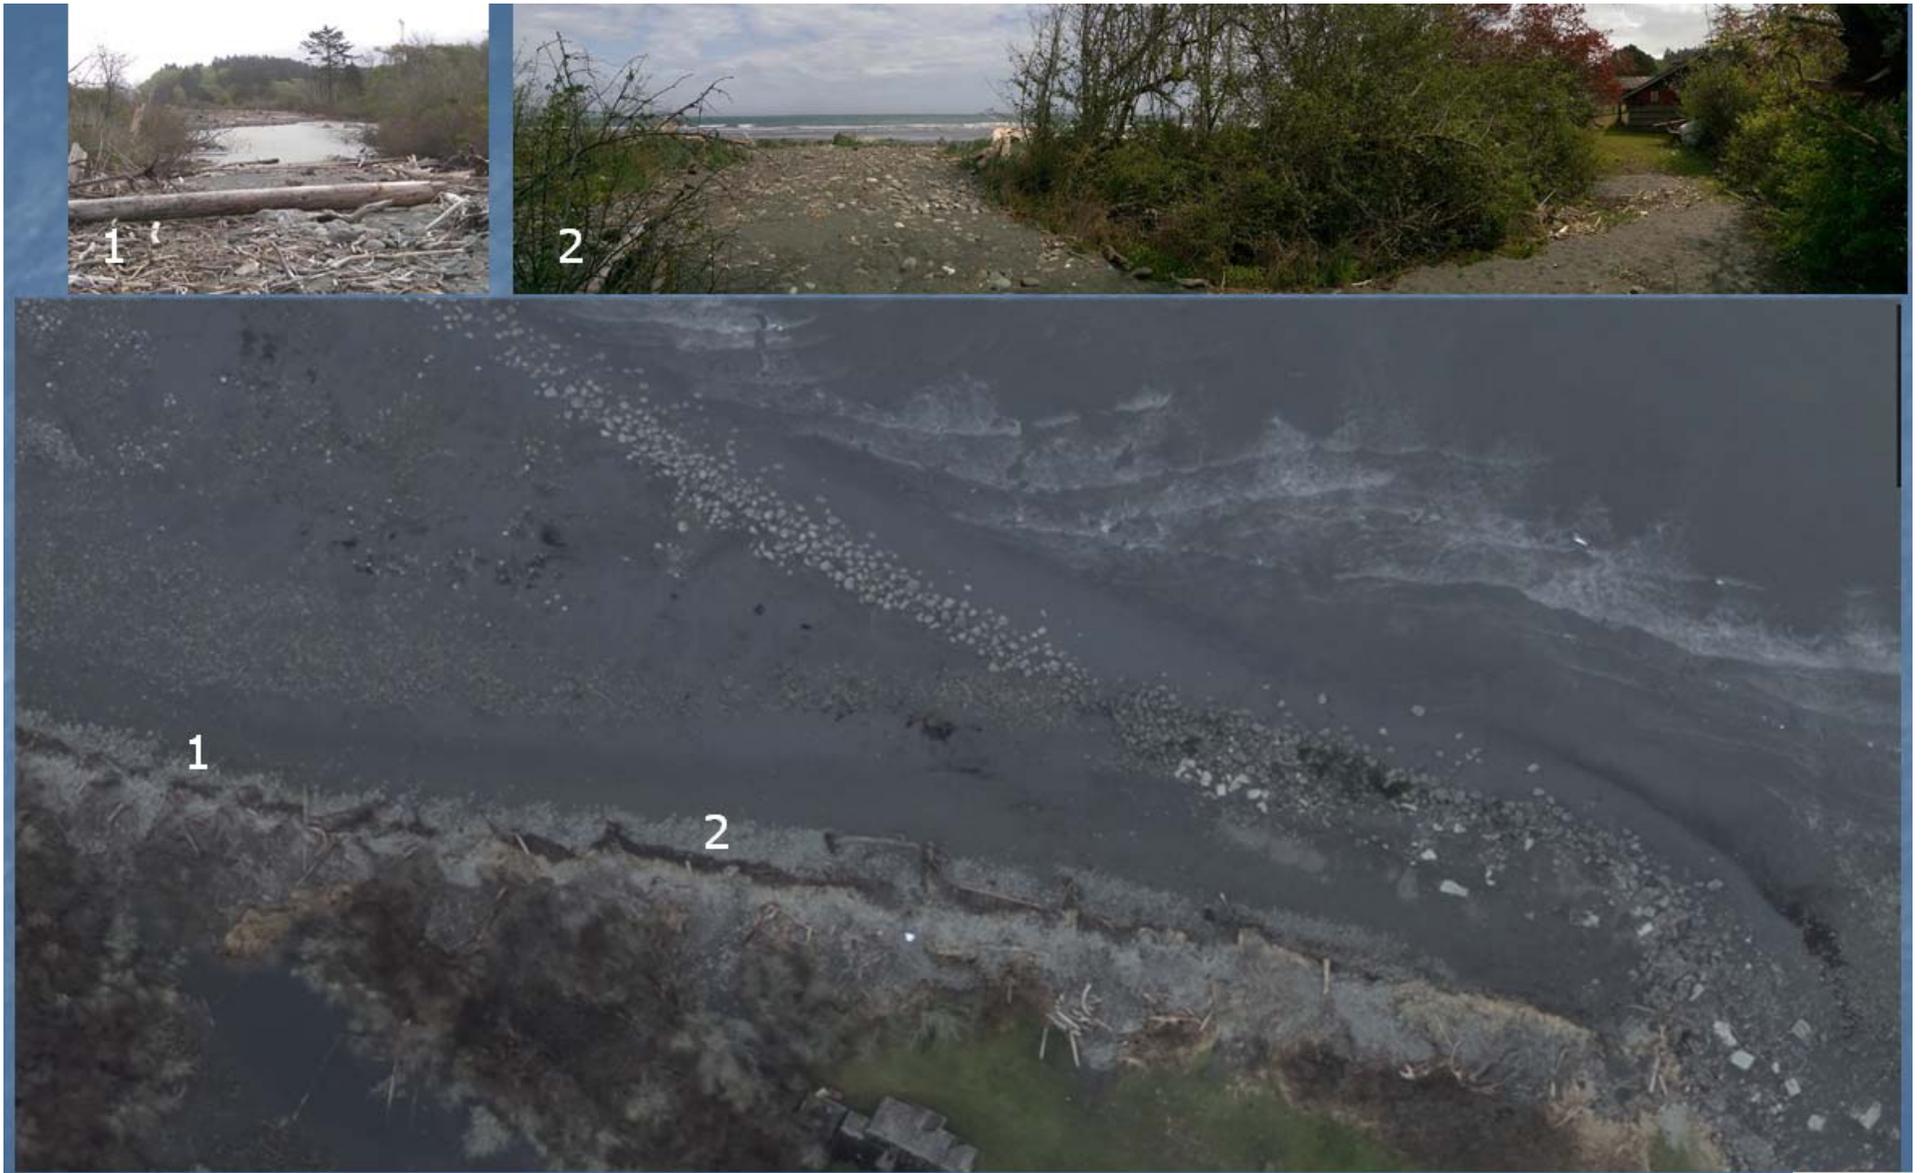
Figure 5. Approximately 2,070 linear feet of failed armor litter the upper and lower intertidal in front of and adjacent to the Beach Lake property. This proposal will design for the removal of derelict armor to encourage natural deposition of beach forming substrate made available by dam removal. Points 1 and 2 indicate current coastal flood breach points. (AerialPhoto: Andy Ritchie, USGS Feb 2015)

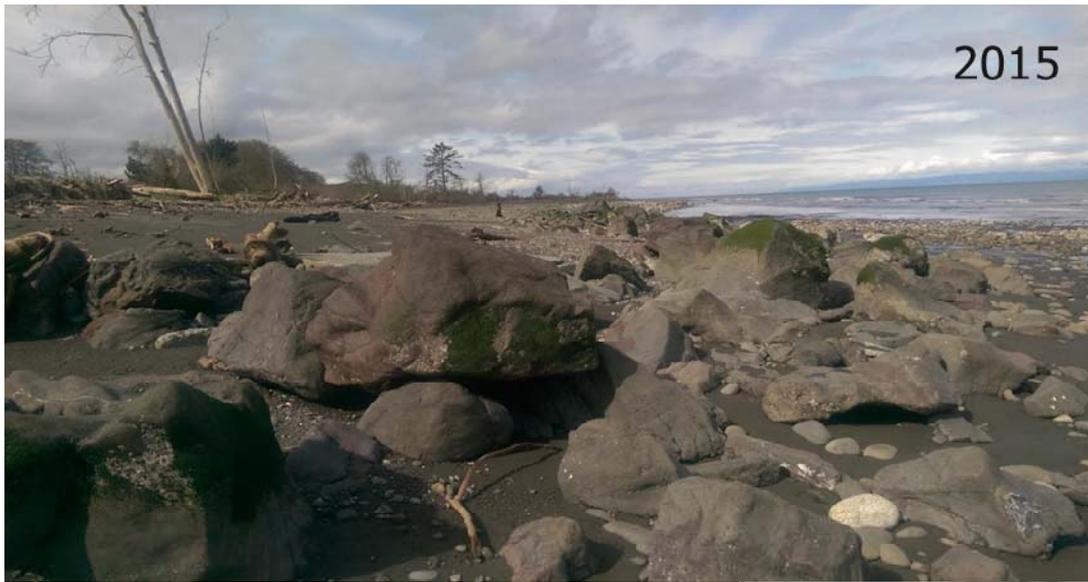
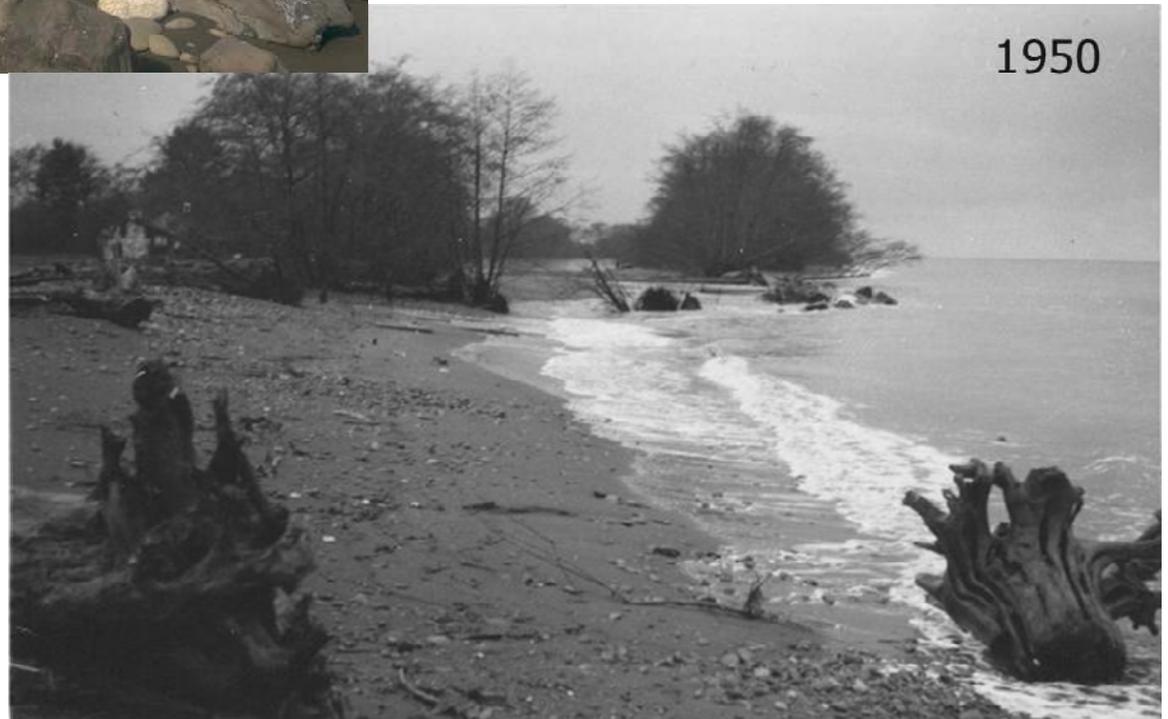
Figure 6. Current and historic beach condition at Beach Lake property shoreline.
(Photo: U.S. National Archives)

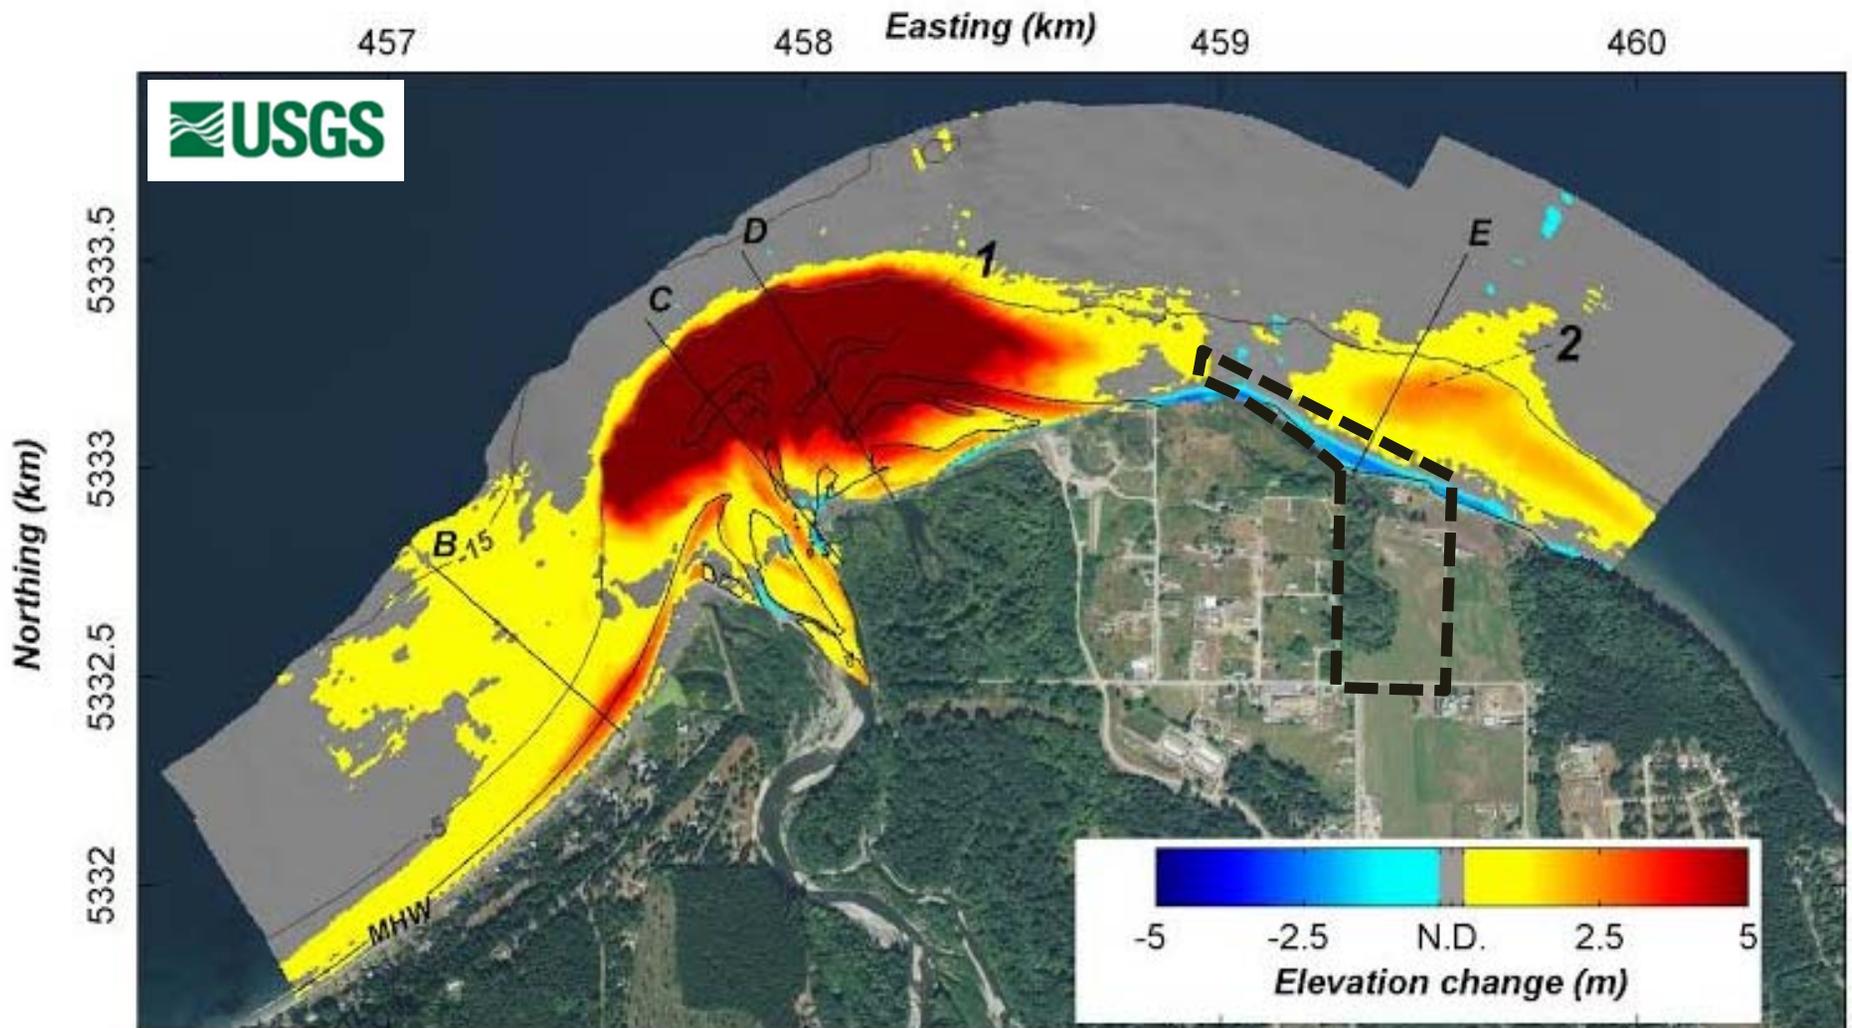
Figure 7. January 2015 USGS survey data showing significant erosion at the project site. Deposition of dam-removal sediments has occurred on the lower intertidal terrace, but no permanent deposition has occurred landward of the 2,700 linear foot stretch of derelict armor that is scattered throughout the intertidal at the project site. (Graphic, USGS)

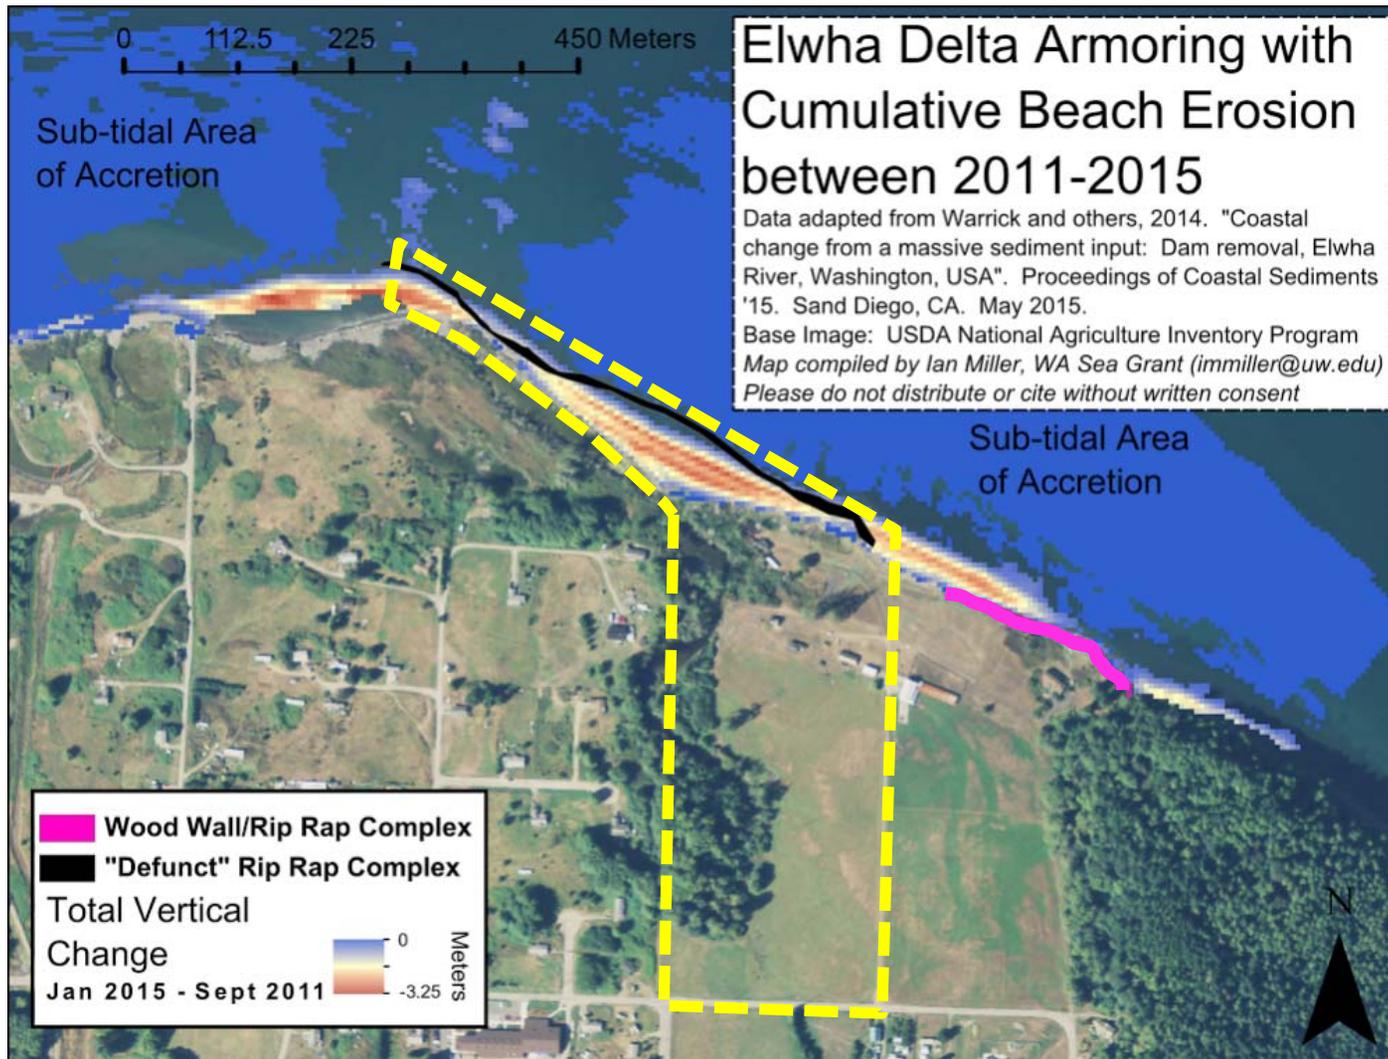
Figure 8. January 2015 survey data showing significant erosion at the project site behind 2,070 linear feet of armor and sub-tidal deposition of dam removal sediments in front of armor. East of the project site are 700 linear feet of unpermitted newly modified wood/rock armoring on private property . If this project is funded, efforts will be made to coordinate removal of armor at the project site with removal of armor from neighboring property.

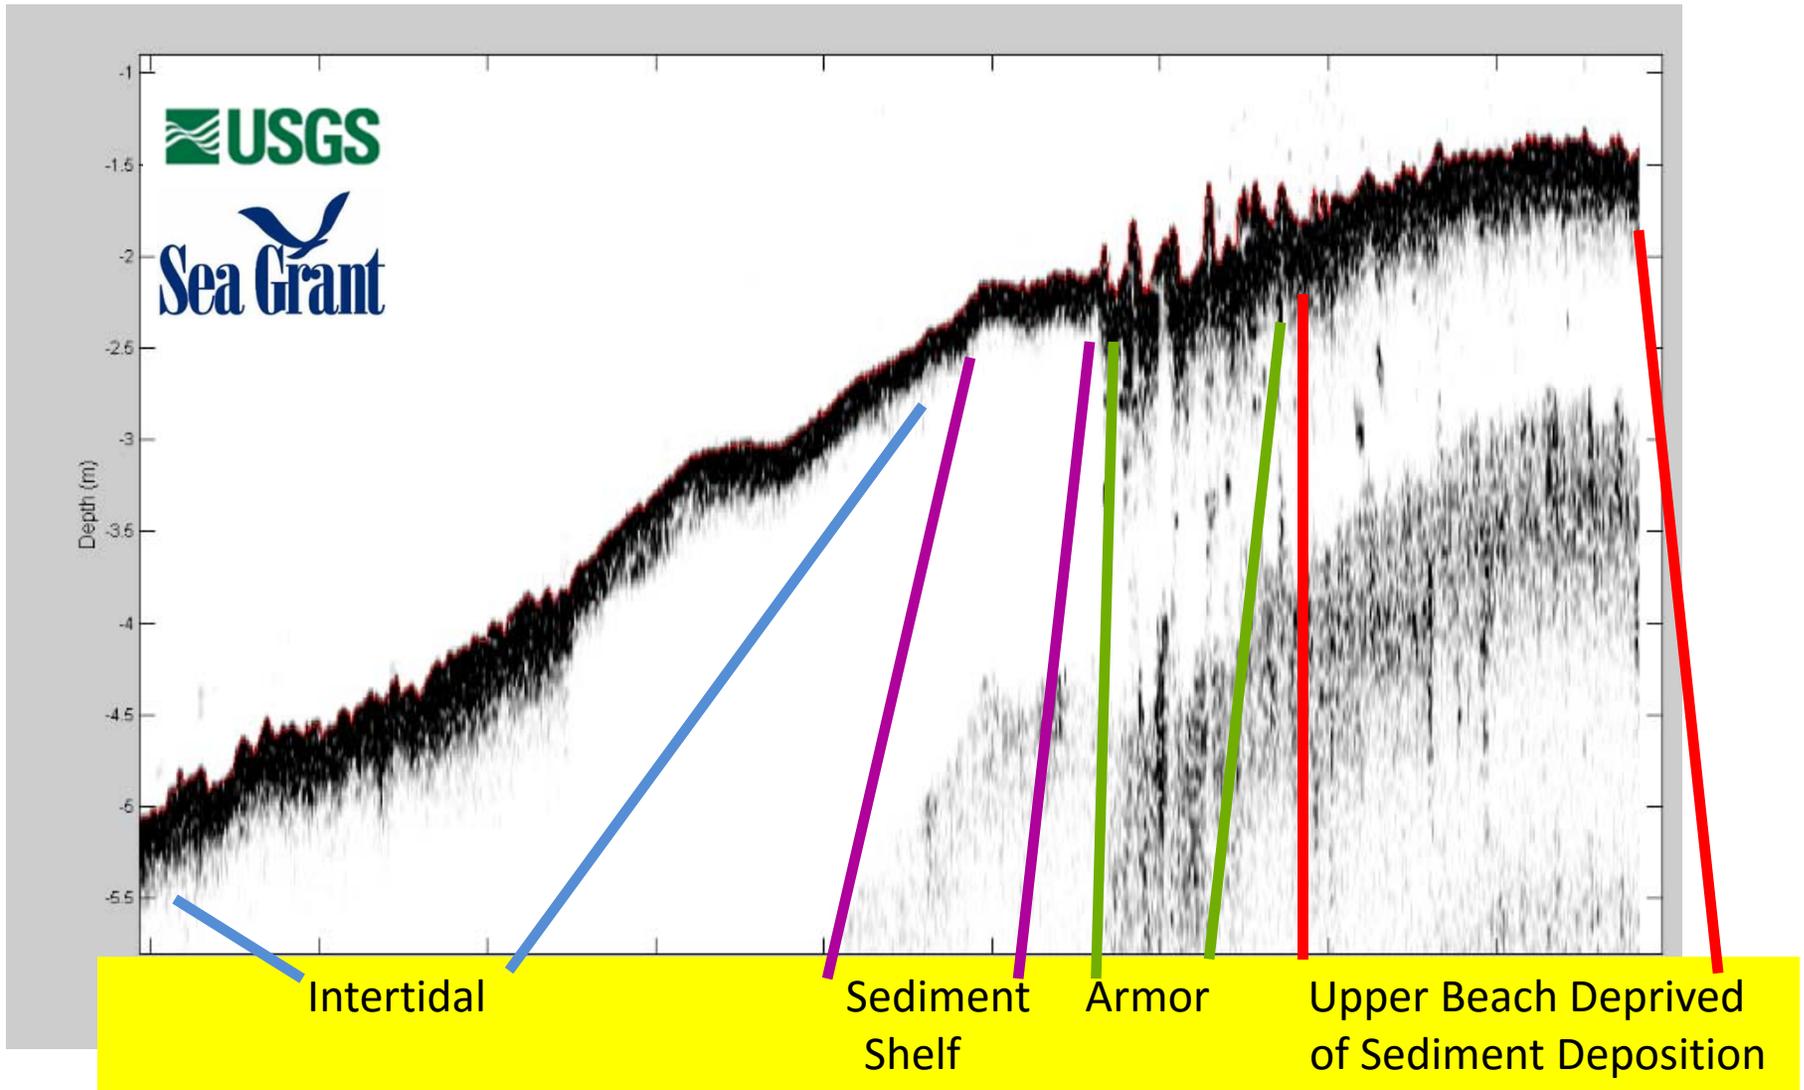
Figure 9. USGS Bathymetric and SeaGrant Topographic data indicating that armor at the project site is impeding deposition of cross beach sediment transport.

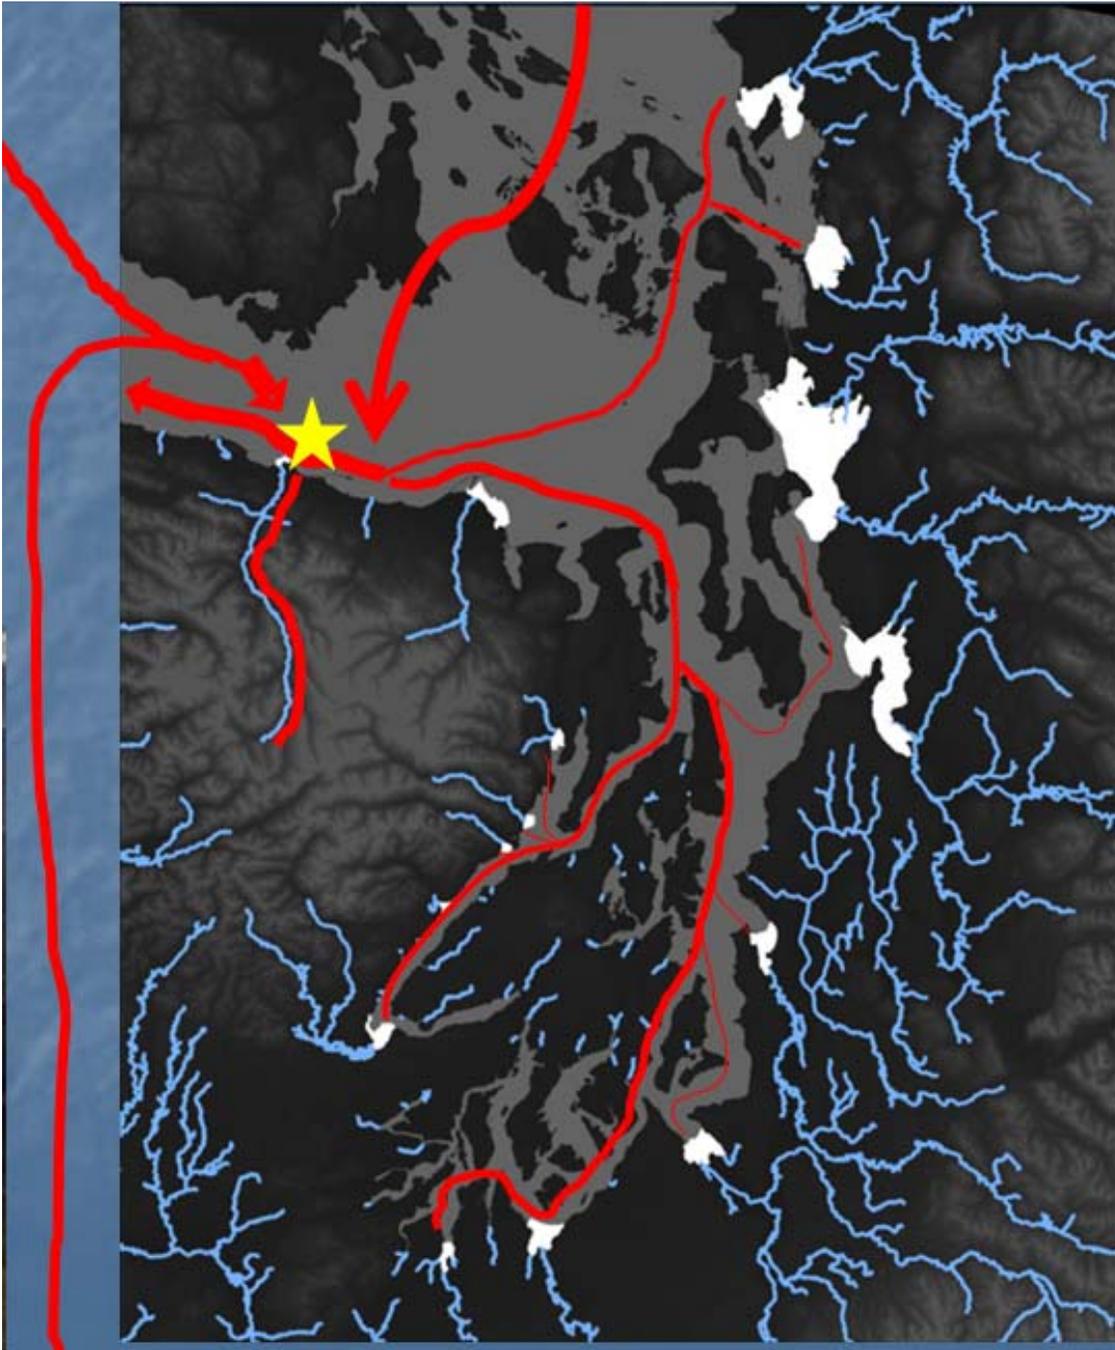
Figure 10. Project site is located at a migratory convergence point of significance to the Pacific salmon population. Fish originating from all watersheds of Puget Sound migrate past and utilize the Elwha River estuary and nearshore. Salmon originating from distant coastal rivers including the Columbia, Fraser and Klamath River systems have been documented at the Elwha estuary.

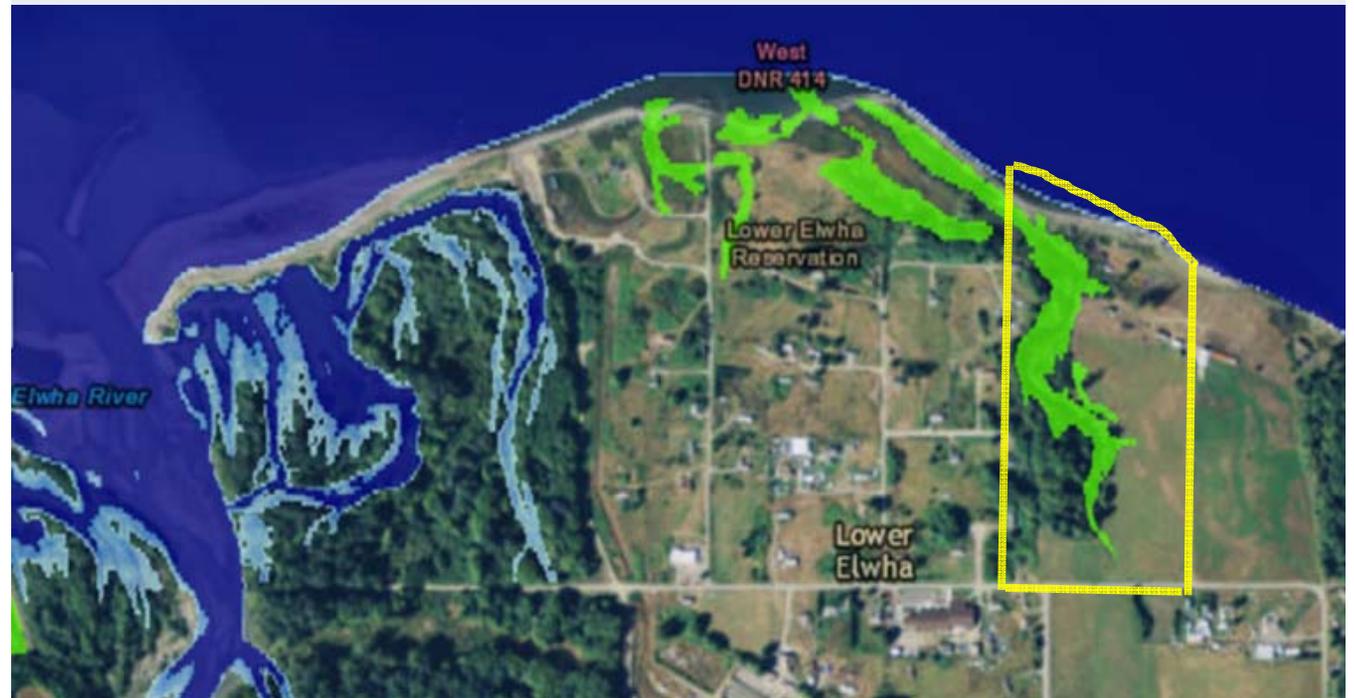
Figure 11. Approximately 21 acres of the 25 acre Beach Lake parcel are mapped in the 100 year floodplain. All buildings planned for removal are located in the 100 year floodplain. The entire parcel is less than 15 feet above sea level. Sea Level is projected to rise by almost 2 feet at the project site by 2100 (NAS, 2012) permanently inundating Beach Lake.

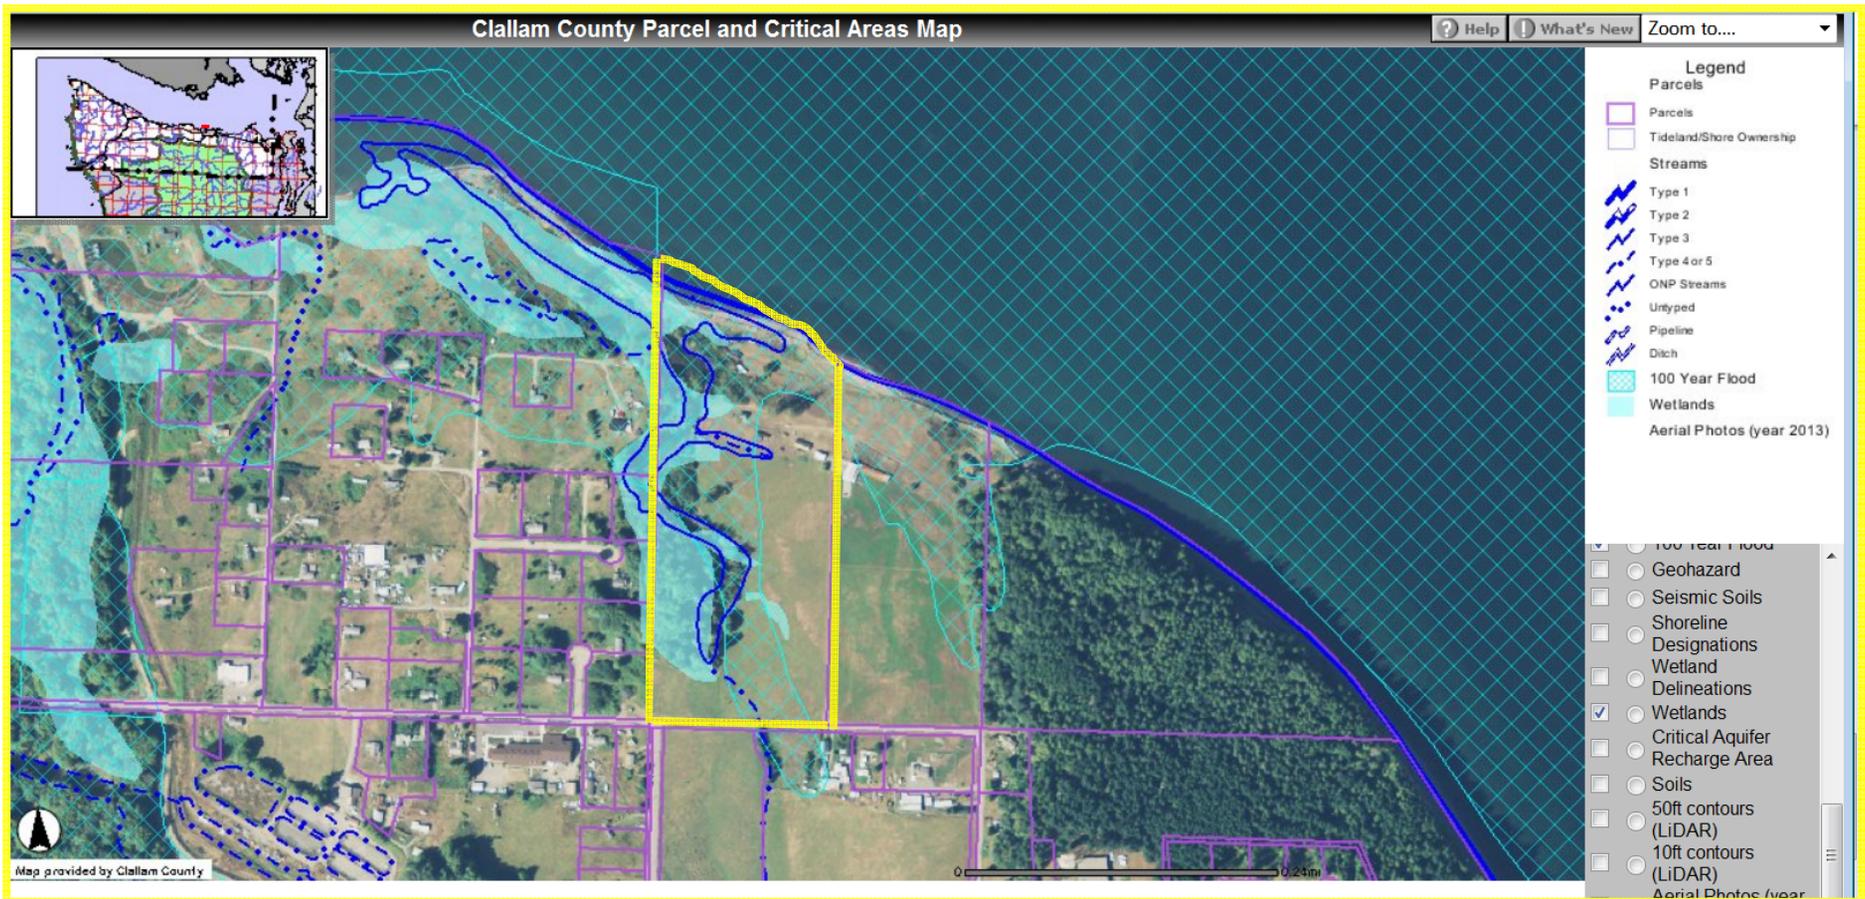
Figure 12. Project parcel layer showing wetlands, historic extent of Beach Lake, coastal floodplain and Type 4 streams draining into Beach Lake.

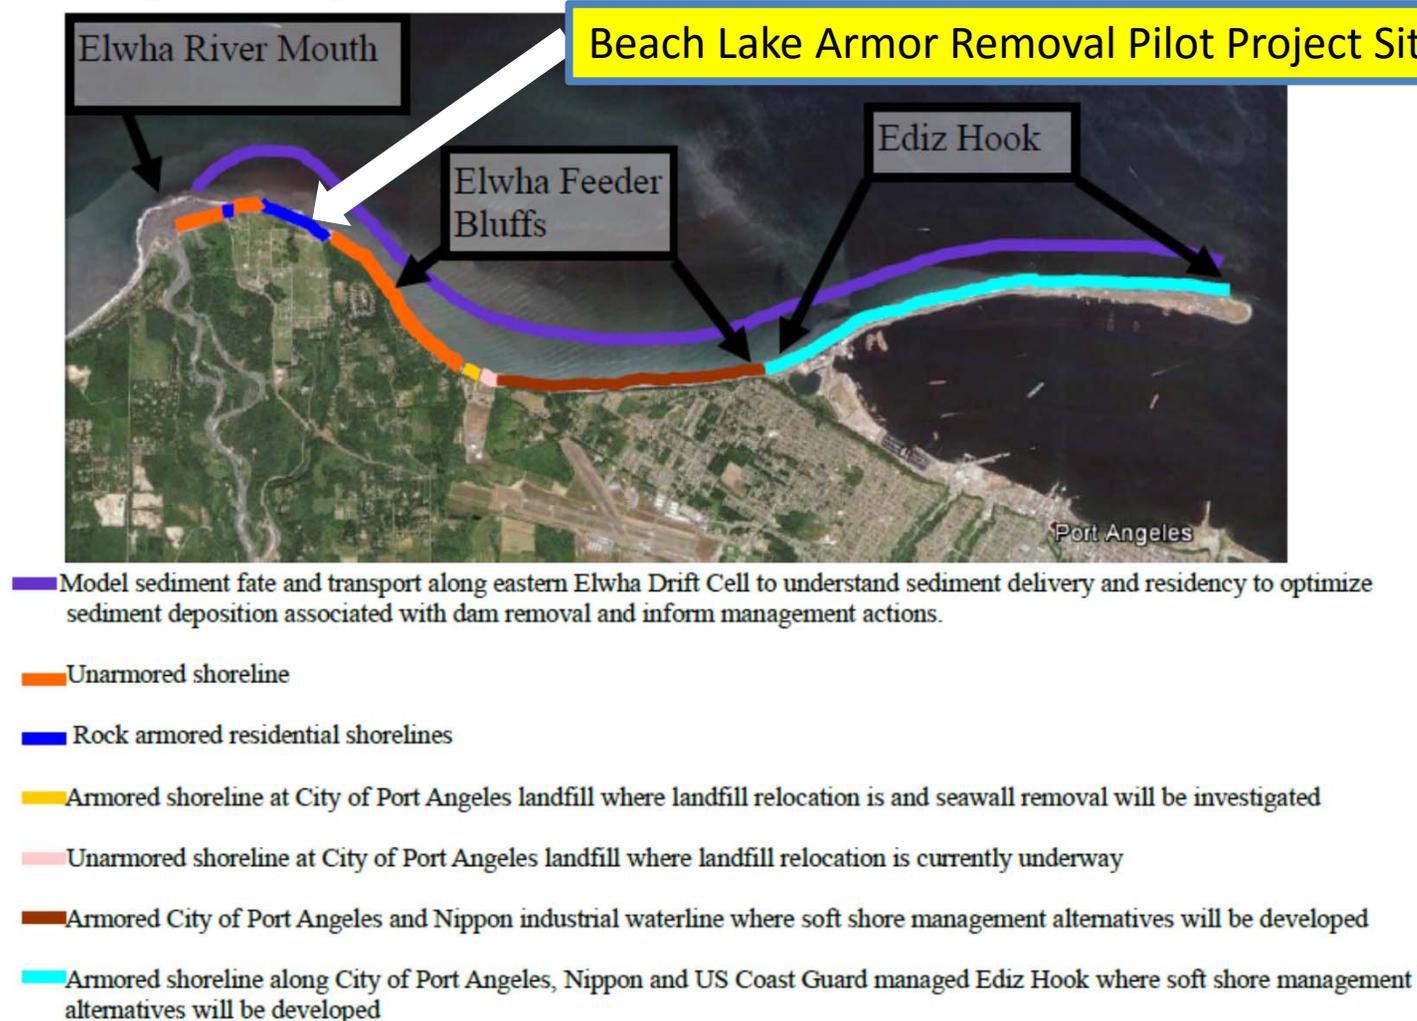
Project Area Map and Potential Project Actions Along Elwha Drift Cell

Figure 13. Beach Lake restoration will serve as a pilot program and demonstration site for armor removal. Lessons learned at Beach Lake will be incorporated into USACE sediment transport modeling investigations to evaluate opportunities to remove some portion of armor from 5.5 miles of heavily armored shoreline that could receive sediments made available by dam removal.

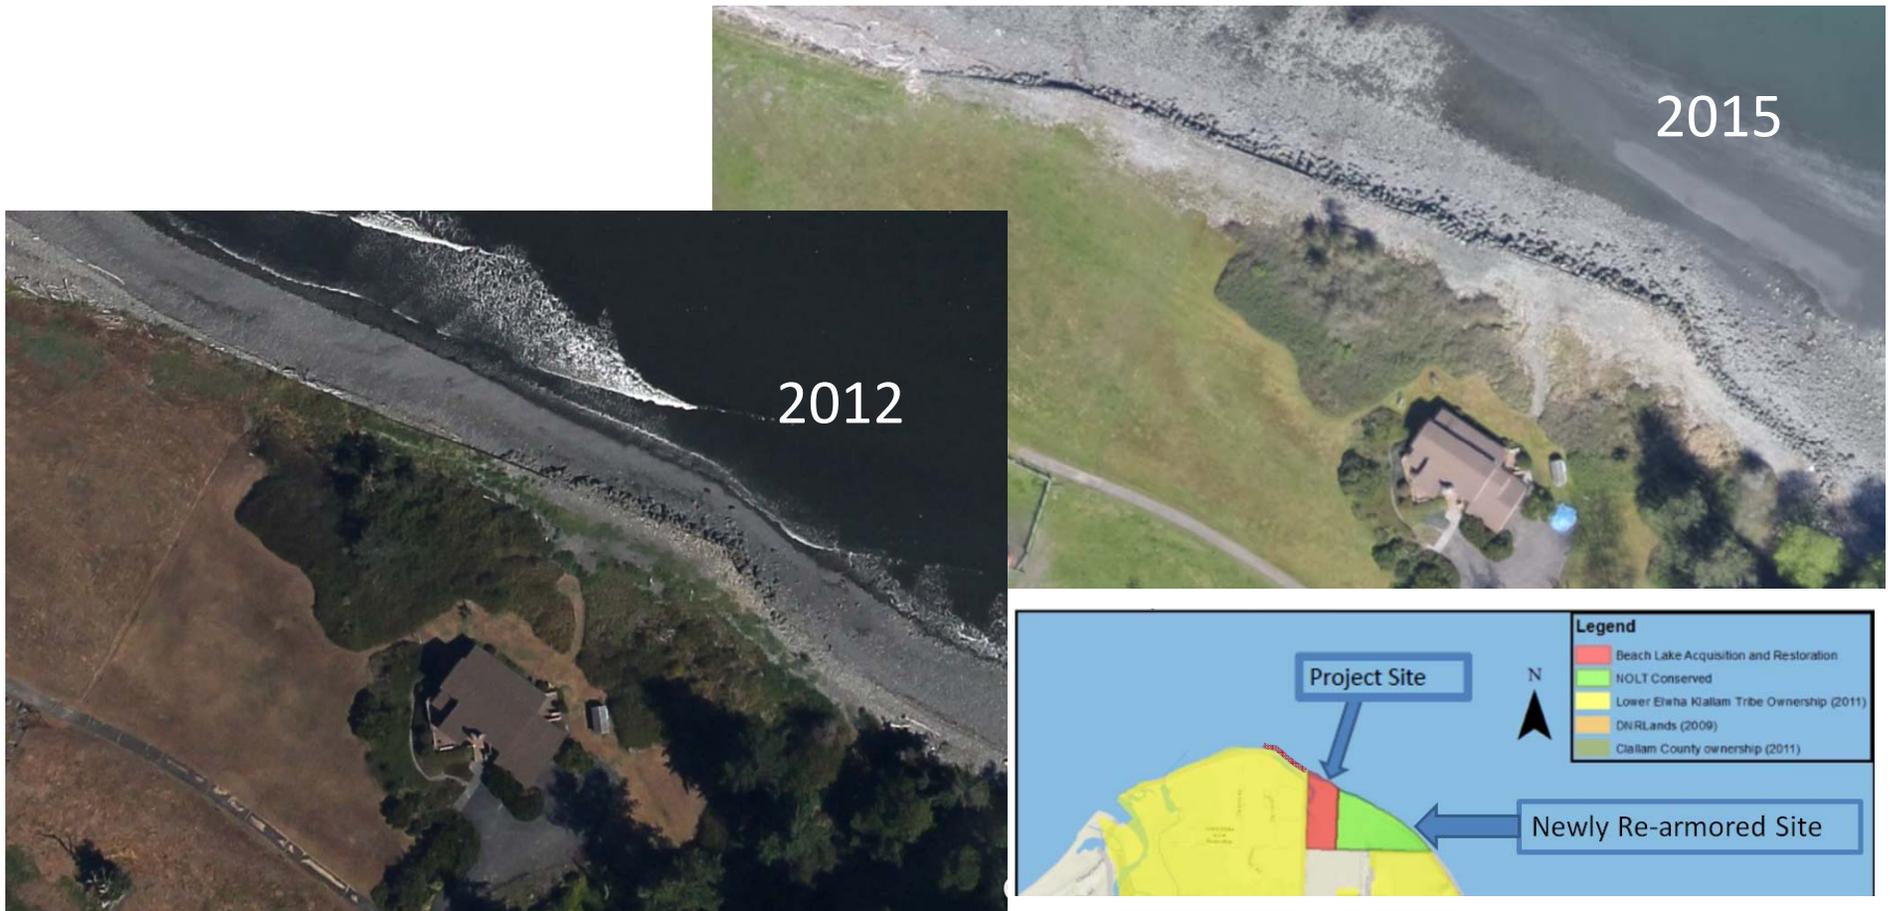
Figure 14. Threat to project site. Adjacent residential parcel recently placed ~700 linear feet of new rock armor on beach to repair failing bulkhead and protect infrastructure on property. The Beach Lake property is currently on the market and it is likely that a new buyer would pursue similar actions to defend built infrastructure from erosion. Beach Lake Acquisition and Restoration project will remove infrastructure and armor rock from the project site and prevent future armoring to ensure habitat sustaining natural beach evolution that is unimpeded by human actions at the project site. A coastal engineering analysis will ensure that armor removal at project site does not adversely affect neighboring property.
