# TECHNICAL MEMORANDUM

**Re:** Water level and temperature monitoring at the Pierce Conservation District property (former Inglin Dairy Farm) on South Prairie Creek

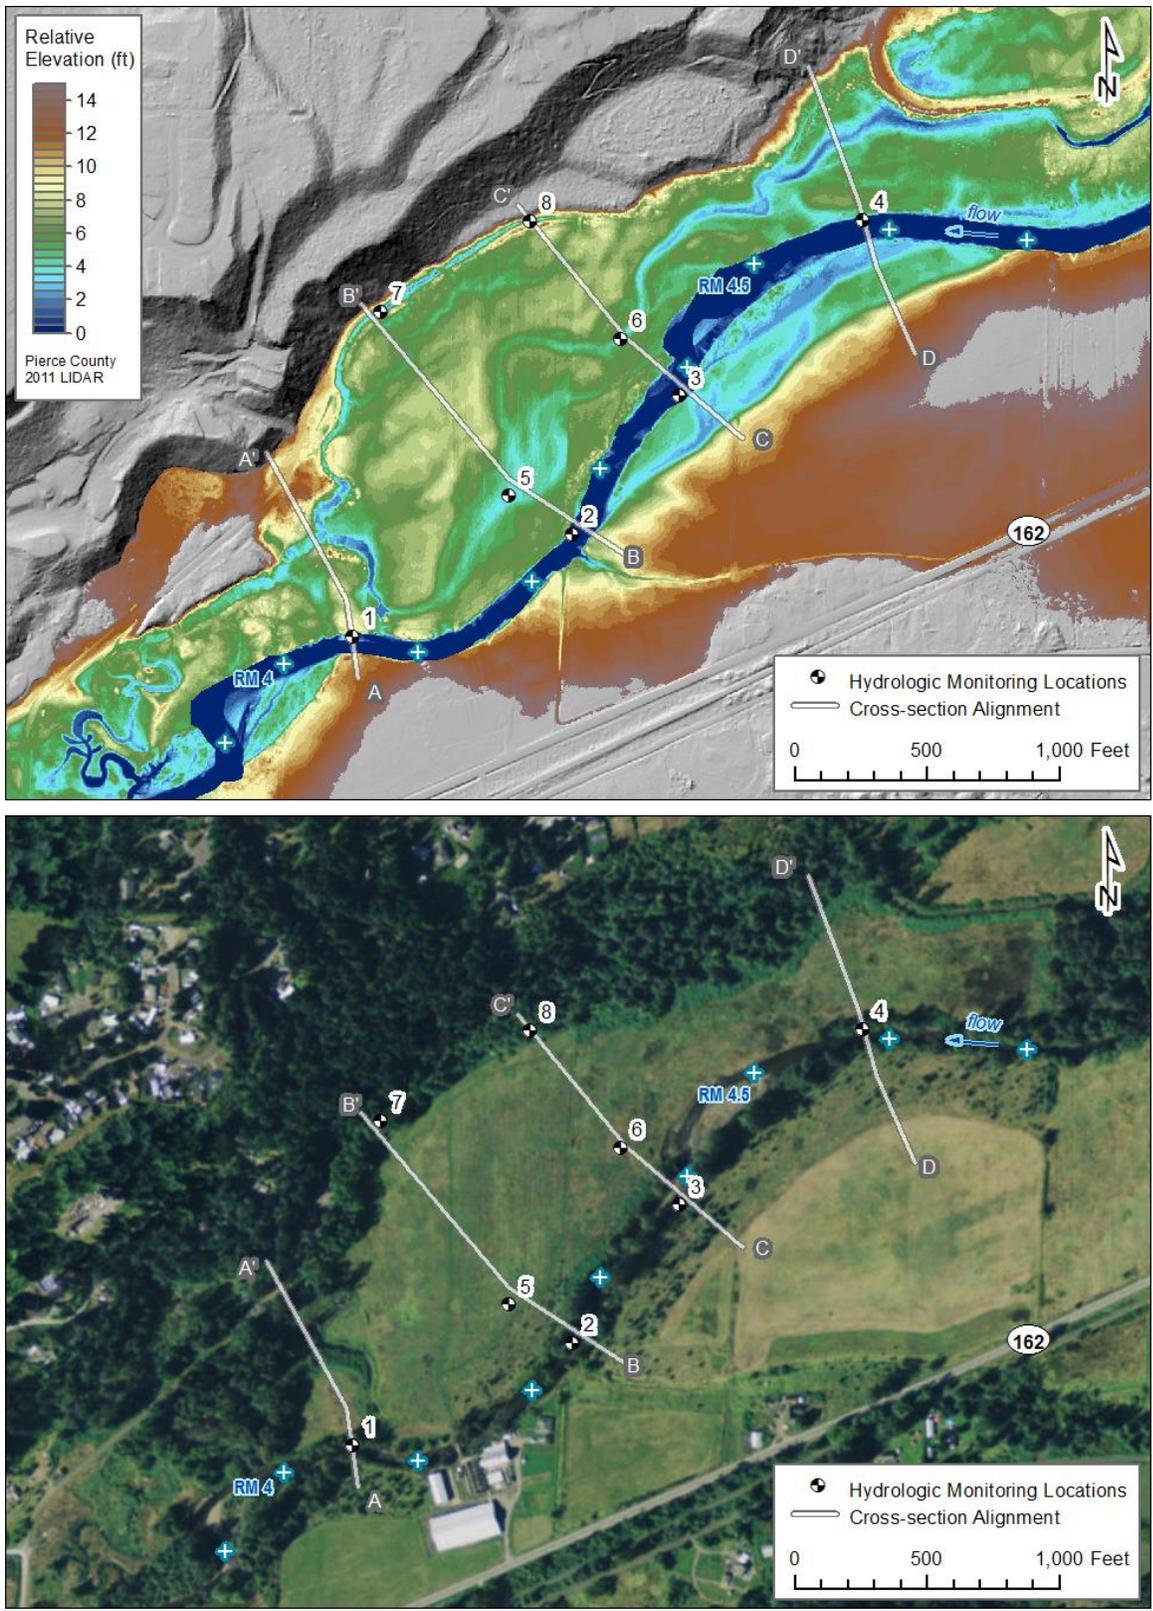
Figure 1. Site maps overlaying hydrologic monitoring locations with relative elevations derived from 2011 LiDAR and a 2013 aerial image.

The project area is located between River Mile (RM) 4.05 and RM 4.6 and includes 4 adjoining parcels with ownership by Pierce Conservation District and Pierce County SWM (Figure 1). The project site was a former dairy facility (Inglin Dairy Farm) that has been acquired for conservation and restoration of natural processes within the stream corridor. The main channel is approximately 100 feet wide and entrenched 8 to 10 feet below the alluvial surface forming the right bank. A low terrace spans up to 1,200 feet in width between the channel and hillslope to the north. A floodplain swale is cut 3 to 5 feet below the terrace surface marking the path of an abandoned channel. A small channel, 10 to 20 feet in width, parallels the valley wall to the north and is fed by spring flow and seeps emerging from groundwater in the adjacent hillslope.

NSD deployed an array of eight water level and temperature dataloggers at the project site in December 2013. Four dataloggers were deployed in the main channel between RM 4 and 4.6, two dataloggers were placed in groundwater monitoring wells in the adjacent floodplain, and two dataloggers were located in the spring fed, wall-base channel that follows the toe of the hillslope at the north edge of the valley (Figure 1). An additional datalogger was deployed in the dairy facility to record ambient air temperature and fluctuations in barometric pressure. Dataloggers recorded a continuous record of level and temperature at 15 minute intervals between December 2013 and January 2015.

temperature dataloggers were deployed at the site (Figure 1) and collected data at 15-minute intervals between December 2013 and January 2015. Key findings from hydrologic monitoring include:

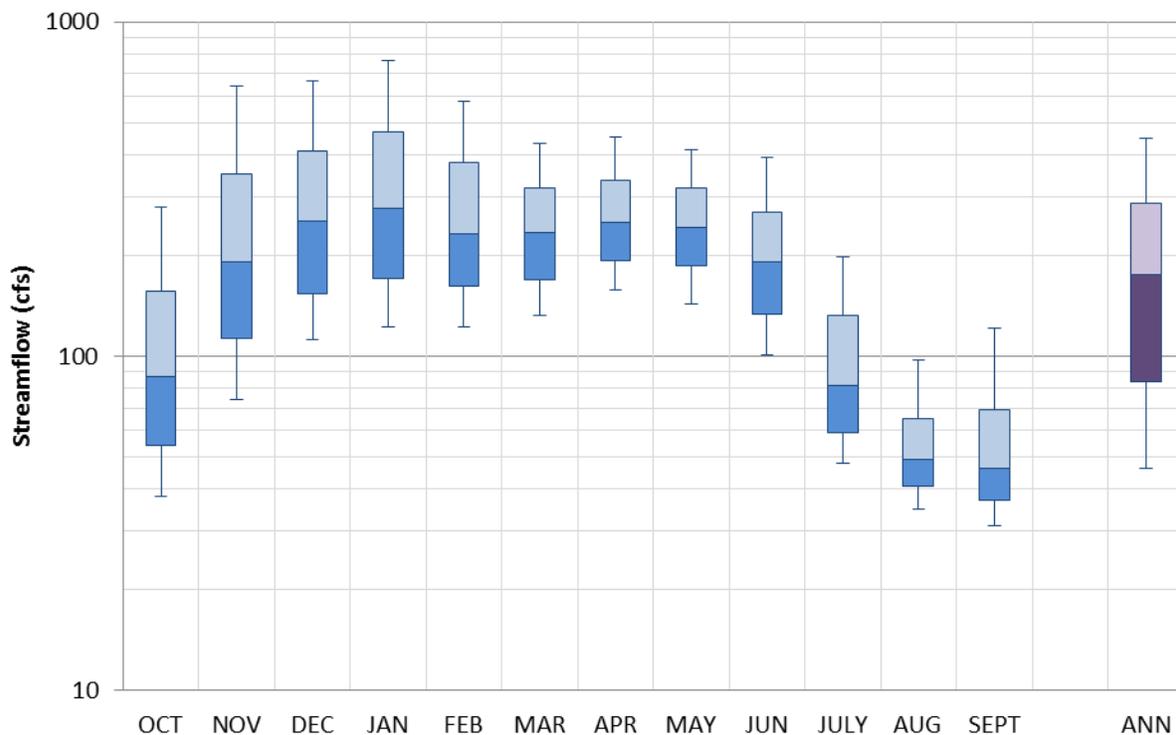
**Figure 2. Seasonal variability represented by box and whisker plots of monthly average streamflow at USGS gaging station #12095000 (South Prairie Creek at South Prairie, WA). Boxes show the range between the 25<sup>th</sup> and 75<sup>th</sup> percentile values over the historical period and are split at the 50<sup>th</sup> percentile (median). Whiskers extend vertically to the 10<sup>th</sup> and 90<sup>th</sup> percentiles of monthly average streamflow, respectively.**

Streamflow in South Prairie Creek has a seasonal flow regime that is characterized by relatively high flows in winter and spring, receding flows throughout the summer, and a rise in flow in response to increased precipitation during fall (Figure 2). Flow duration statistics derived from the record of mean daily streamflow are plotted on Figure 4.

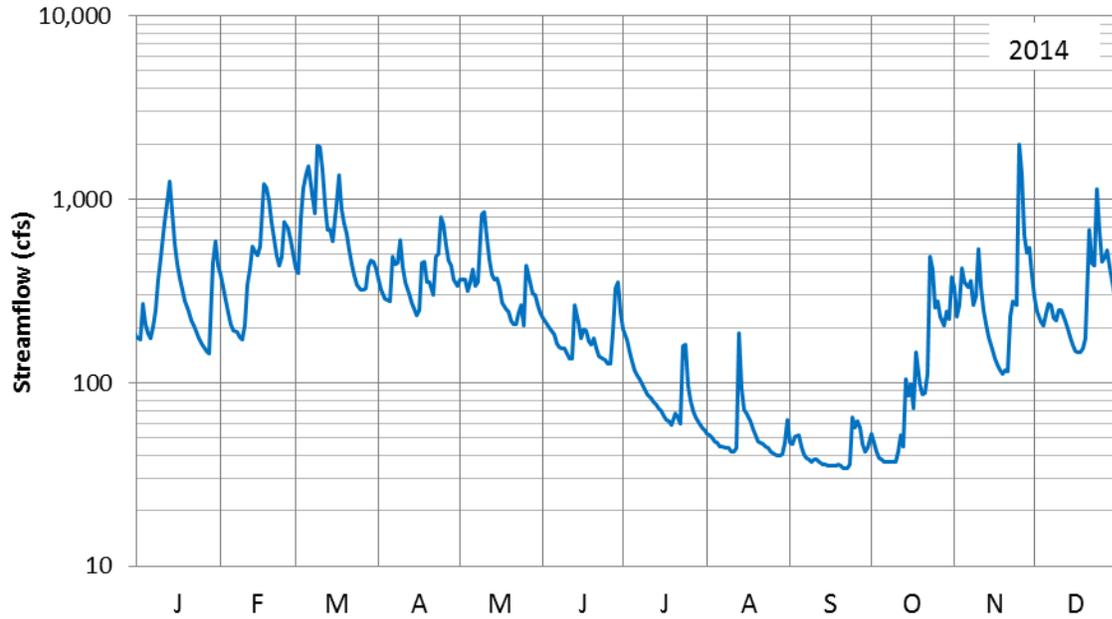
Figure 3. Annual hydrograph of mean daily streamflow for 2014 at USGS gaging station #12095000 (South Prairie Creek at South Prairie, WA).

Annual time series of water level and temperature observations for 2014 are illustrated for each site in a series of plots from Figure 6 to Figure 13. Surface water fluctuations in the main channel (sites 1-4) show the response to variations in flow recorded at the USGS gage upstream (Figure 3). Multiple flood pulses occurred between January and March, including a peak of 2,500 cfs (>1.5-year recurrence interval) on March 9, 2014. Flows receded through spring and summer reaching an annual minimum of 31 cfs in mid-September. Flows rose in response to increased rainfall in October and November. The annual maximum

peak flow of 3,330 cfs (between 2- and 5-year recurrence interval flood) occurred on November 25. Overall, mean annual flow for calendar year 2014 (302 cfs) was 28% greater than the historical average at the USGS gage upstream (#12095000).

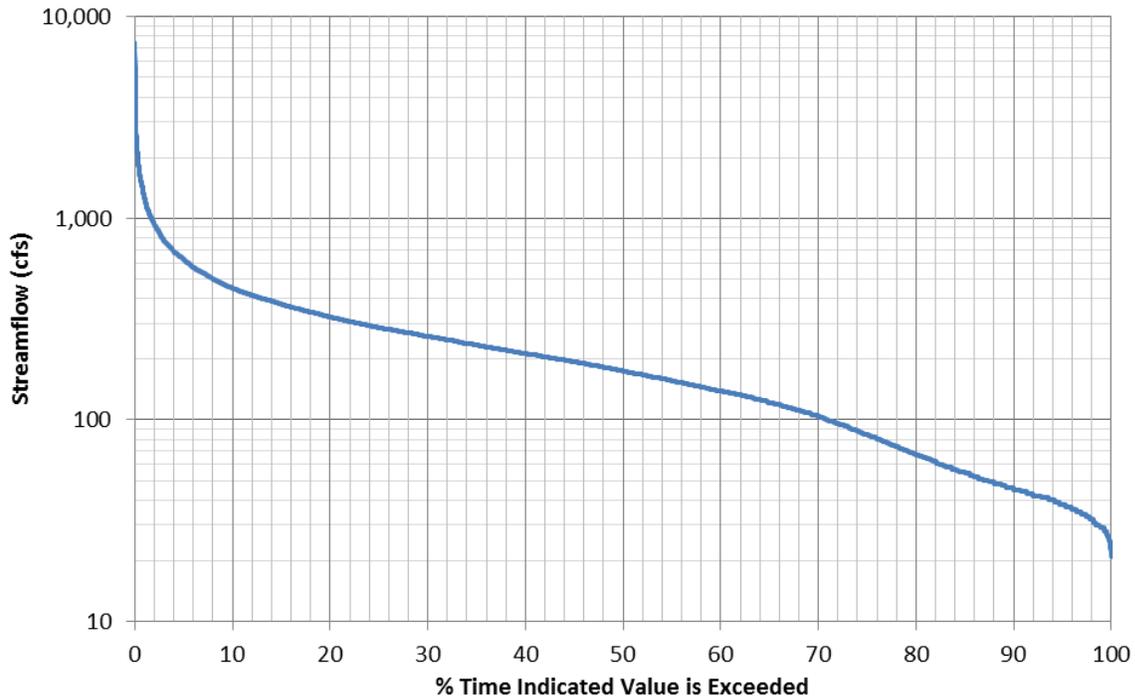
Figure 4. Flow duration statistics derived from the historical record of mean daily streamflow at USGS gaging station #12095000 (South Prairie Creek at South Prairie, WA).

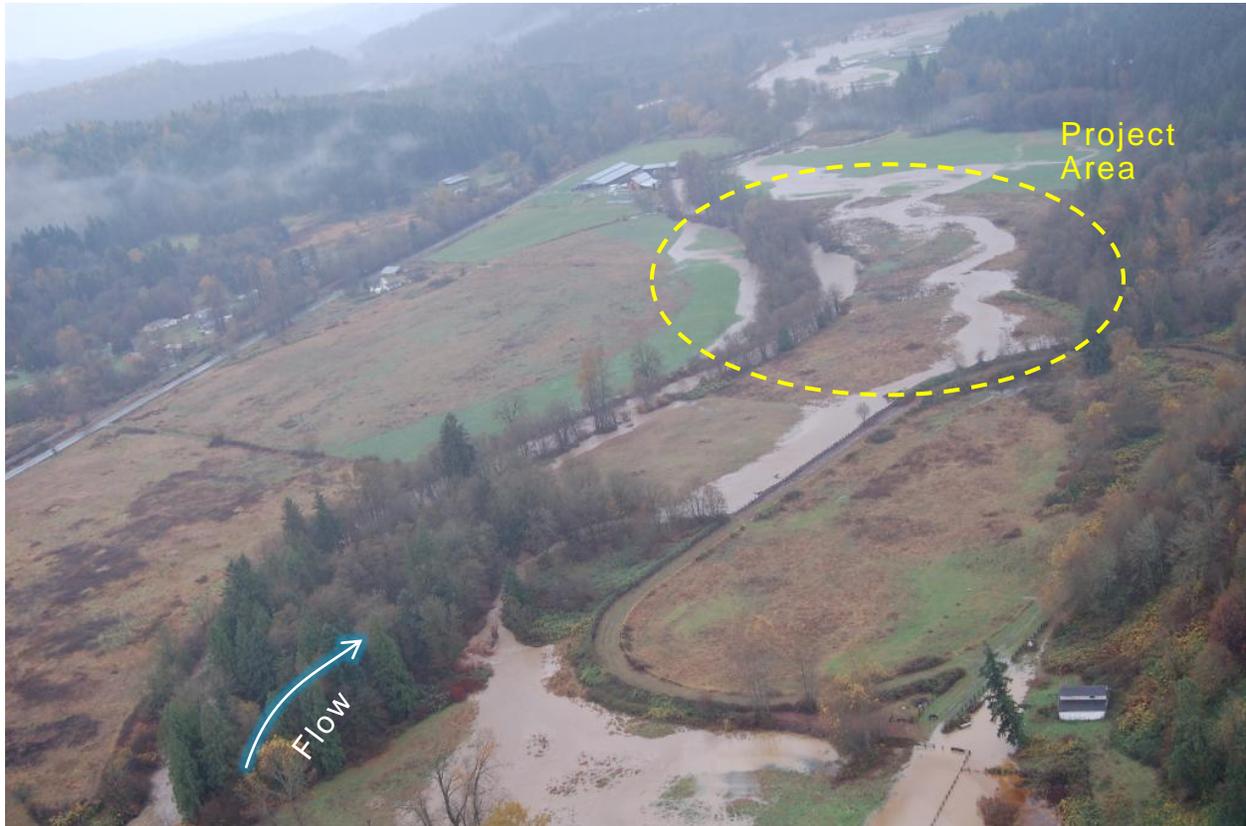
**Figure 5. Oblique aerial photo during the November 7, 2006 flood event along South Prairie Creek (6,540 cfs). Image source: Pierce County SWM.**

Reconnaissance imagery taken by Pierce County SWM during the November 7, 2006 flood (6,530 cfs) shows areas of inundation and preferential flowpaths during an event with an expected recurrence interval between 10- and 25-years (Figure 5). Overbank flow upstream of the horse facility on an adjacent parcel collects into a drainage channel that connects with a floodplain swale representing an abandoned channel feature on the low terrace between South Prairie Creek and the north valley wall.

Site 5 is a shallow groundwater monitoring well in the floodplain swale 280 feet northwest of SPC-2 near RM 4.25 (Figure 1). The floodplain swale extends upstream past SPC-6 through cross-section C-C' and continues northeasterly to intersect with a low relief swale draining away from the main channel to north near RM 4. An extension of the floodplain swale connected to SPC-5 and 6 also continues upstream beyond RM 4, abuts the edge of the horse facility on the adjacent property, and connects with a low area in the right bank at RM 5 (Figure 5).

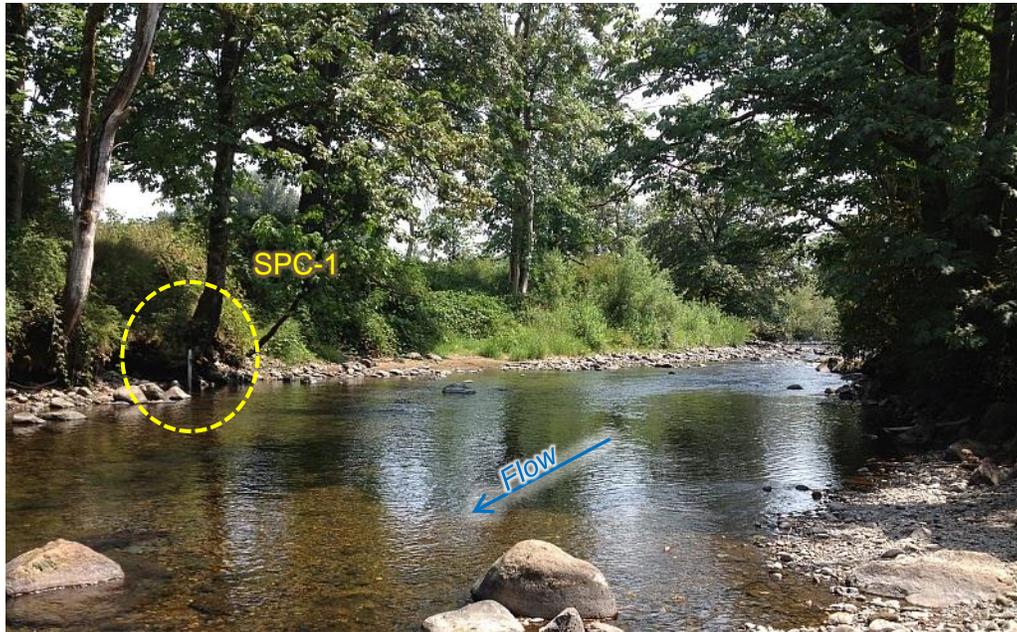
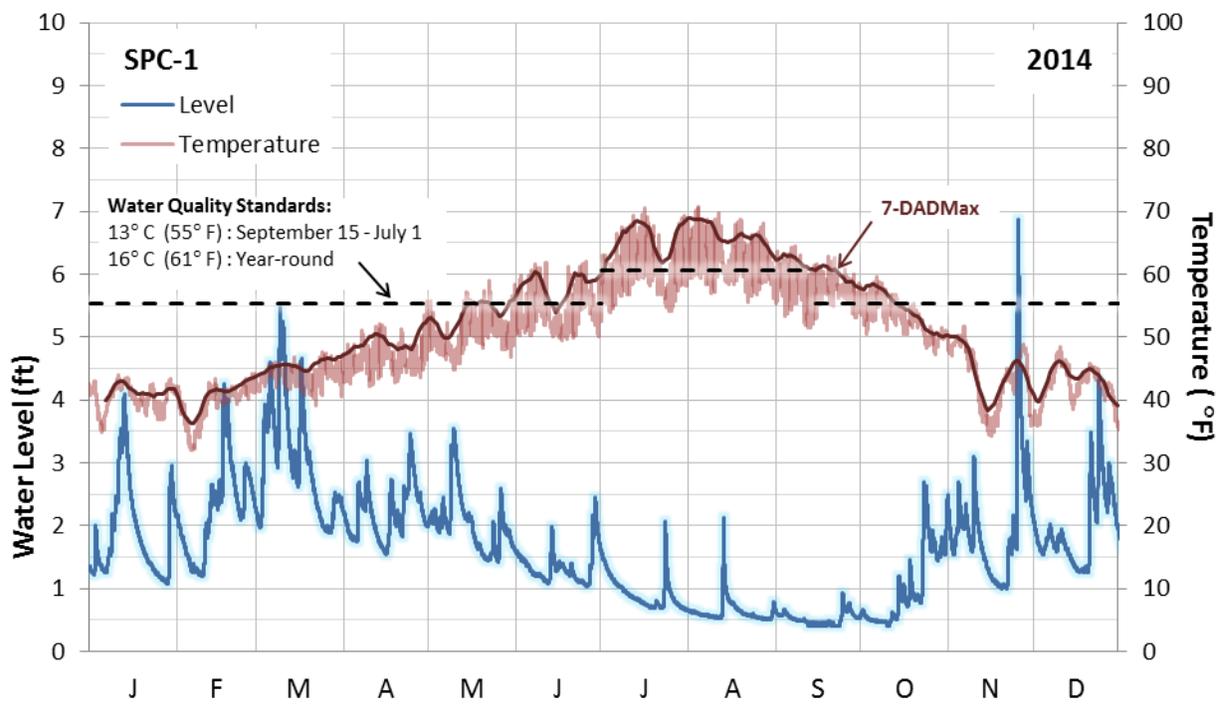
Figure 6. Annual time series (2014) of water level and temperature at SPC-1 on the right bank 400 feet downstream of the bridge.

Site 1 is located along the right bank near RM 4.05 and is 400 feet downstream of the bridge crossing over South Prairie Creek at the former Inglin Dairy (Figure 1). Water level (depth) generally fluctuated between 1 and 4 feet during winter months and receded to a minimum depth of 0.4 feet in September (Figure 6). The November 2014 flood peaked at a maximum depth of 6.9 feet. Water surface elevations are overlaid with cross-sectional profile A-A' in Figure 14. Bank heights on both sides of the channel are high and the maximum water surface elevation in November was contained by the channel with several feet of freeboard along both banks.

Water temperature generally ranged between 35 and 45° F through winter but climbed over summer with a maximum 7-DADMax value of 69° F at the beginning of August (Figure 6). Temperature exceeded the water quality standard for a duration of 131 days in 2014.

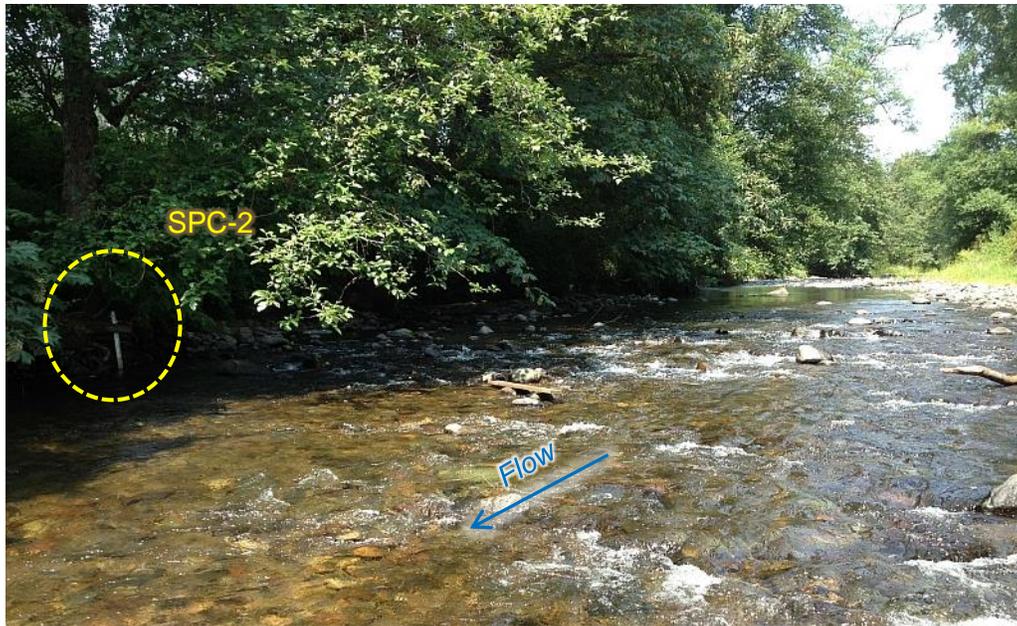
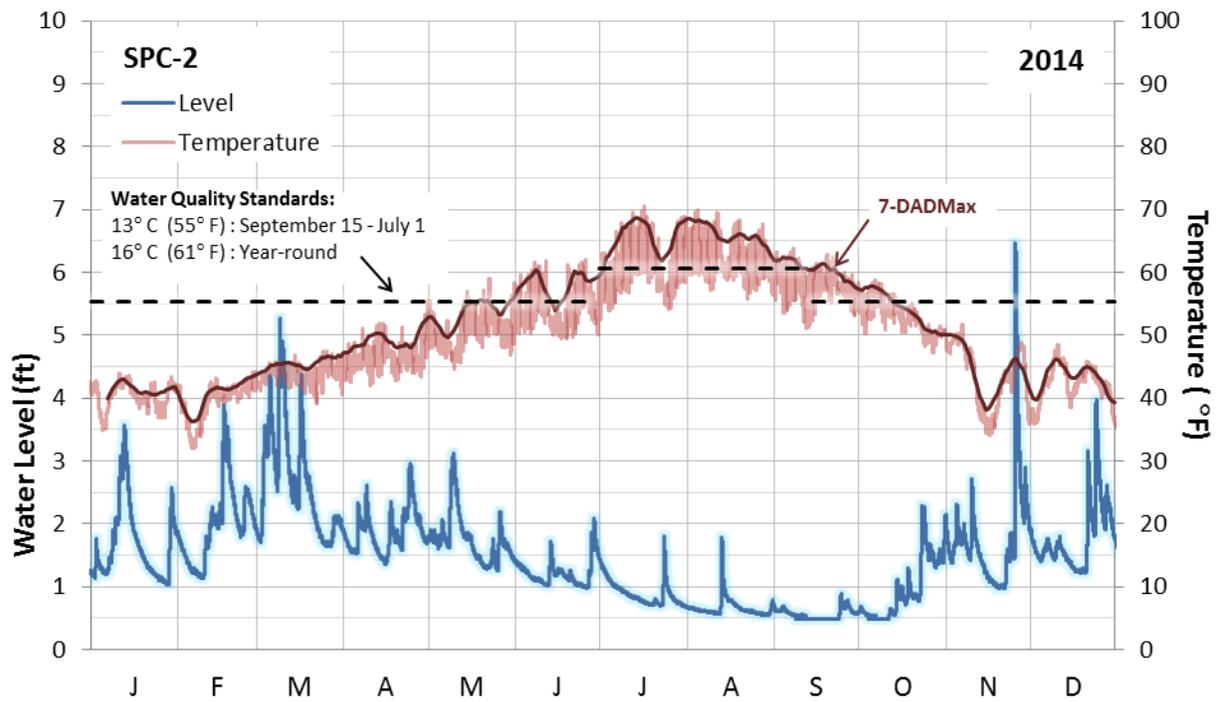
Figure 7. Annual time series (2014) of water level and temperature at SPC-2 on the right bank 600 feet upstream of the bridge.

Site 2 is located along the right bank near RM 4.25 and is 600 feet upstream of the bridge crossing over South Prairie Creek at the former Inglin Dairy (Figure 1). Water level fluctuations closely followed those described for site SPC-1 (Figure 7). The November 2014 flood peaked at a maximum depth of 6.5 feet. The maximum water surface elevation in November remained 2 to 3 feet below the right bank at cross-section B-B' (Figure 15).

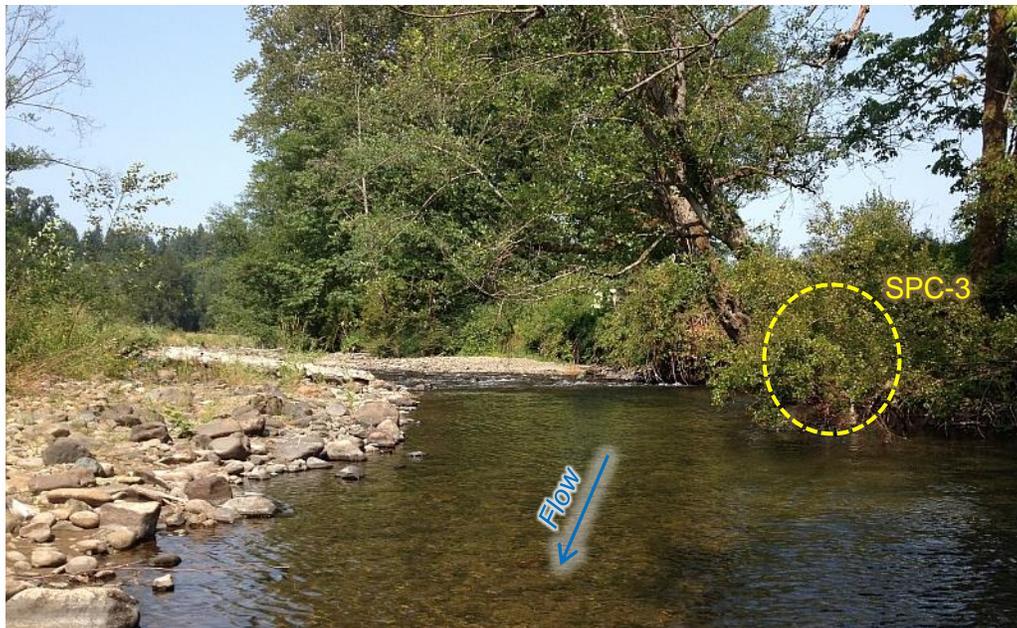
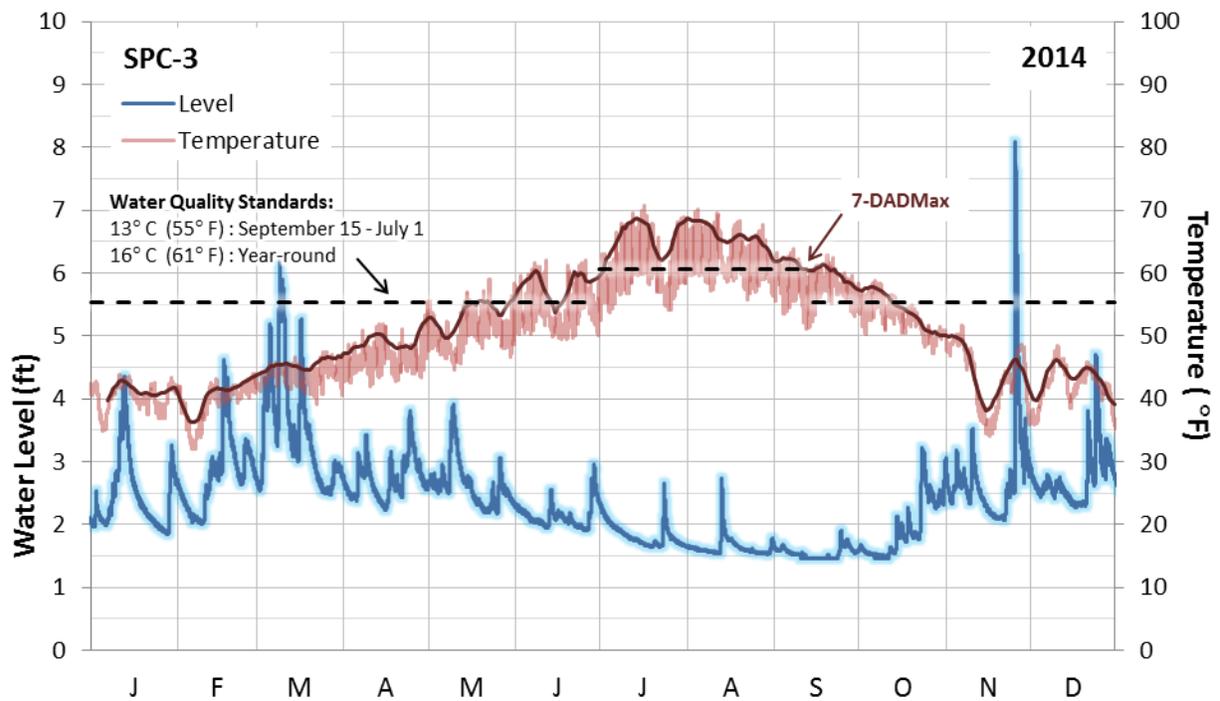
Figure 8. Annual time series (2014) of water level and temperature at SPC-3 on the left bank 1,200 feet upstream of the bridge.

Site 3 is located along the left bank near RM 4.4 and is immediately downstream of a steep bank that eroded laterally on the opposite (north) side of the channel in 2009 (Figure 1). The pool along the left bank maintained a minimum depth of 1.5 feet and reached a maximum depth of 8.1 feet in November (Figure 8). The peak water surface nearly overtopped the left bank at cross-section C-C' but remained approximately 2 feet below the right bank and adjacent ground surface of the low terrace to the north (Figure 16).

Fluctuation of water temperature was nearly identical to the values observed at SPC-1 and 2 with 7-DADMax exceeding the water quality standard for a duration of 126 days in 2014 (Figure 8).

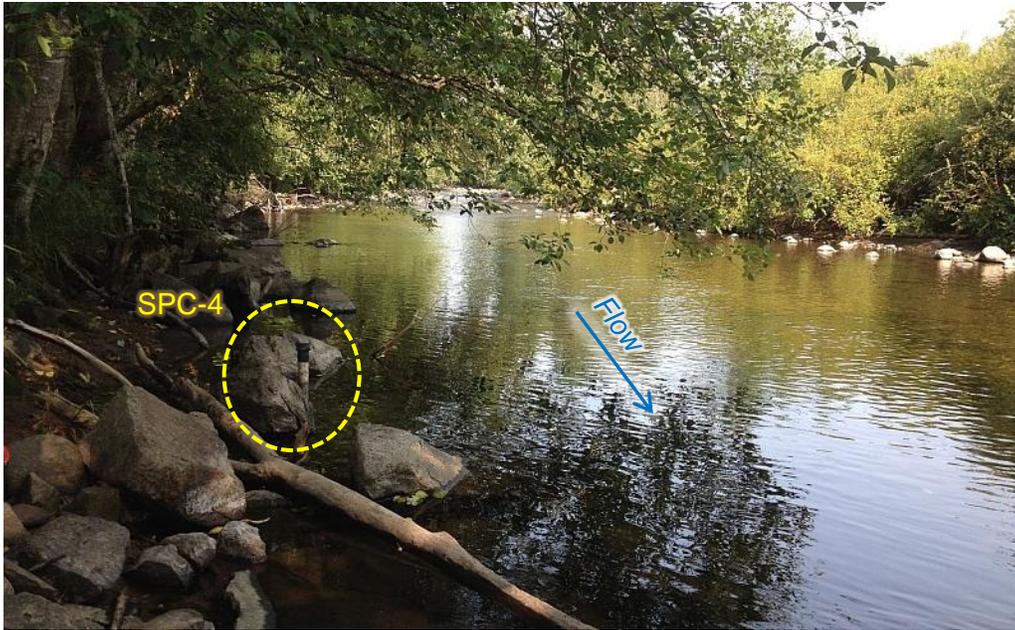
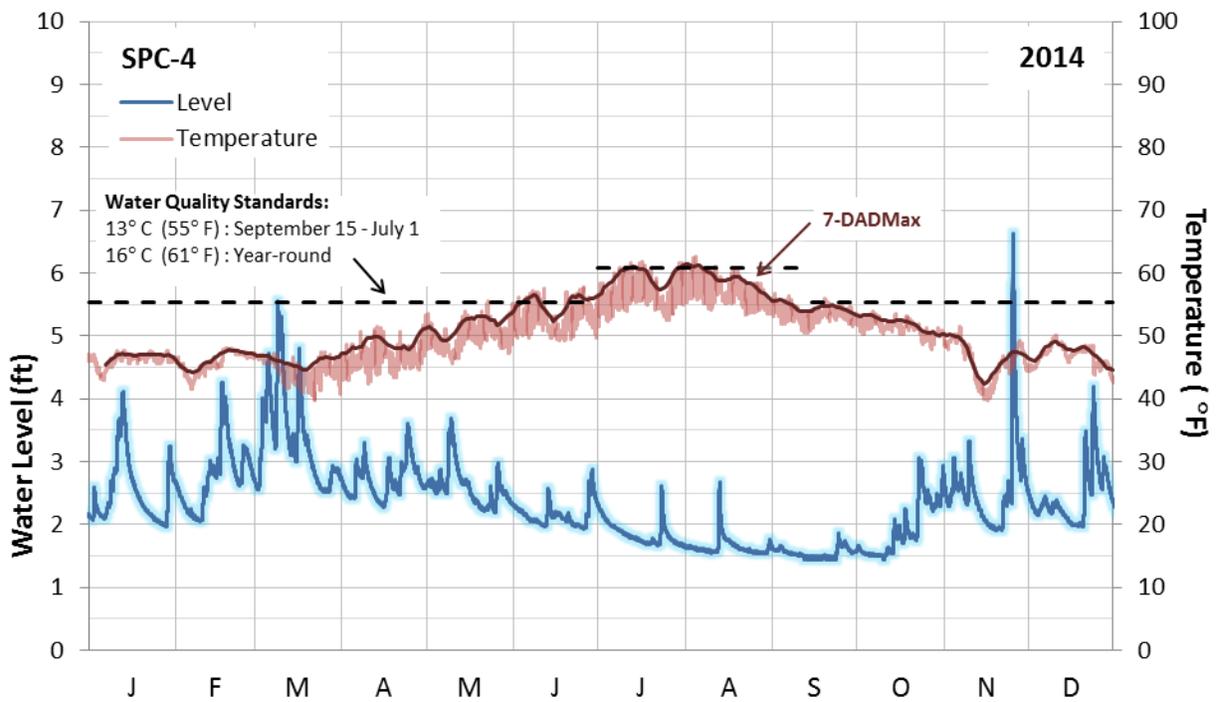
Figure 9. Annual time series (2014) of water level and temperature at SPC-4 on the right bank approximately 2,300 feet upstream of the bridge.

Site 4 is located along the right bank near RM 4.6 at the upstream end of the project area (Figure 1). The channel maintained a minimum depth of 1.5 feet and reached a maximum depth of 6.8 feet in November (Figure 9). The peak water surface nearly overtopped the left bank at cross-section D-D' but remained approximately 4 feet below the right bank and adjacent ground surface of the low terrace to the north (Figure 17).

Water temperature observations at SPC-4 were somewhat anomalous compared to concurrent observations from sites 1-3 downstream. The range of water temperatures at SPC-4 was moderated with a generally higher winter temperature and cooler summer temperatures compared to the downstream sites (Figure 9). The largest differences between temperature at SPC-4 and the downstream sites was observed during July

and August when air temperature exceeded 90° F on multiple days. During the extreme heat, water temperature at SPC-4 was up to 8° F cooler than the concurrent temperature downstream at SPC-3. The 7-DADMax at SPC-4 exceeded the water quality standard for a duration of 29 days in 2014. We hypothesize that the relative difference in temperature between SPC-4 and other main channel locations could be attributed to localized upwelling of hyporheic flows or influx of groundwater from the adjacent floodplain area. A more extensive sampling of water temperature in South Prairie Creek would be required to verify the explanation.

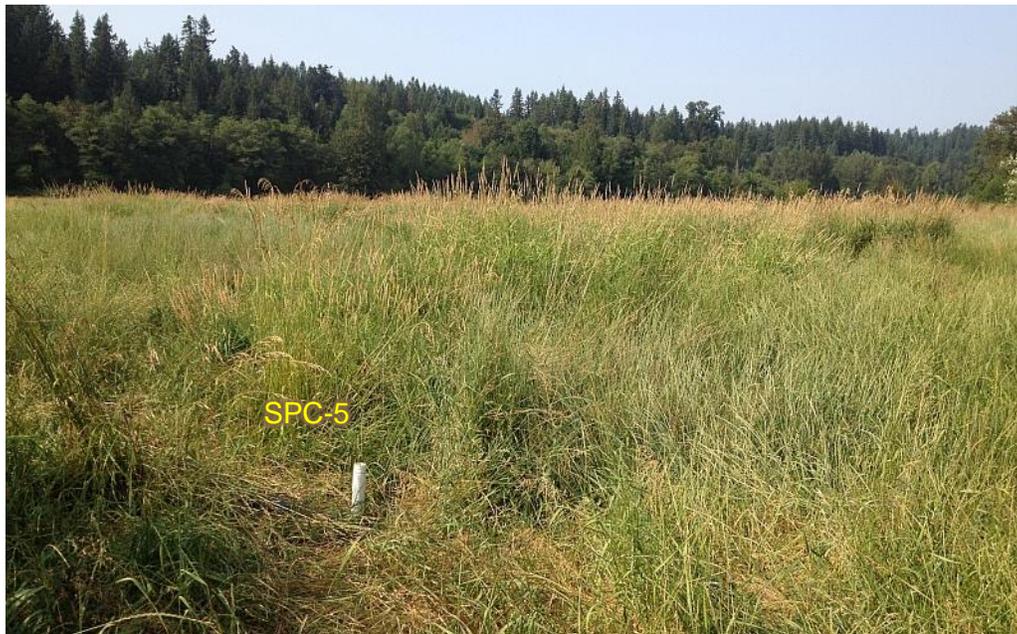
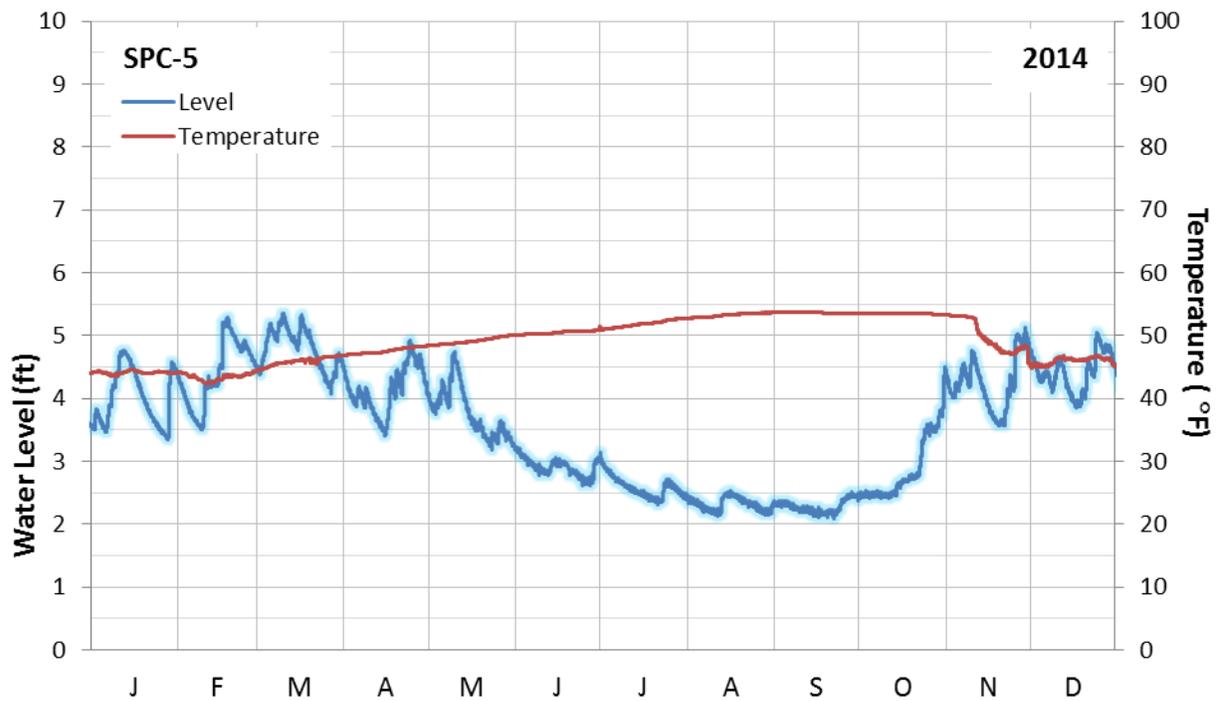
Figure 10. Annual time series (2014) of water level and temperature at SPC-5, a groundwater monitoring well in the floodplain swale 280 feet northwest of SPC-2.

The well was augered in the center of the swale to a depth of 4.8 feet below the ground surface. Water level fluctuated from a minimum depth of 2.1 feet in September to a maximum depth of 5.3 feet in March (Figure 10). The minimum water level in September corresponds to water surface elevation 2.6 feet *below* the ground surface. Maximum water levels in March correspond to a water surface elevation that is 0.6 feet *above* the ground surface (Figure 15).

Water temperature in the shallow groundwater at SPC-5 is highly moderated relative to observations from main channel locations (Figure 10). Winter minimum temperature was 43° F in February. Temperature slowly increased through the spring, reached a maximum of 54° F in late August and maintained a nearly constant temperature through early November when temperature dropped to the winter average near 46° F.

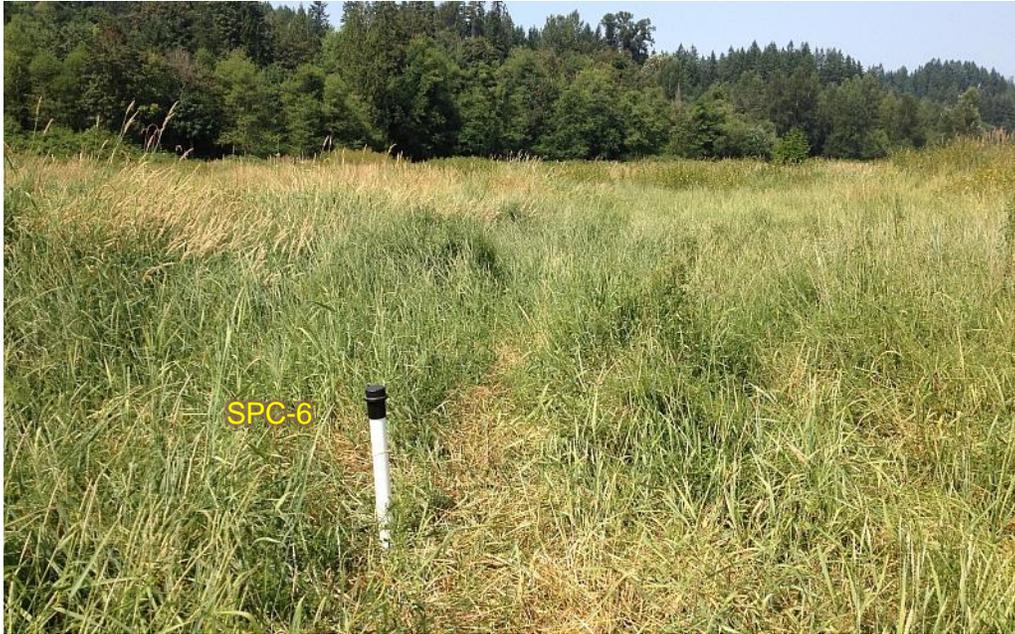
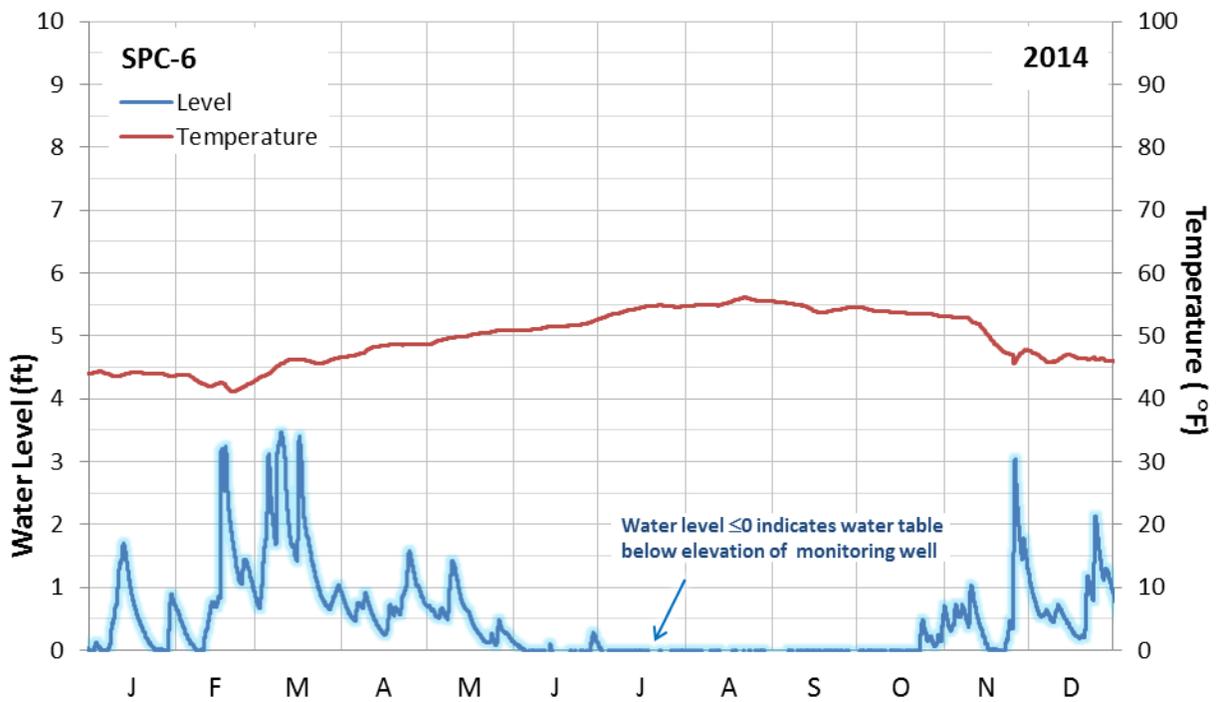
Figure 11. Annual time series (2014) of water level and temperature at SPC-6, a groundwater monitoring well in the floodplain swale 310 feet northwest of SPC-3.

Site 6 is a shallow groundwater monitoring well in the floodplain swale 310 feet northwest of SPC-3 near RM 4.5 (Figure 1). The well was augered in the center of the swale to a depth of only 3.3 feet below the ground surface due to refusal by a coarse cobble layer that underlies most of the terrace surface. Water level dropped below the base of the well for >150 days in 2014. The maximum water depth occurred in March when water rose to a depth of 3.5 feet (Figure 11). The peak water level corresponds to a surface water elevation that is 0.3 feet above the ground surface resulting in shallow inundation of the floodplain swale (Figure 16). Water level in SPC-6 has a slightly flashier regime compared to SPC-5; however, the shallow groundwater perched beneath the floodplain surface appears to maintain a consistent hydraulic gradient toward the main channel (Figure 19)

Water temperature in the shallow groundwater at SPC-6 was moderated relative to the fluctuations in surface water at the main channel locations (Figure 11). The temperature profile is very similar to observations from SPC-5 with a slightly higher maximum temperature of 56° F in late August.

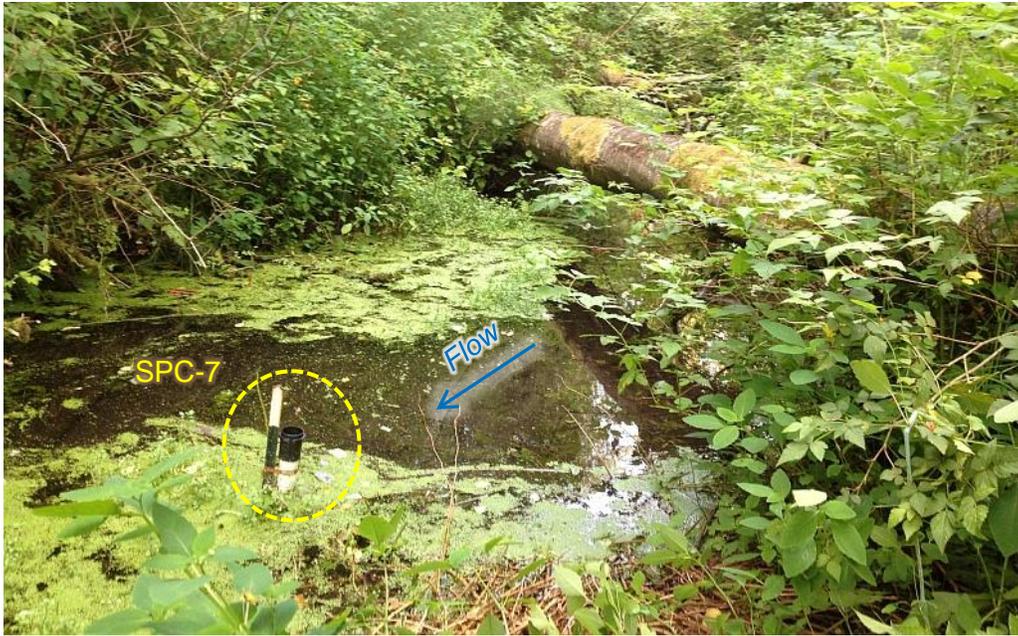
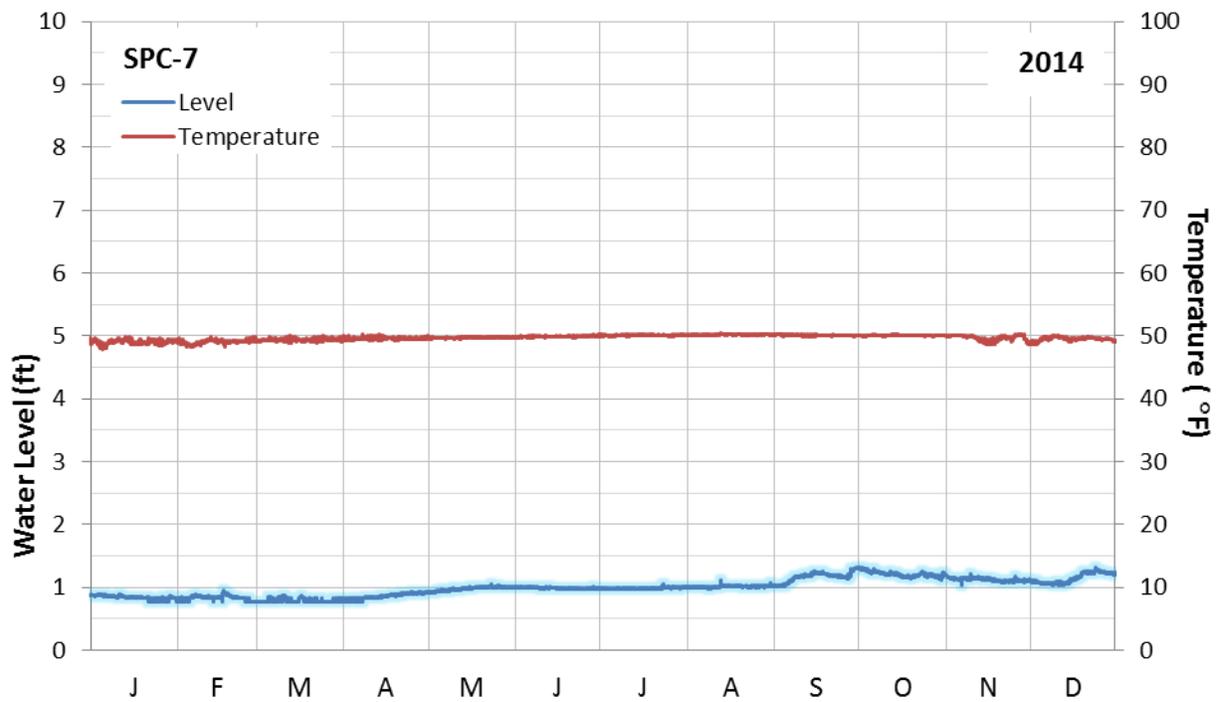
Figure 12. Annual time series (2014) of water level and temperature at SPC-7 in the spring-fed, wall-base channel 1,110 feet northwest of South Prairie Creek in a transect with SPC-2 and SPC-5.

Water level at SPC-7 remained nearly constant over 2014 gradually varying within a narrow range of depths between 0.8 and 1.2 feet (Figure 12). The wall-base channel at SPC-7 is 1.5 feet above the streambed in the main channel and about 3 feet below the floodplain swale along cross-section B-B' (Figure 15). The wall-base channel is flanked by a low berm and appears to have been artificially excavated in attempt to increase drainage of the adjacent pasture areas when the project site was managed as a dairy farm. During winter, water level at SPC-7 is generally 1 to 2 feet below the concurrent water surface elevations in the floodplain swale at SPC-5 (Figure 18). During summer, flow in the wall base channel is perched 0.5 to 1 foot above the shallow groundwater at SPC-5.

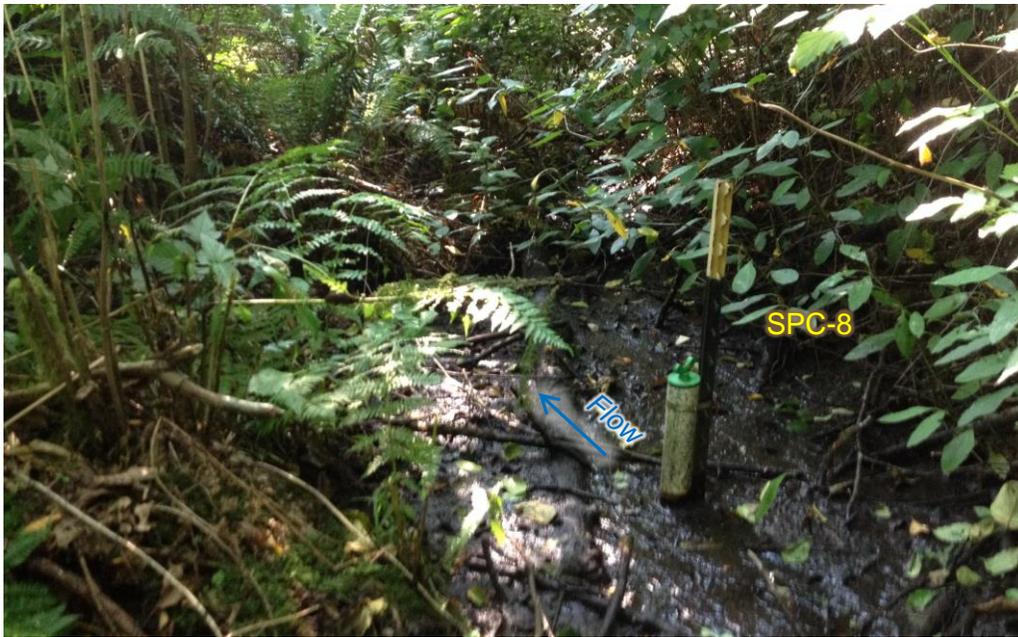
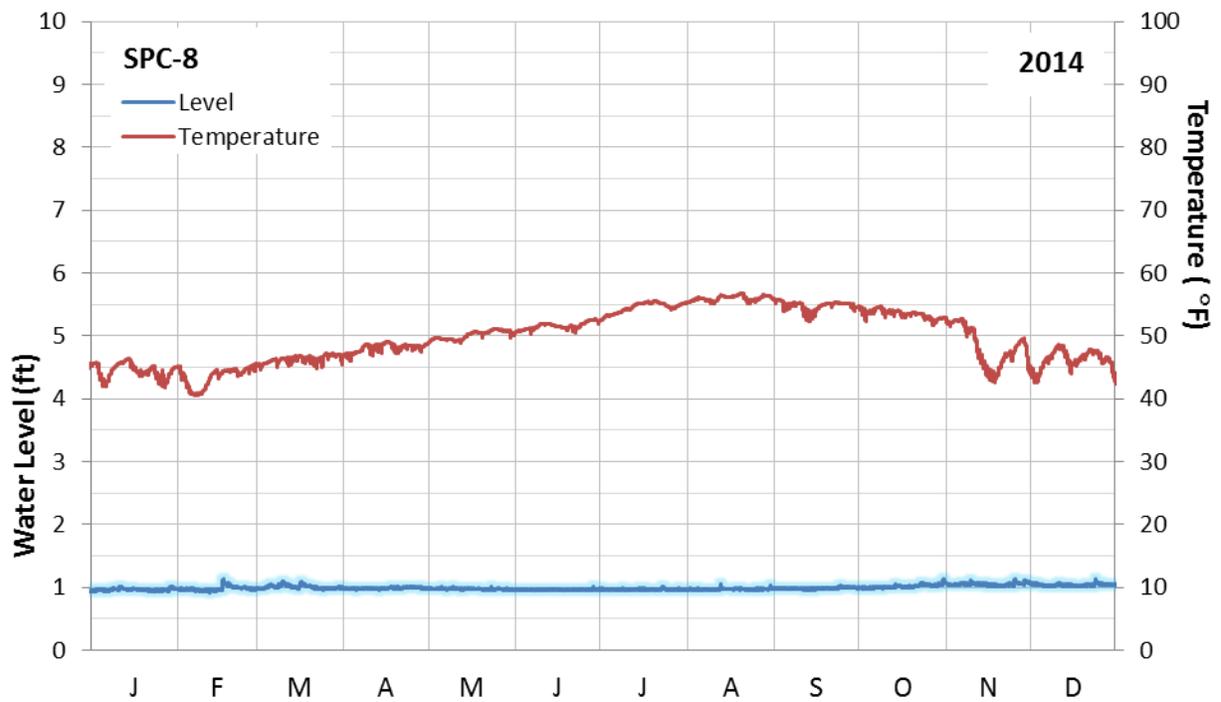
Figure 13. Annual time series (2014) of water level and temperature at SPC-8 in the wall-base channel 800 feet northwest of South Prairie Creek in a transect with SPC-3 and SPC-6.

Site 8 is a surface water monitoring site in the wall-base channel 800 feet northwest of South Prairie Creek along cross-section C-C' in a transect with SPC-3 and SPC-6. The stilling well is embedded within a layer of saturated organic material (muck) that has filled the bed of the channel. The channel is flanked by a large berm on the left bank appears to have been excavated to intercept the groundwater seepage from the adjacent hillslope. Water depth did not vary over the duration of monitoring and maintained a constant depth of 1 foot in the stilling well (Figure 13). This depth corresponds to the top of the muck layer that fills the bed of the channel.

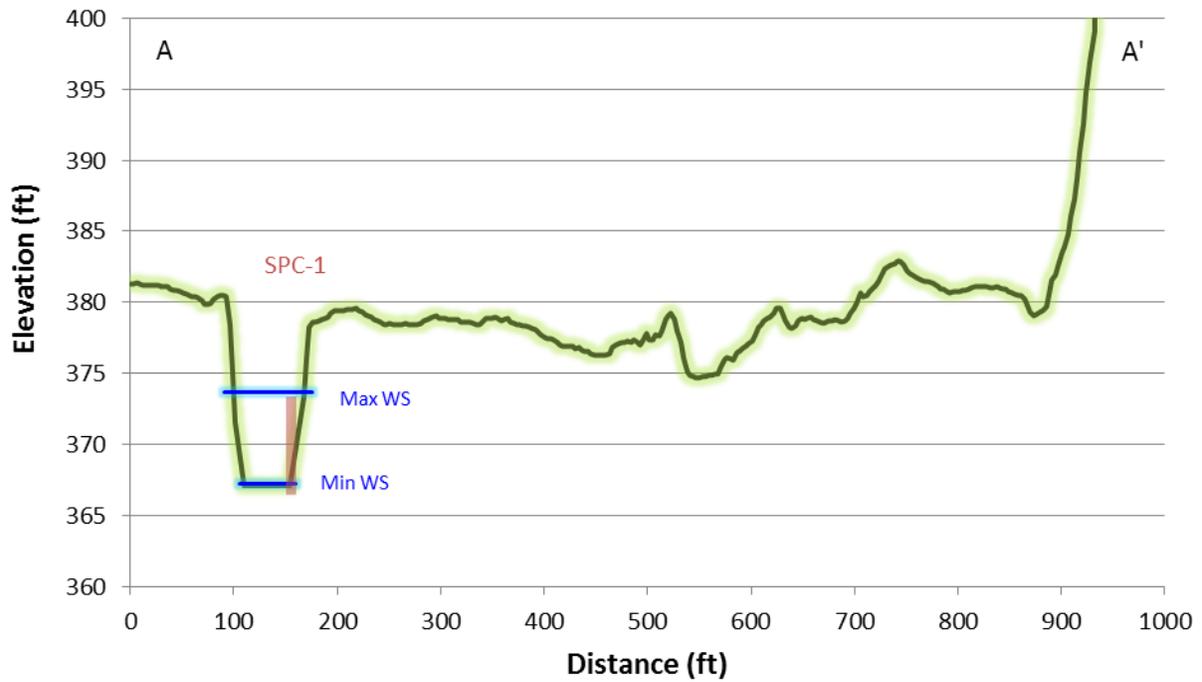
Figure 14. Cross-section A-A' with the range of observed water surface elevations from site SPC-1 in 2014.
