# TECHNICAL MEMORANDUM

**Re:** Water level and temperature monitoring at the Pierce Conservation District property (former Inglin Dairy Farm) on South Prairie Creek

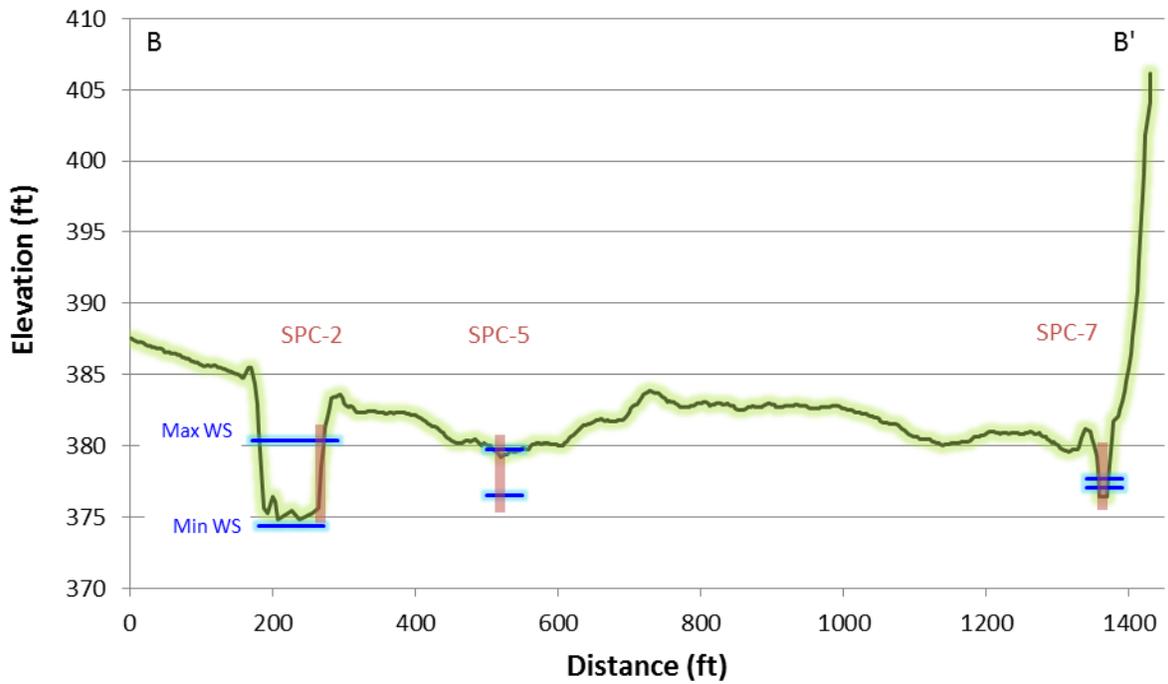
Figure 15. Cross-section B-B' with the range of observed water surface elevations from sites SPC-2, 5, and 7 in 2014.

Site 2 is located along the right bank near RM 4.25 and is 600 feet upstream of the bridge crossing over South Prairie Creek at the former Inglin Dairy (Figure 1). Water level fluctuations closely followed those described for site SPC-1 (Figure 7). The November 2014 flood peaked at a maximum depth of 6.5 feet. The maximum water surface elevation in November remained 2 to 3 feet below the right bank at cross-section B-B' (Figure 15).

The well was augered in the center of the swale to a depth of 4.8 feet below the ground surface. Water level fluctuated from a minimum depth of 2.1 feet in September to a maximum depth of 5.3 feet in March (Figure 10). The minimum water level in September corresponds to water surface elevation 2.6 feet *below* the ground surface. Maximum water levels in March correspond to a water surface elevation that is 0.6 feet *above* the ground surface (Figure 15).

Water level at SPC-7 remained nearly constant over 2014 gradually varying within a narrow range of depths between 0.8 and 1.2 feet (Figure 12). The wall-base channel at SPC-7 is 1.5 feet above the streambed in the main channel and about 3 feet below the floodplain swale along cross-section B-B' (Figure 15). The wall-base channel is flanked by a low berm and appears to have been artificially excavated in attempt to increase drainage of the adjacent pasture areas when the project site was managed as a dairy farm. During winter, water level at SPC-7 is generally 1 to 2 feet below the concurrent water surface elevations in the floodplain swale at SPC-5 (Figure 18). During summer, flow in the wall base channel is perched 0.5 to 1 foot above the shallow groundwater at SPC-5.

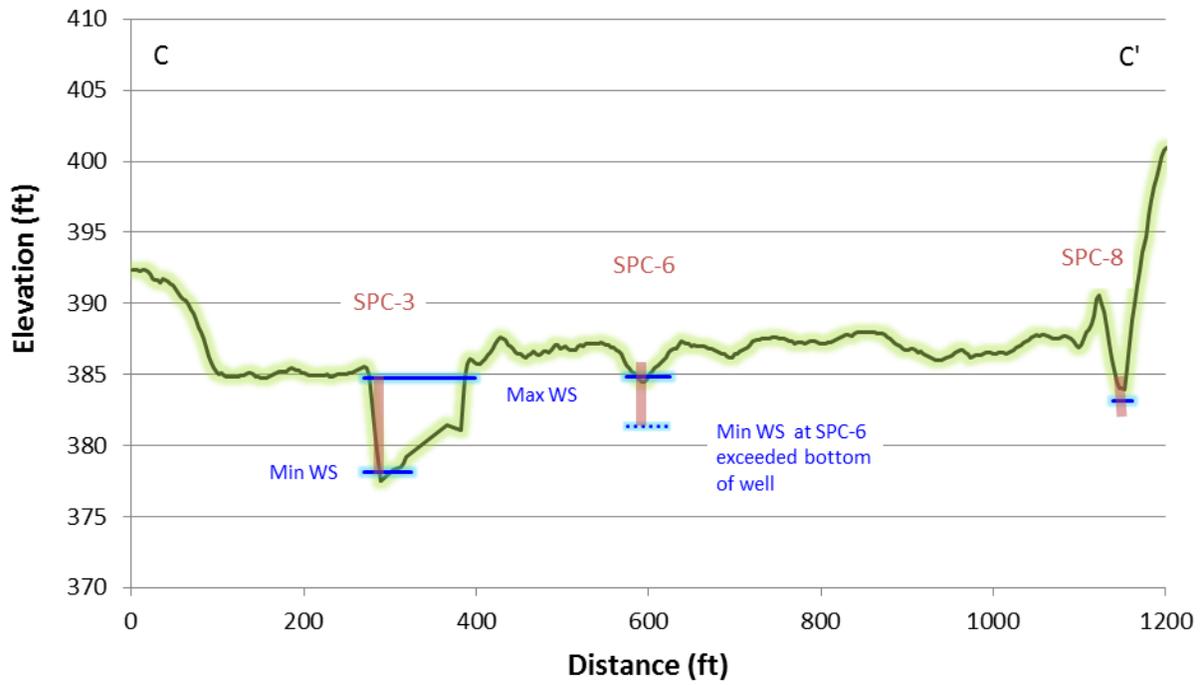
Figure 16. Cross-section C-C' with the range of observed water surface elevations from sites SPC-3, 6, and 8 in 2014.

Site 3 is located along the left bank near RM 4.4 and is immediately downstream of a steep bank that eroded laterally on the opposite (north) side of the channel in 2009 (Figure 1). The pool along the left bank maintained a minimum depth of 1.5 feet and reached a maximum depth of 8.1 feet in November (Figure 8). The peak water surface nearly overtopped the left bank at cross-section C-C' but remained approximately 2 feet below the right bank and adjacent ground surface of the low terrace to the north (Figure 16).

The wall-base channel at SPC-8 has an invert elevation of 382.5 feet indicating a downstream gradient of 0.009 ft/ft (0.9%) between SPC-7 and 8. The wall-base channel is 1.9 feet below the floodplain swale in cross-section C-C' (Figure 16). Plots of concurrent water surface elevations show that the water table at SPC-8 is consistently perched above the fluctuating water table in the floodplain swale at SPC-6 (Figure 19).

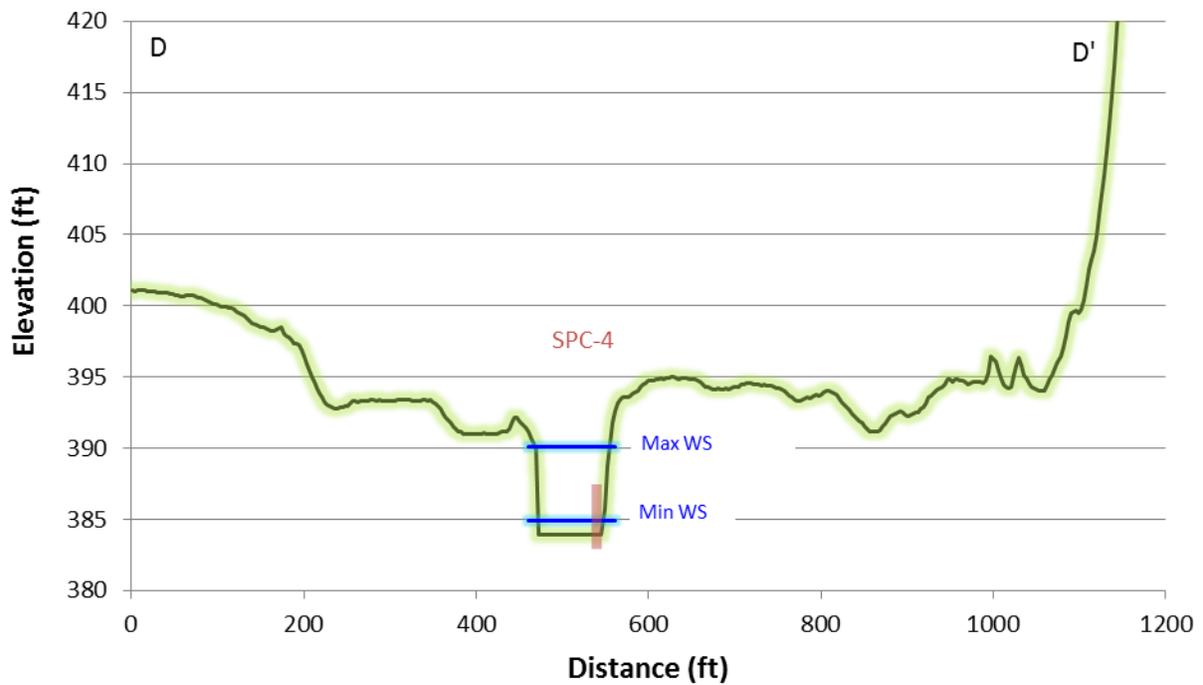
Figure 17. Cross-section D-D' with the range of observed water surface elevations from site SPC-4 in 2014.

Site 4 is located along the right bank near RM 4.6 at the upstream end of the project area (Figure 1). The channel maintained a minimum depth of 1.5 feet and reached a maximum depth of 6.8 feet in November (Figure 9). The peak water surface nearly overtopped the left bank at cross-section D-D' but remained approximately 4 feet below the right bank and adjacent ground surface of the low terrace to the north (Figure 17).

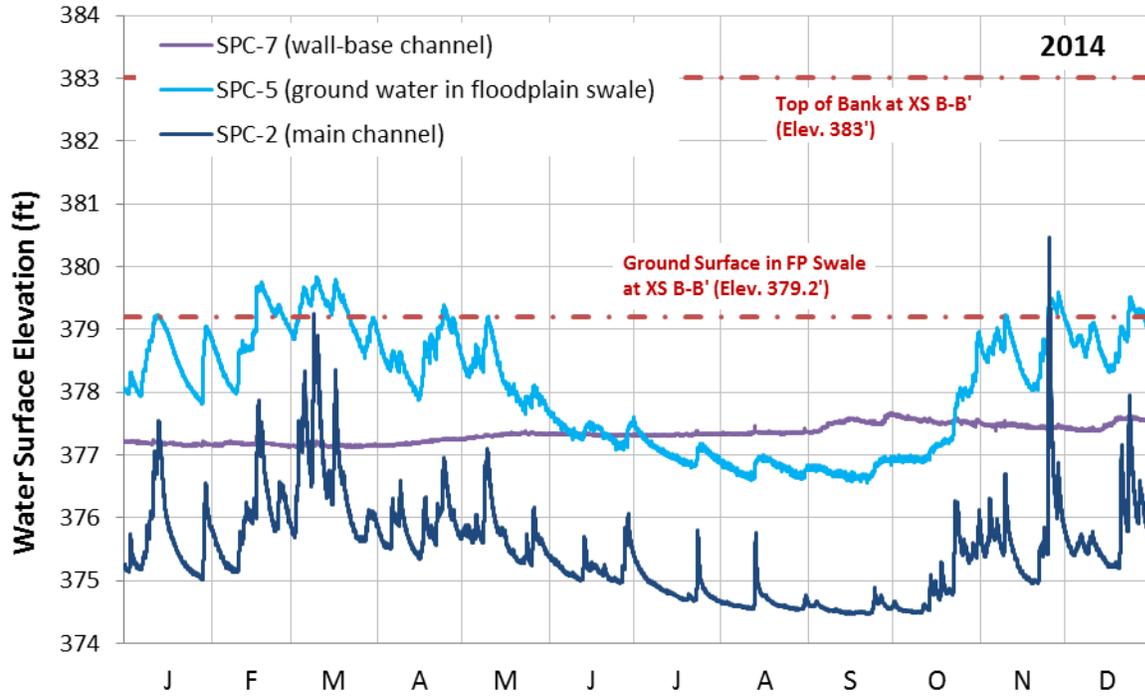
Figure 18. Comparison of water surface elevations for Sites SPC-2, 5, and 7 (cross-section B-B')

Comparisons of shallow groundwater elevations at SPC-5 with concurrent water surface elevations in the main channel (SPC-2) and adjacent wall-base channel (SPC-7) are plotted in Figure 18. Shallow groundwater at SPC-5 is consistently perched 2 to 3 feet higher than the concurrent water surface elevation in the main channel. Throughout winter, water level fluctuated from approximately 1 foot below the ground surface to approximately 1 foot above the ground surface with a repeated wetting and drying of the floodplain swale. During flood flows, such as the March 9<sup>th</sup> or November 25<sup>th</sup> events, water level at SPC-5 is nearly equivalent to the water surface in the channel, although there is an area of high ground along the right bank that limits floodplain connectivity through this segment (Figure 15). During the summer low flow period, ground water remains close to the ground surface and maintains a positive hydraulic gradient towards the main channel.

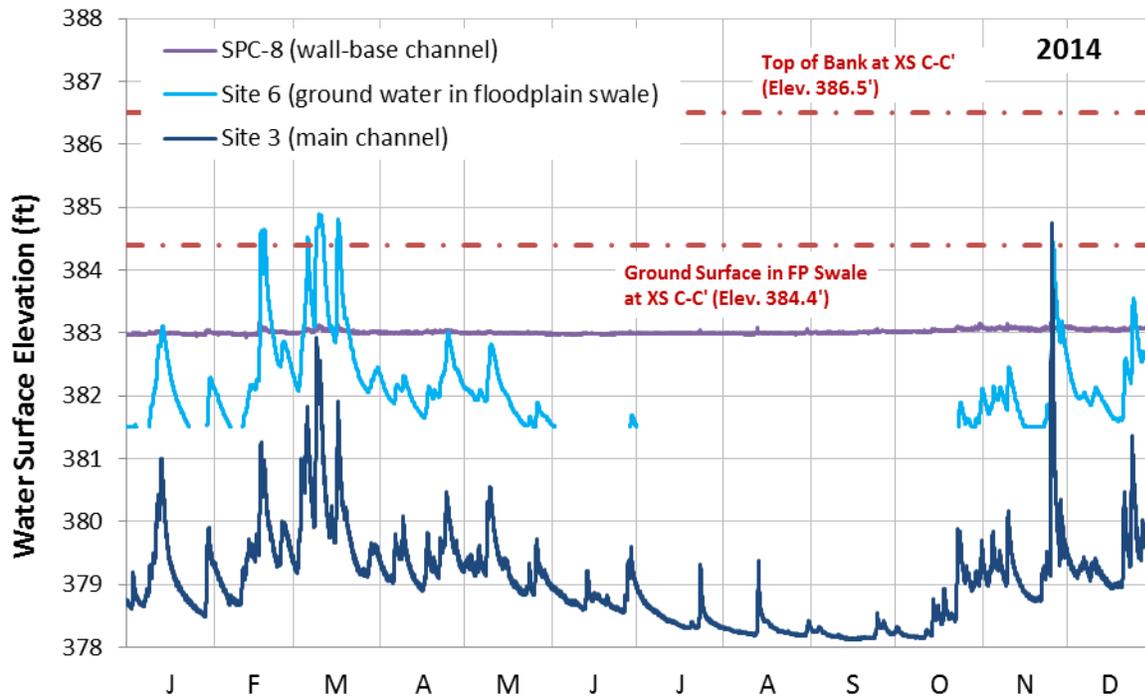
Figure 19. Comparison of water surface elevations for Sites SPC-3, and 6 (cross-section C-C')

Site 6 is a shallow groundwater monitoring well in the floodplain swale 310 feet northwest of SPC-3 near RM 4.5 (Figure 1). The well was augered in the center of the swale to a depth of only 3.3 feet below the ground surface due to refusal by a coarse cobble layer that underlies most of the terrace surface. Water level dropped below the base of the well for >150 days in 2014. The maximum water depth occurred in March when water rose to a depth of 3.5 feet (Figure 11). The peak water level corresponds to a surface water elevation that is 0.3 feet above the ground surface resulting in shallow inundation of the floodplain swale (Figure 16). Water level in SPC-6 has a slightly flashier regime compared to SPC-5; however, the shallow groundwater perched beneath the floodplain surface appears to maintain a consistent hydraulic gradient toward the main channel (Figure 19)
