Salmon Creek Culvert Replacement
Hydraulic Analysis
W. Uncas Road

Prepared by:
Watershed Science & Engineering
110 Prefontaine Pl S., Suite 508
Seattle, WA 98104

May 12, 2015

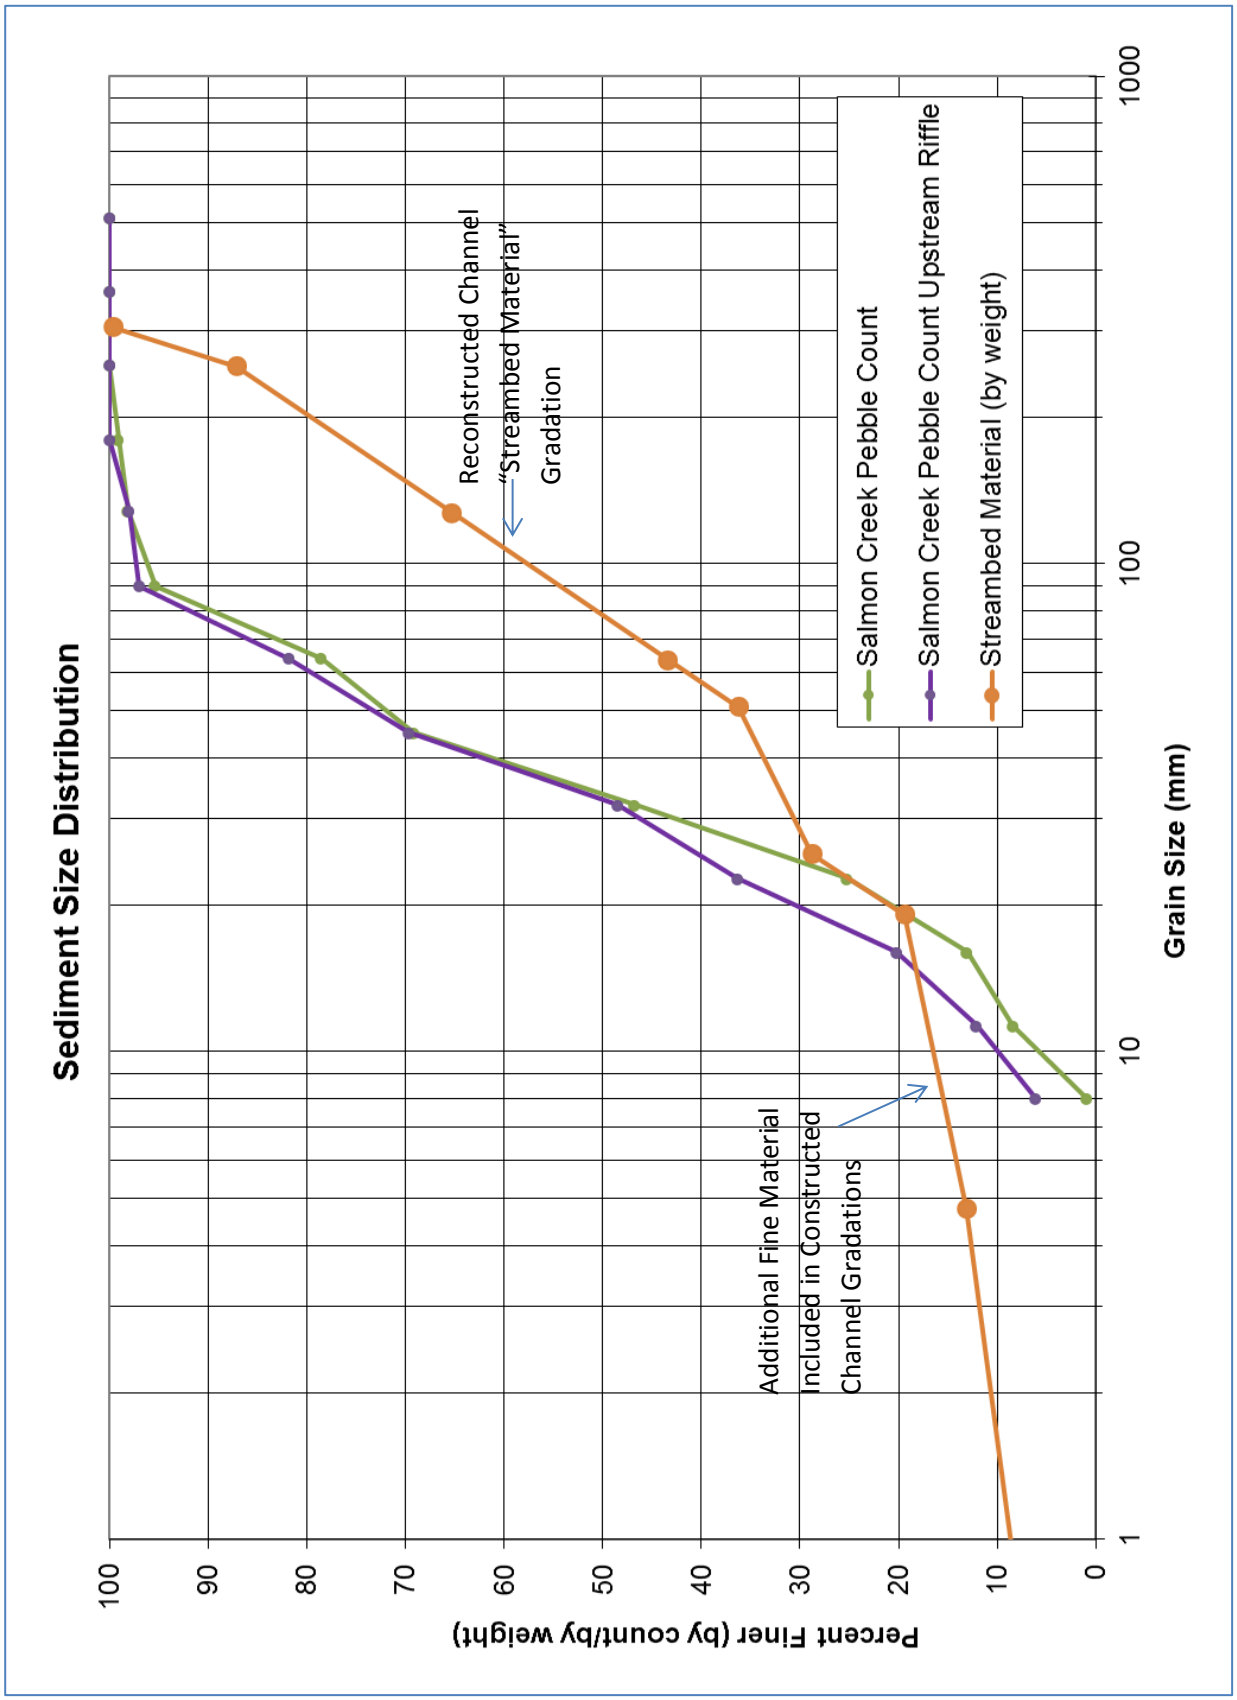
Figure 2. Salmon Creek Sediment Size Distribution Based on Wolman Pebble Count.

8 WSE completed Wolman Pebble counts in order to estimate a surface bed material gradation (Photo 6). Two separate counts were conducted: one at the riffle immediately upstream from the culvert and the other approximately 600-feet upstream. Both counts suggest a mean particle diameter (D_{50}) of approximately 35 mm (1.5 inches, see Figure 2). (Note – Figure 2 contains additional sediment size gradation data which will be discussed later in this report.)

As an added precaution and to improve habitat it is best to keep the thalweg of the channel from shifting laterally to the riprap covered abutment slope. To reduce this likelihood we included additional coarse material in the streambed material mix, as shown in Figure 2, and specified in Table 3.

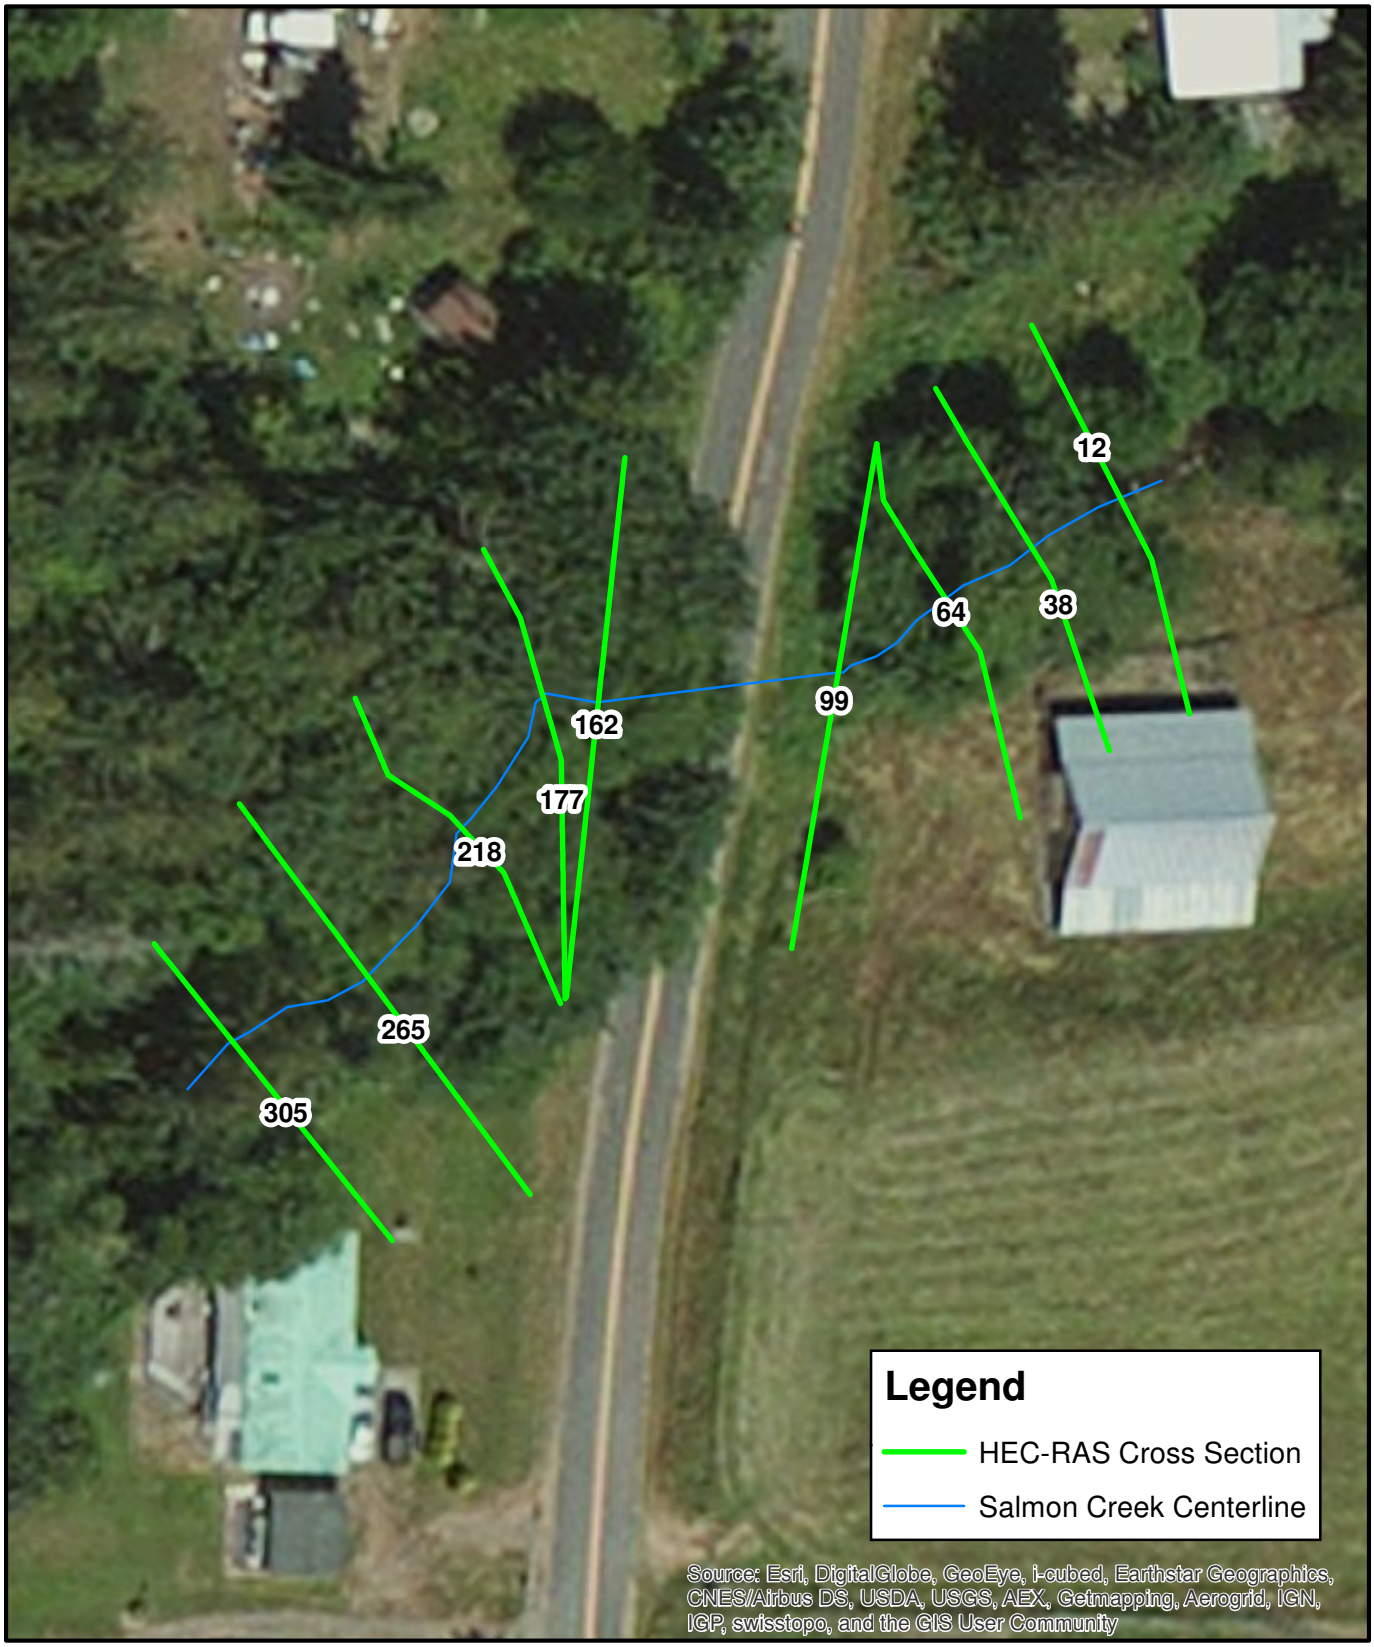
Figure 3

The "existing condition" model geometry represents conditions that exist today. The geometry is based on topographic survey collected by Van Aller Surveying in October, 2014. Model cross section layout is shown in Figure 3.

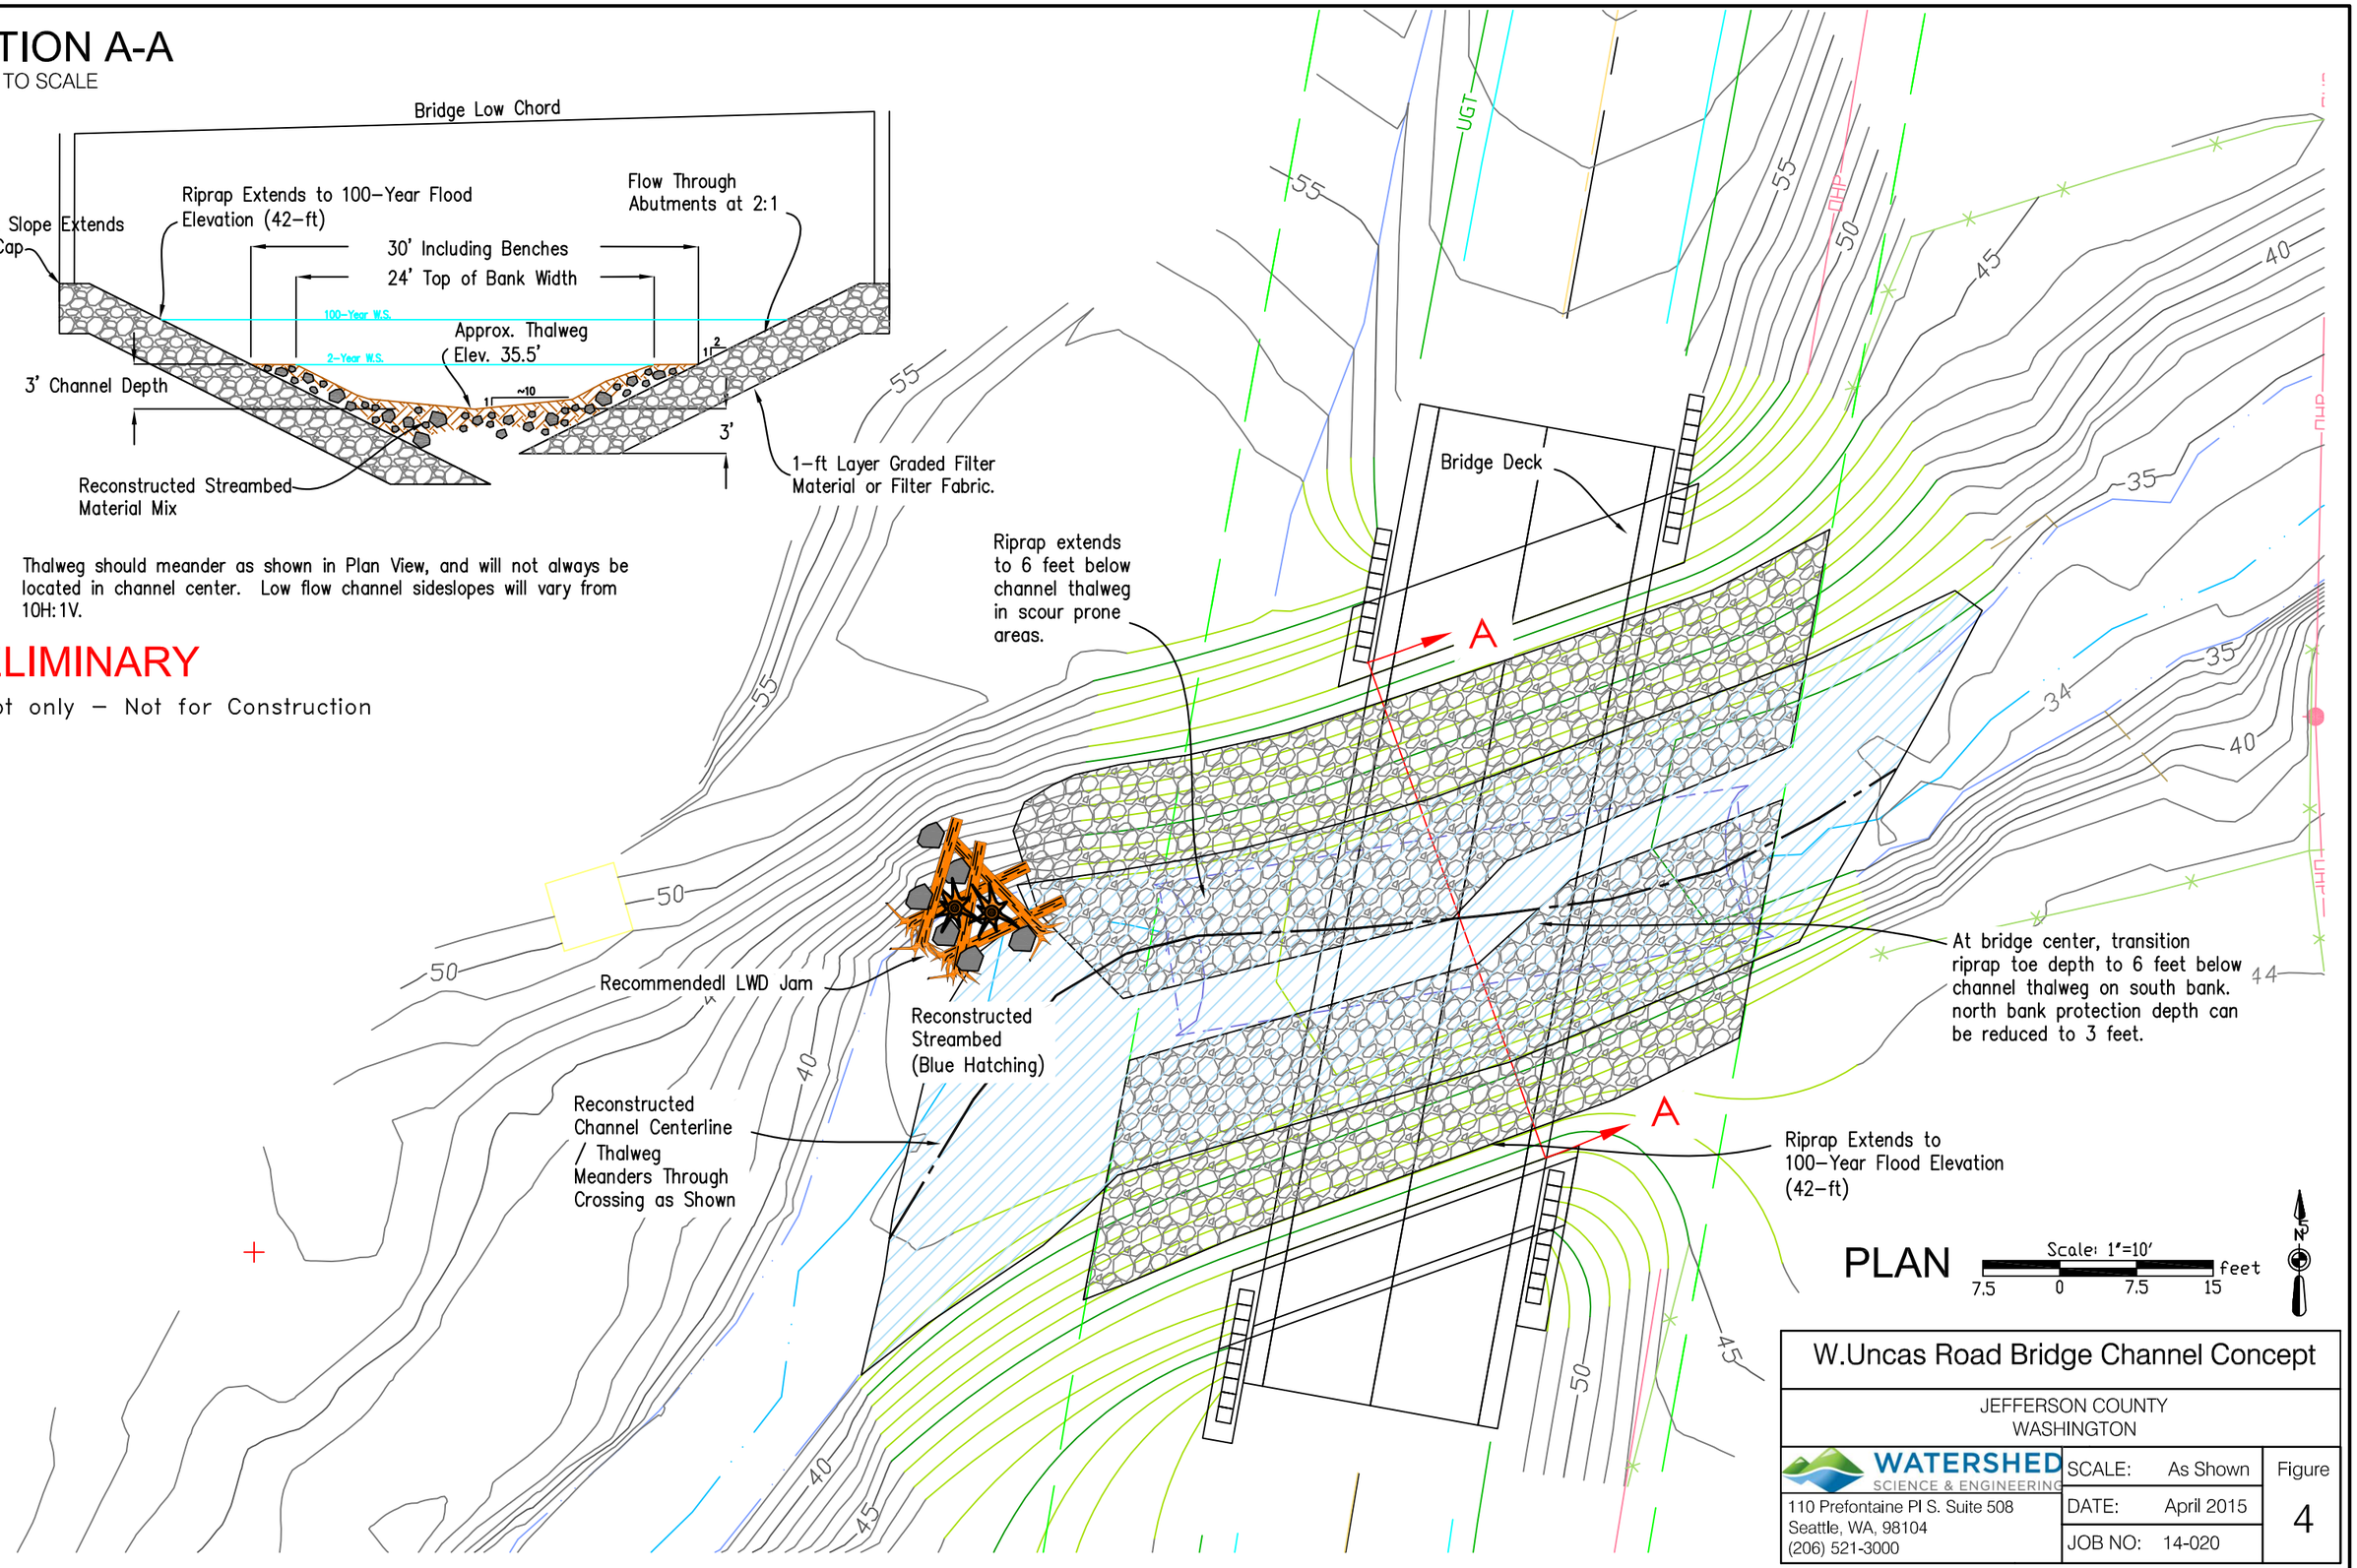
W.Uncas Road Bridge Channel Concept		
JEFFERSON COUNTY WASHINGTON		
WATERSHED SCIENCE & ENGINEERING 110 Prefontaine Pl S. Suite 508 Seattle, WA, 98104 (206) 521-3000	SCALE: As Shown DATE: April 2015 JOB NO: 14-020	Figure 4

"Proposed" condition model geometries were then created to represent conditions that would exist following installation of the proposed bridge crossing. Through discussion with Shearer Design, it was determined that an 80-ft bridge span (skewed 30 degrees to the channel) was adequate to allow re-construction of a 30-foot low flow channel between 2H:1V sloping abutments. The proposed bridge layout is shown in Figure 4.

Figures 4 shows the proposed channel layout for the reconstructed bridge channel. Bed material should conform to the gradation detailed in Table 3. Additional fine material has been specified to fill void spaces and prevent interstitial flow. Steambed material used to construct the channel shall be clean, naturally occurring water rounded gravel and cobble material. Angular rock from quarries, ledge rock, talus slopes are not acceptable for this application. Streambed material shall have uniform distribution of size and conform to the following gradation requirements.

Streambed material for the stream channel restoration should be made up of the "Streambed Material" listed in Table 3. The recommended design shown in Figure 4 includes includes filling the scour hole downstream of the culvert to eliminate the drop in bed surface and provide continuity between the reconstructed crossing and the downstream reach. A cross section view of the proposed channel has been included in the channel design figures. An initial "V" shaped low flow channel should be placed at the time the channel is constructed as shown in the cross section elevation view (Figure 4). The low flow channel should be placed to meander as shown in the plan view. Channel sideslopes will be approximately 10H:1V, but will to vary slightly to construct the channel meander while maintaining the longitudinal channel slope.

A large wood jam upstream of the bridge opening is recommended to help redirect flow into the re-aligned bridge channel and protect the left (south) bank abutment from erosion (see Figure 4).

Both abutments will need to be protected from lateral erosion and local scour. The recommended approach is to cover the slopes with a 3-foot thick blanket of WSDOT specified heavy-loose rock riprap set on a 1-ft thick graded filter or appropriate geotextile filter fabric (Figure 4). To prevent scour from undermining the slope protection, the toe of the riprap will need to be keyed into and buried below the bed of the stream at all locations (Figure 4). The toe of the riprap protection should extend to or below elevation 32 feet (NAVD 88) along the upstream right (south) and downstream left (north) banks. It should extend to or below 30 feet (NAVD) along the upstream left (north) and downstream right (south) banks, this because as described above deeper scour is expected in these areas (see Figure 4). To simplify construction, all protection could be extended to elevation 30 feet rather than varying the depth as shown in Figure 4.

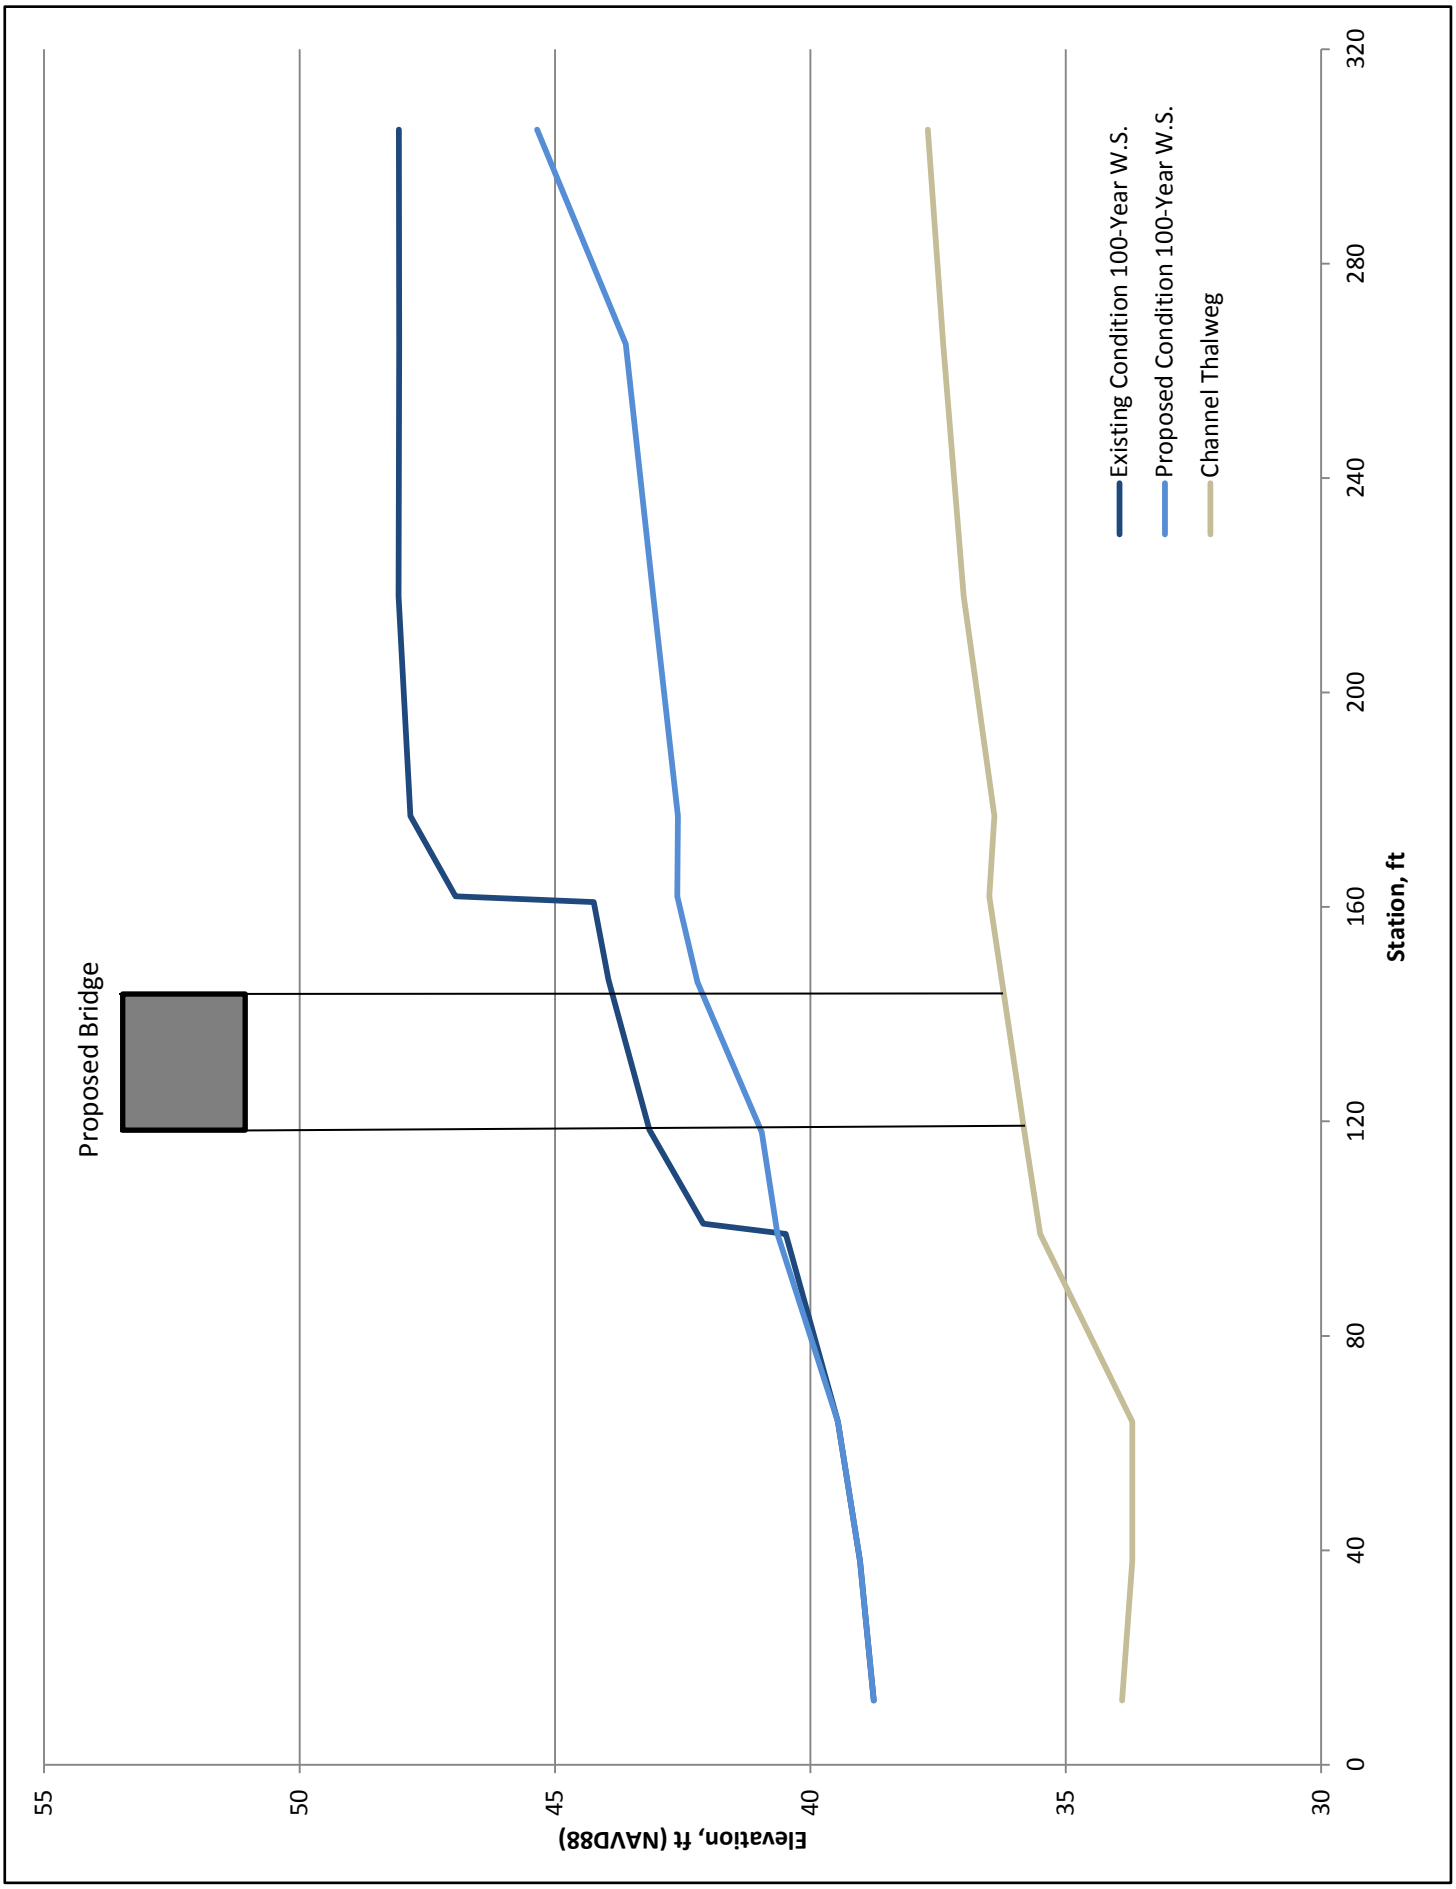
Figure 5. 100 Year Water Surface Profile Comparison

Both the Existing and Proposed condition models were run for flows listed in Table 1. Results for the 100-year event are presented in Table 2 and the profiles are compared in Figure 5. The existing culvert structure can safely pass the 100-year event without roadway overtopping; however, the crossing constricts flow, resulting in increased water surface elevation and reduced velocities immediately upstream from the crossing, and increased velocities and scour potential downstream.
