# Barrier Evaluation Form – Single Culvert at Crossing

Project Name: <b>Floodplain side channel connectivity (FC 14 Cedar Grove)</b>		SRFB Project #: <b>15-1166</b>	County: <b>Skagit</b>
HPA #: <b>NA</b>		Parcel #: <b>NA-in Skagit County ROW</b>	
GPS Location: Datum - <b>WGS84 -decimal degrees</b>		Latitude: <b>48.52786</b>	Longitude: <b>-121.73797</b>
¼ Section: <b>NW 1/4</b>	Section: <b>14</b>	Township: <b>35N</b>	Range: <b>8</b> <input checked="" type="checkbox"/> East <input type="checkbox"/> West
Stream Name: <b>Ovenell Springs</b>		Tributary To: <b>Skagit River</b>	WRIA #: <b>04.0176x</b>
Driving Directions: <b>from I-5 take exit 230 to HWY 20 east, turn right onto Concrete-Sauk Valley RD and travel about 3 miles, turn right onto Cedar Grove Avenue and continue about 1000 yards.</b>

# Ovenell Springs Parcel Map

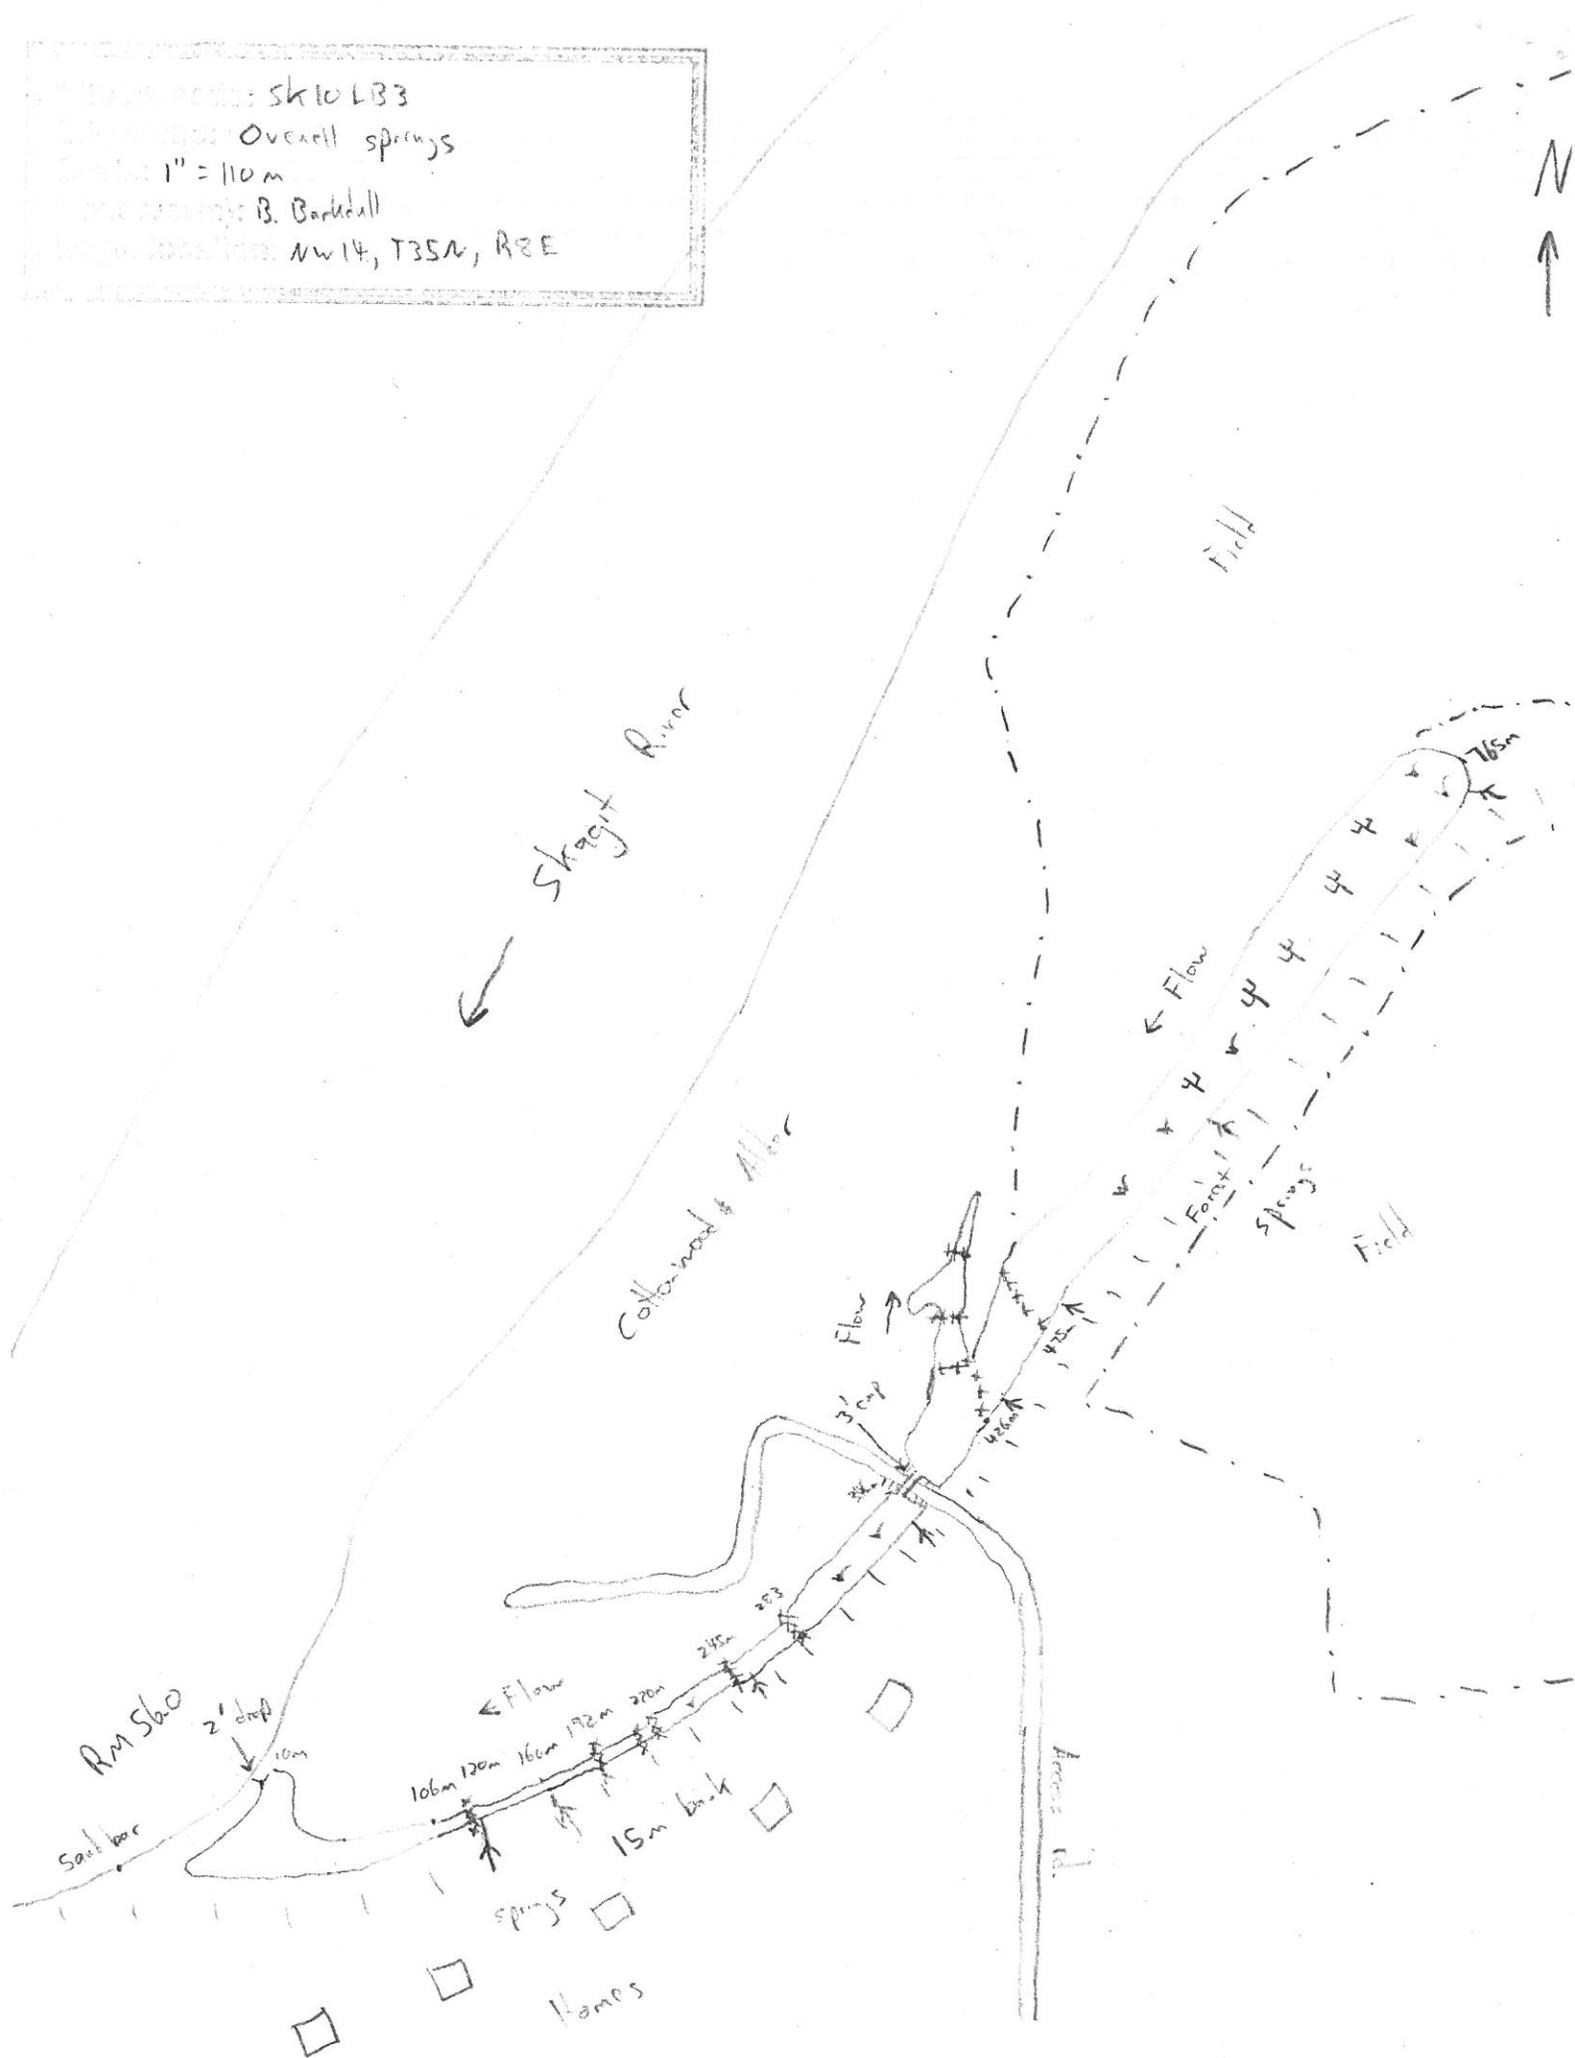
1. Well No. 10: SK10 LB3  
 2. Well No. 11: Overall springs  
 Scale: 1" = 110m  
 Drawn by: B. Barkdall  
 Section: NW 14, T35N, R2E

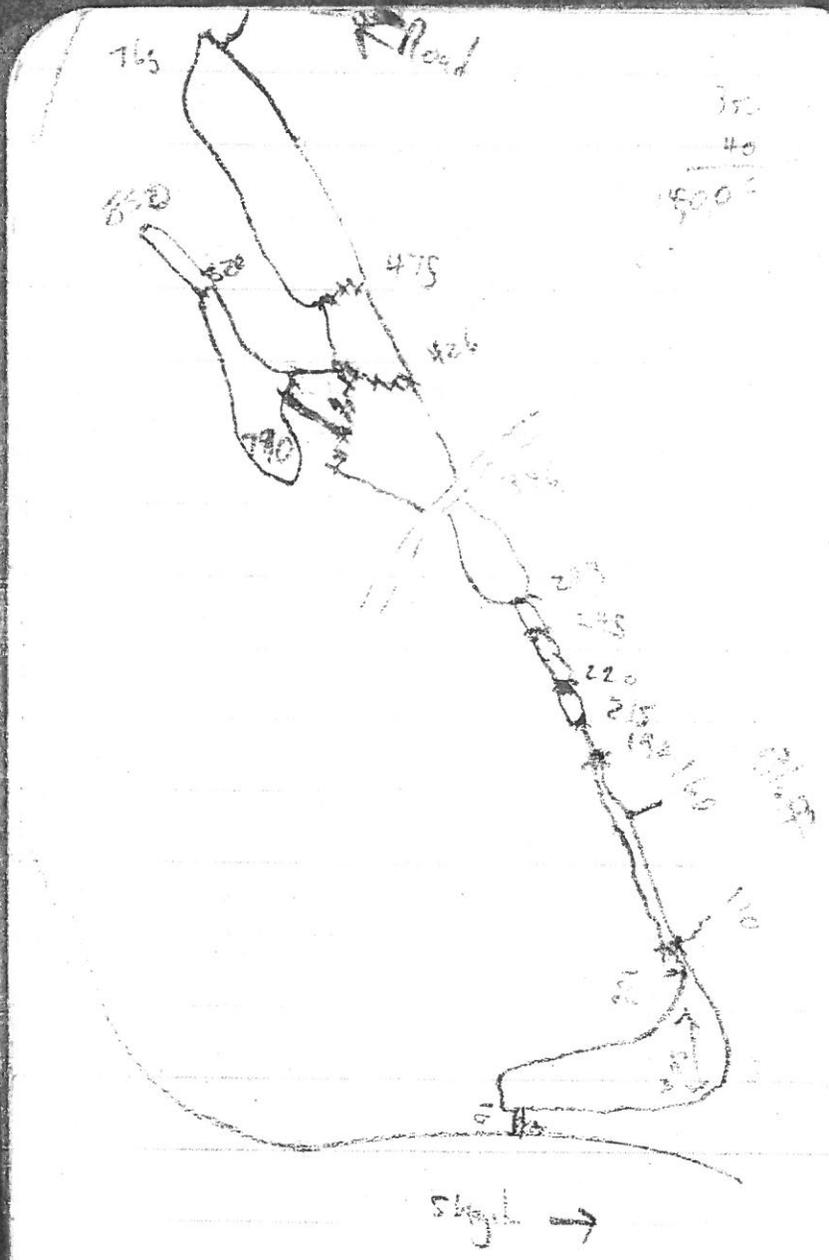
4/22/06 Cedar Grove spring 510

- 0-0 1.0 lots
- 10. 1.0 opens up 2' deep at base
- 106 20 1m deep, willows, mud bottom
- 120 10 Remove dam large stream
