Figure 1. Geomorphic features in the North Fork Nooksack River, Farmhouse reach. Excerpted from Geoengineers 2012.

Figure 8. Site plan for Phase 2 restoration by subphase. Phase 2b is proposed for this project.

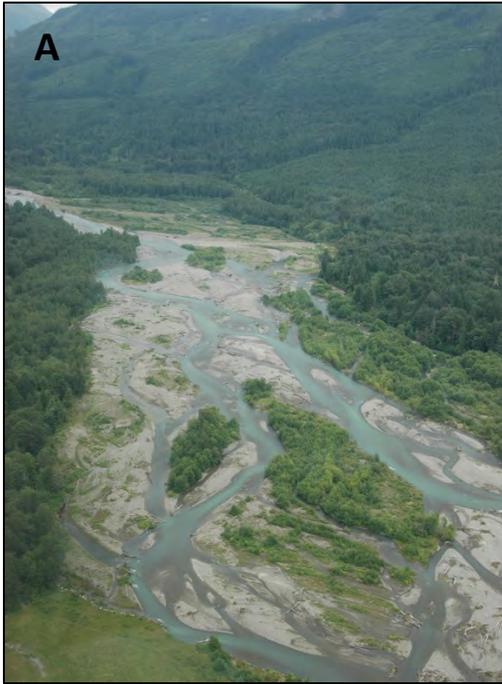
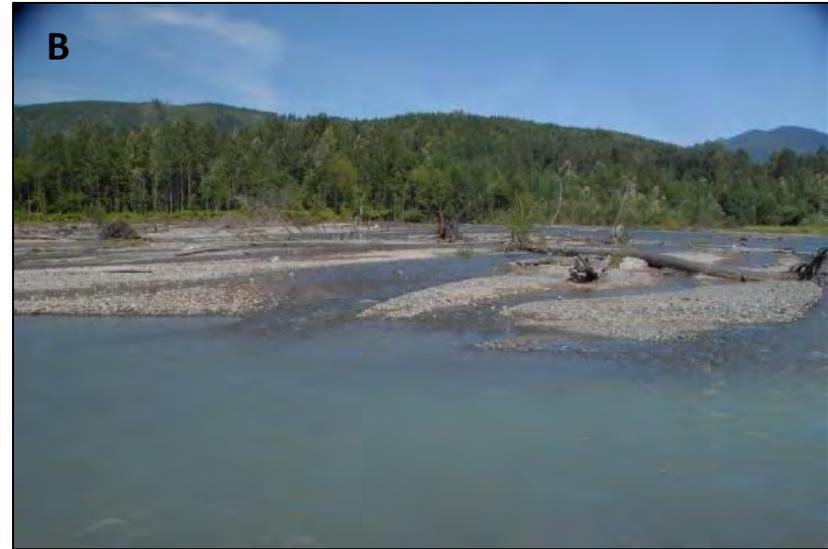
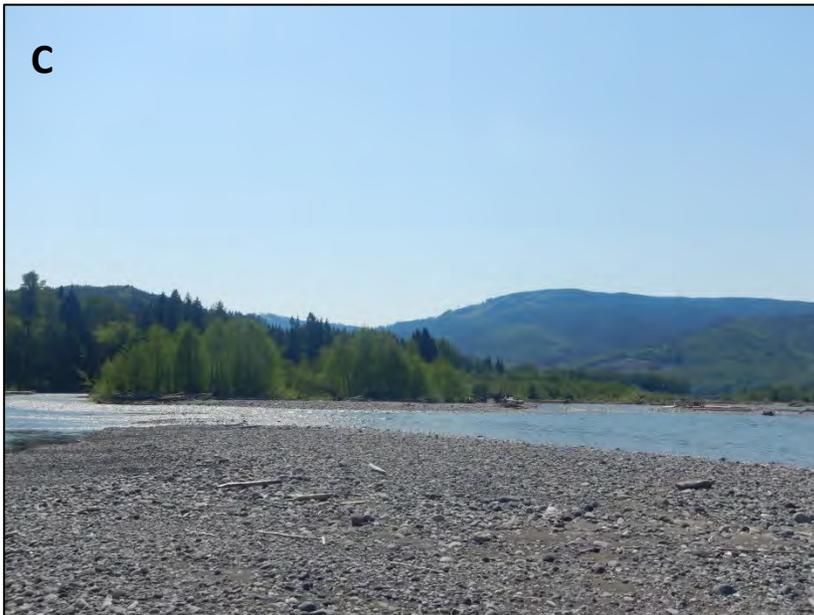
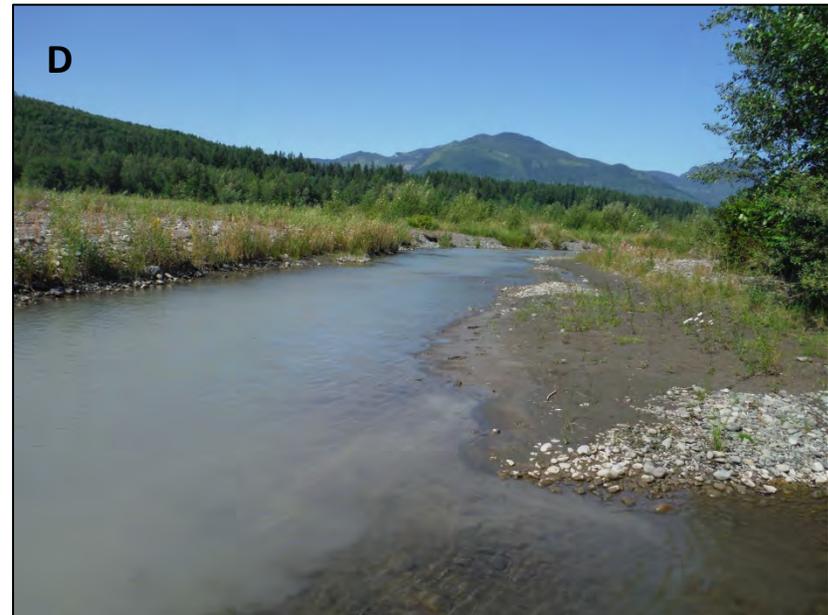
Figure 7. Photos of Farmhouse reach: A: Aerial oblique view of braided subreach (RM) taken June 2014; B: main channel character; C: Phase 2B channel island; D: Falls Creek side channel. Top left photo courtesy of Herrera and right photo courtesy of GeoEngineers.

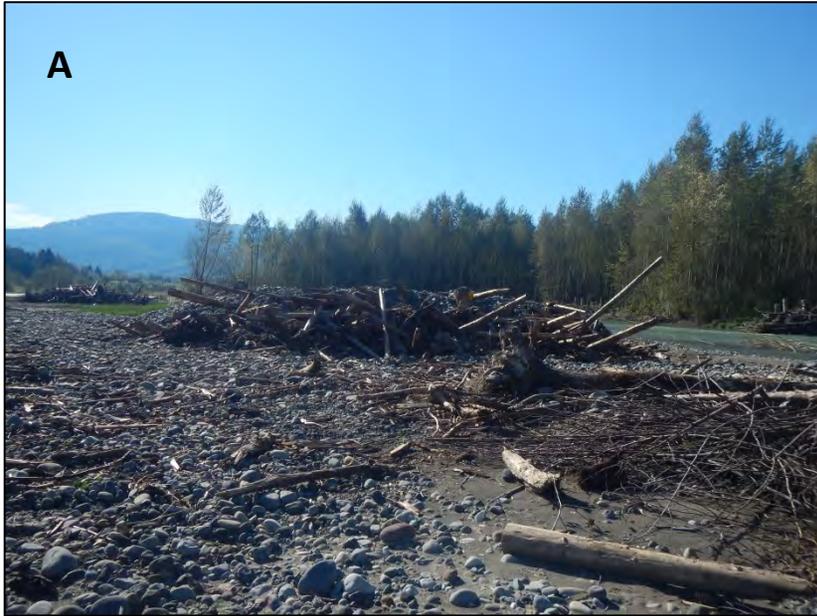
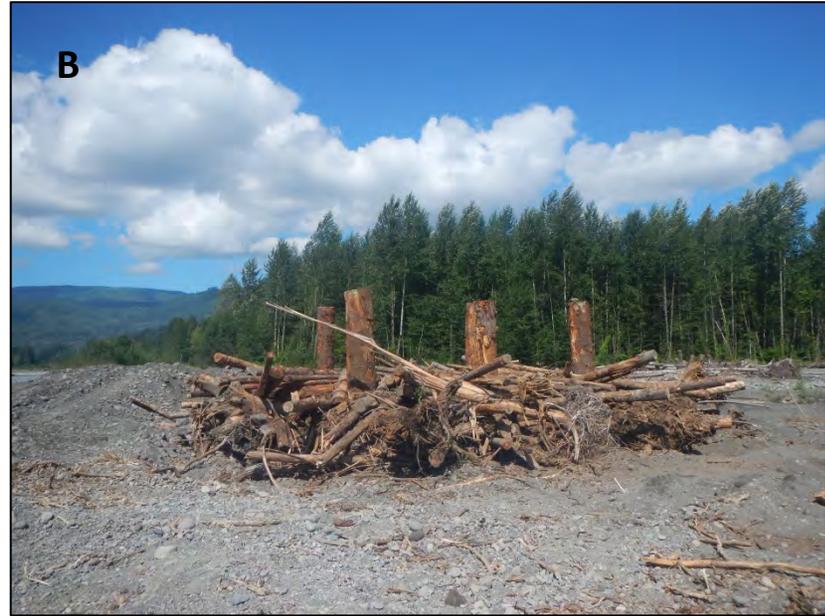
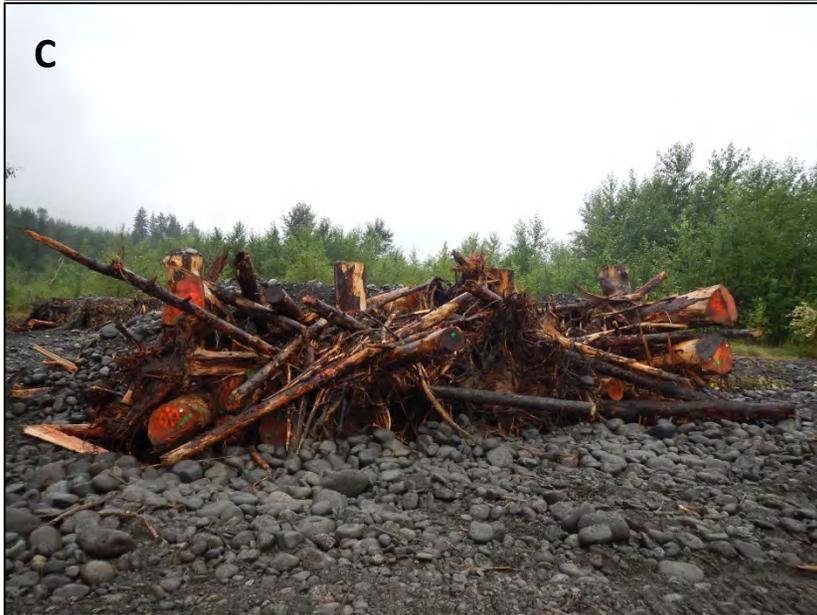
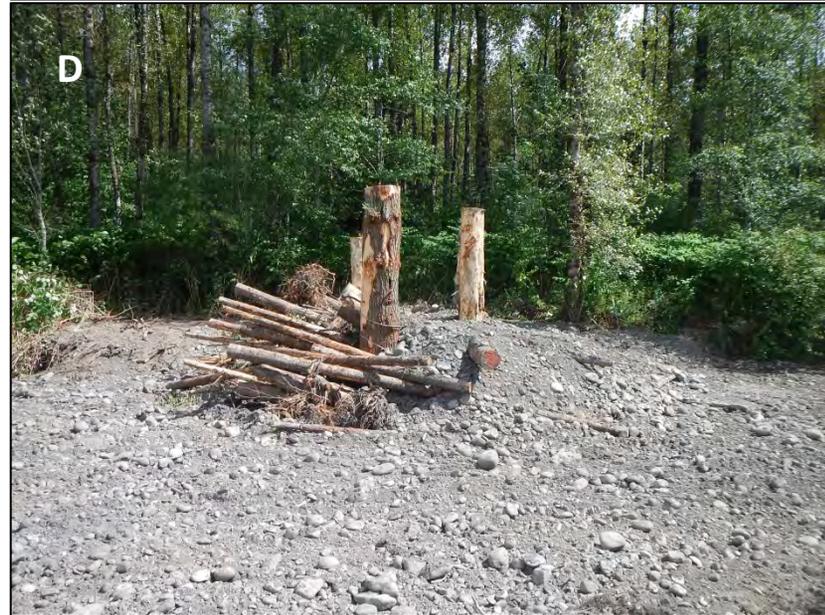
Figure 9. Structure types proposed for the North Fork Nooksack River Farmhouse Reach restoration project. A: Type 1; B: Timber Gnarl; C: Type 2; D: Type 3 side channel structures. Note only the Timber Gnarl and Type 3 ELJ's are proposed in Phase 2b.

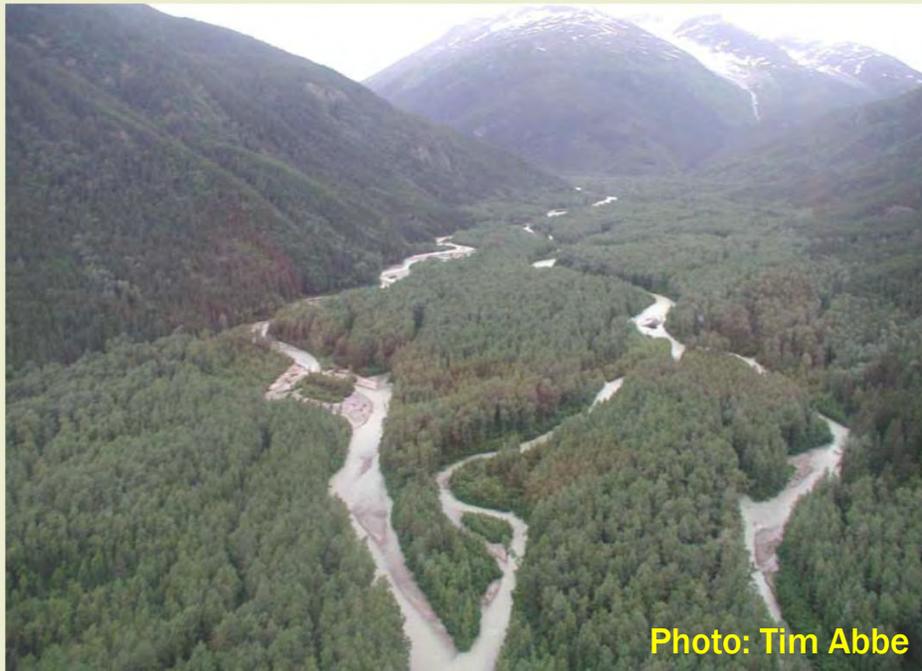
1850 (Analog)

- Anastomosing Channel (Taiya River, AK)
- Extensive mature floodplain forest side-channel network
- Forest and wood stabilized channel banks

Figure 10. Floodplain forest conditions in the Taiya River (historical analog) and the North Fork Nooksack River.

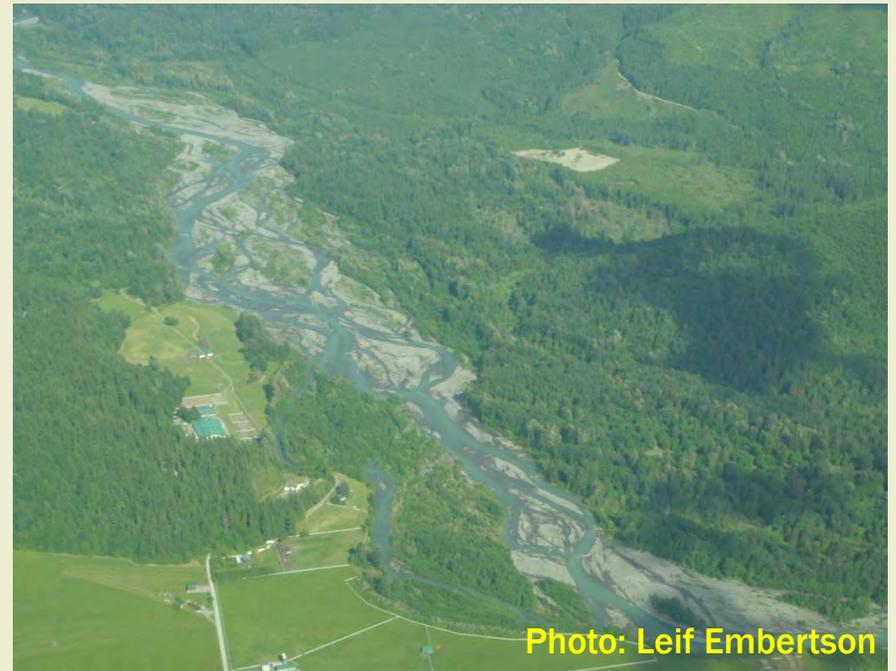
North Fork Nooksack (2011)

- Shallow Braided River Channel
- Immature red alder dominated floodplain forest
- Loss of forest channel bank stability
- Loss of stable side-channels
- Very limited functional salmon habitat
